# Brickyard Conditions Survey

Castle Rock, Colorado

June 2022

Ricker | Cunningham  
9552 Middle Fork Street  
Littleton, CO 80125-8467  
303.458.5800 phone  
[www.rickercunningham.com](http://www.rickercunningham.com)

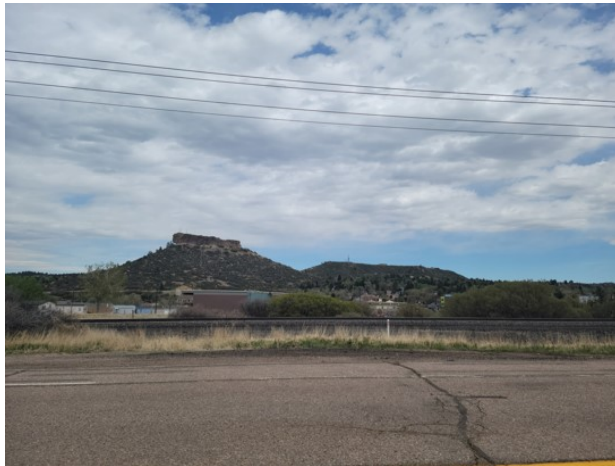
Visible Factors b,d,f,h

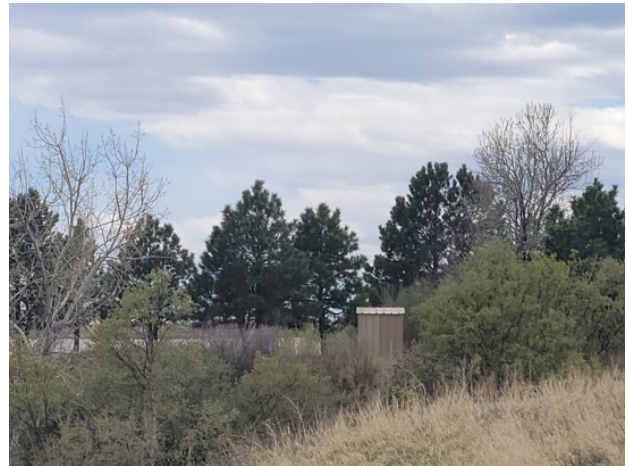
Visible Factors a,d,e

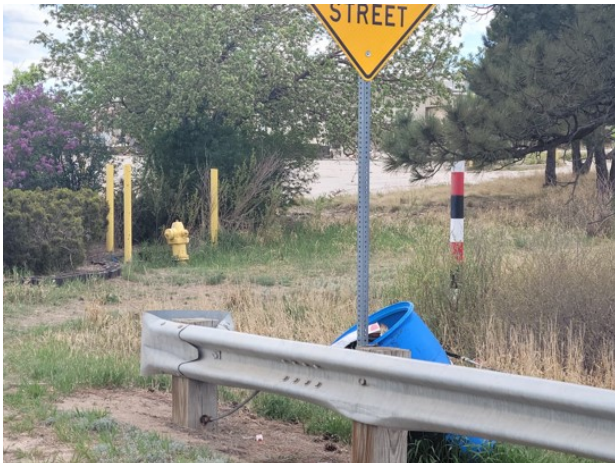
Visible Factors b,c,d,e

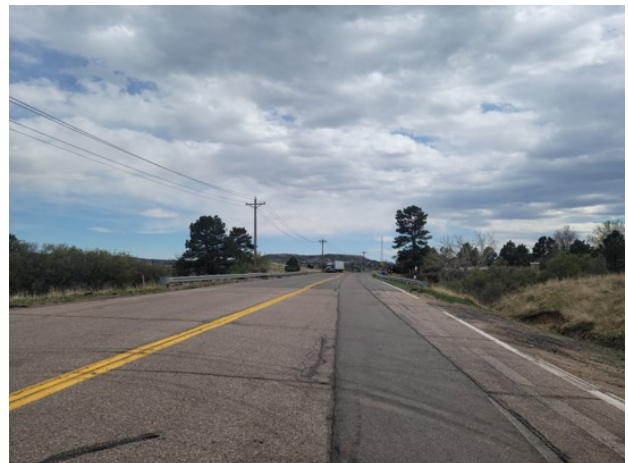
Visible Factors b,c,d,f,h

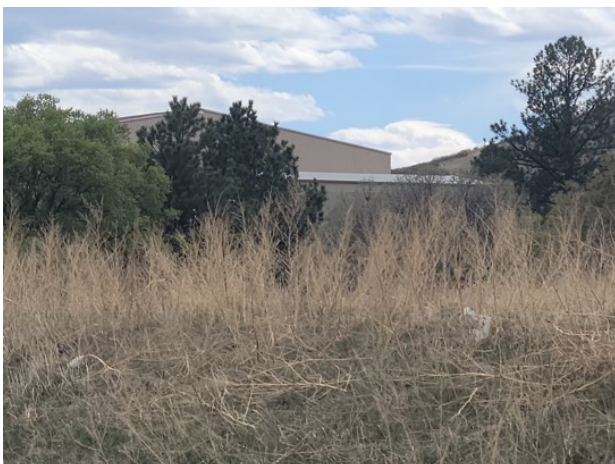
Visible Factors d,e

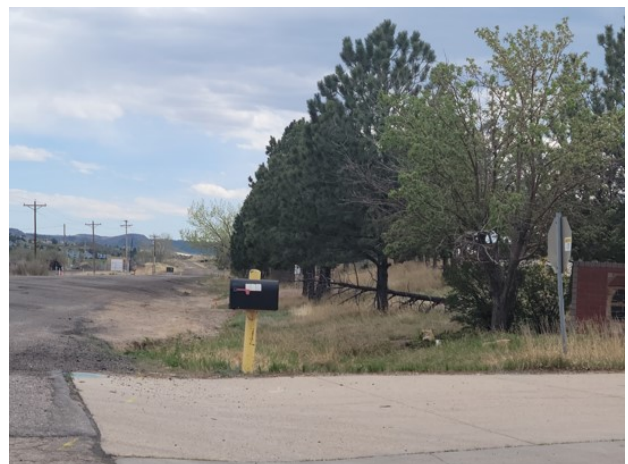
Visible Factors a,b,c,d,e,h,i

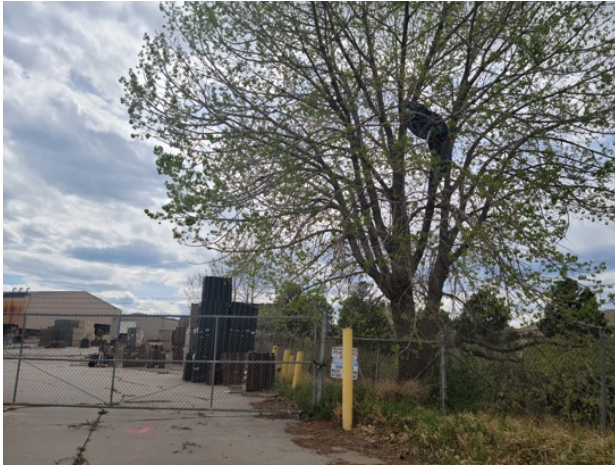
Visible Factors c,d,e,f,h,i,k.5

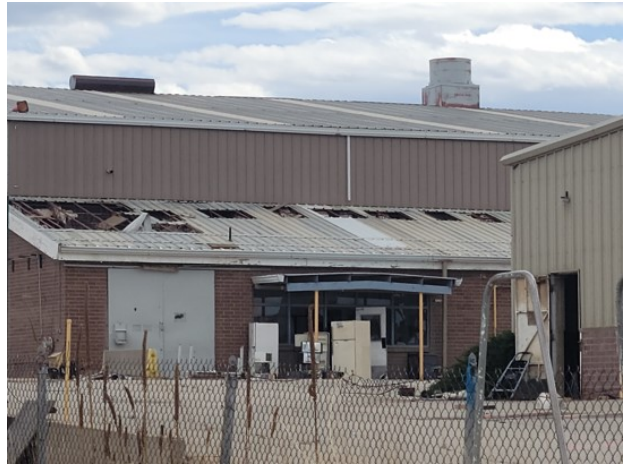
Visible Factors a,c,d,e,h,i,k.5

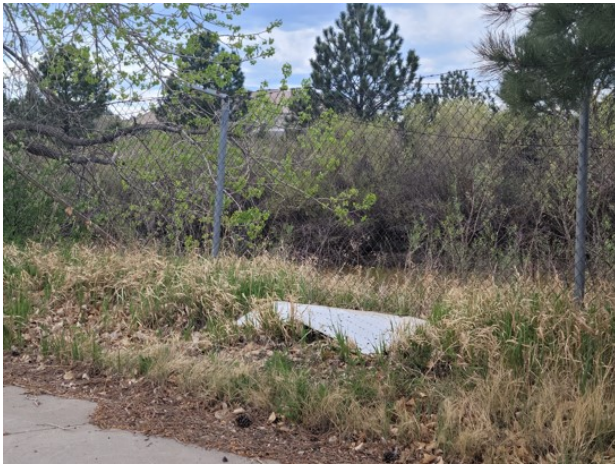
Visible Factors d,e,h,i,k.5

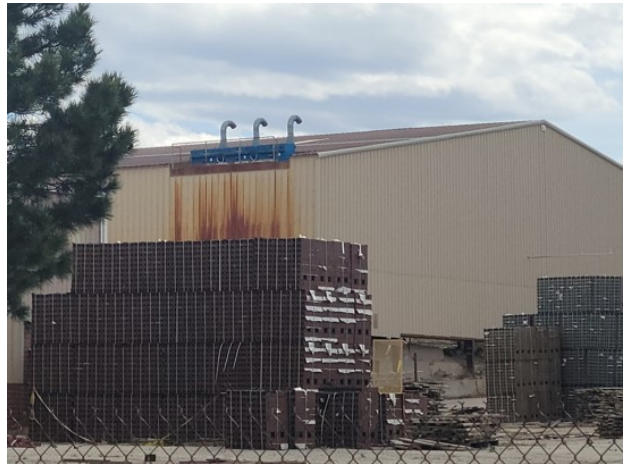
Visible Factors a,d,e,h,i,k.5

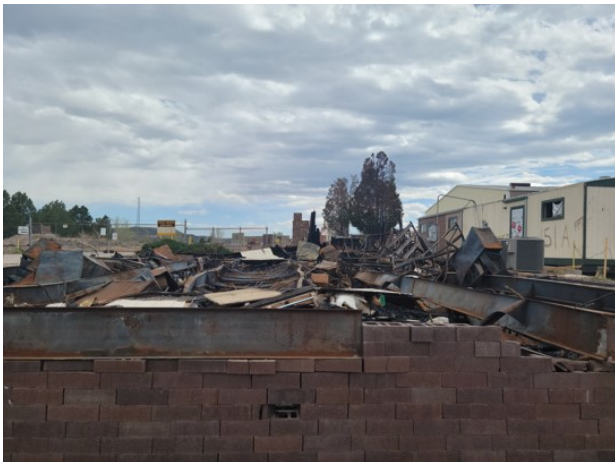
Visible Factors a,d,e,h,i,k.5

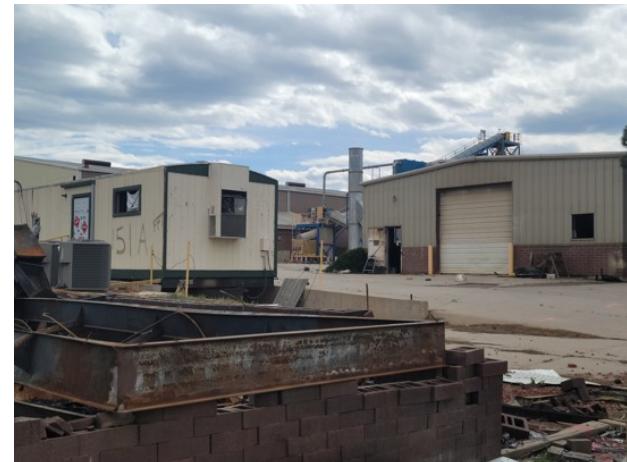
Visible Factors a,c,i,k.5
