## HISTORIC PRESERVATION BOARD APPLICATION

PROJECT NAME: Window and Door Restoration for the Douglas Masonic LodgePROPERTY ADDRESS / GENERAL LOCATION: 300 Wilcox StreetLEGAL DESCRIPTION: Range 8, Township 67, Block 19, Lot 7 in Castle Rock, ColoradoPROJECT DESCRIPTION: Please see enclosed Project Description, floor plan & photos to better understand the scope of work.  
The project will include exterior door restoration and window restoration. See Attachment A and Budget Worksheet.

DOUGLAS MASONIC  
LODGE  
NO. 153 A.F. & A.M.

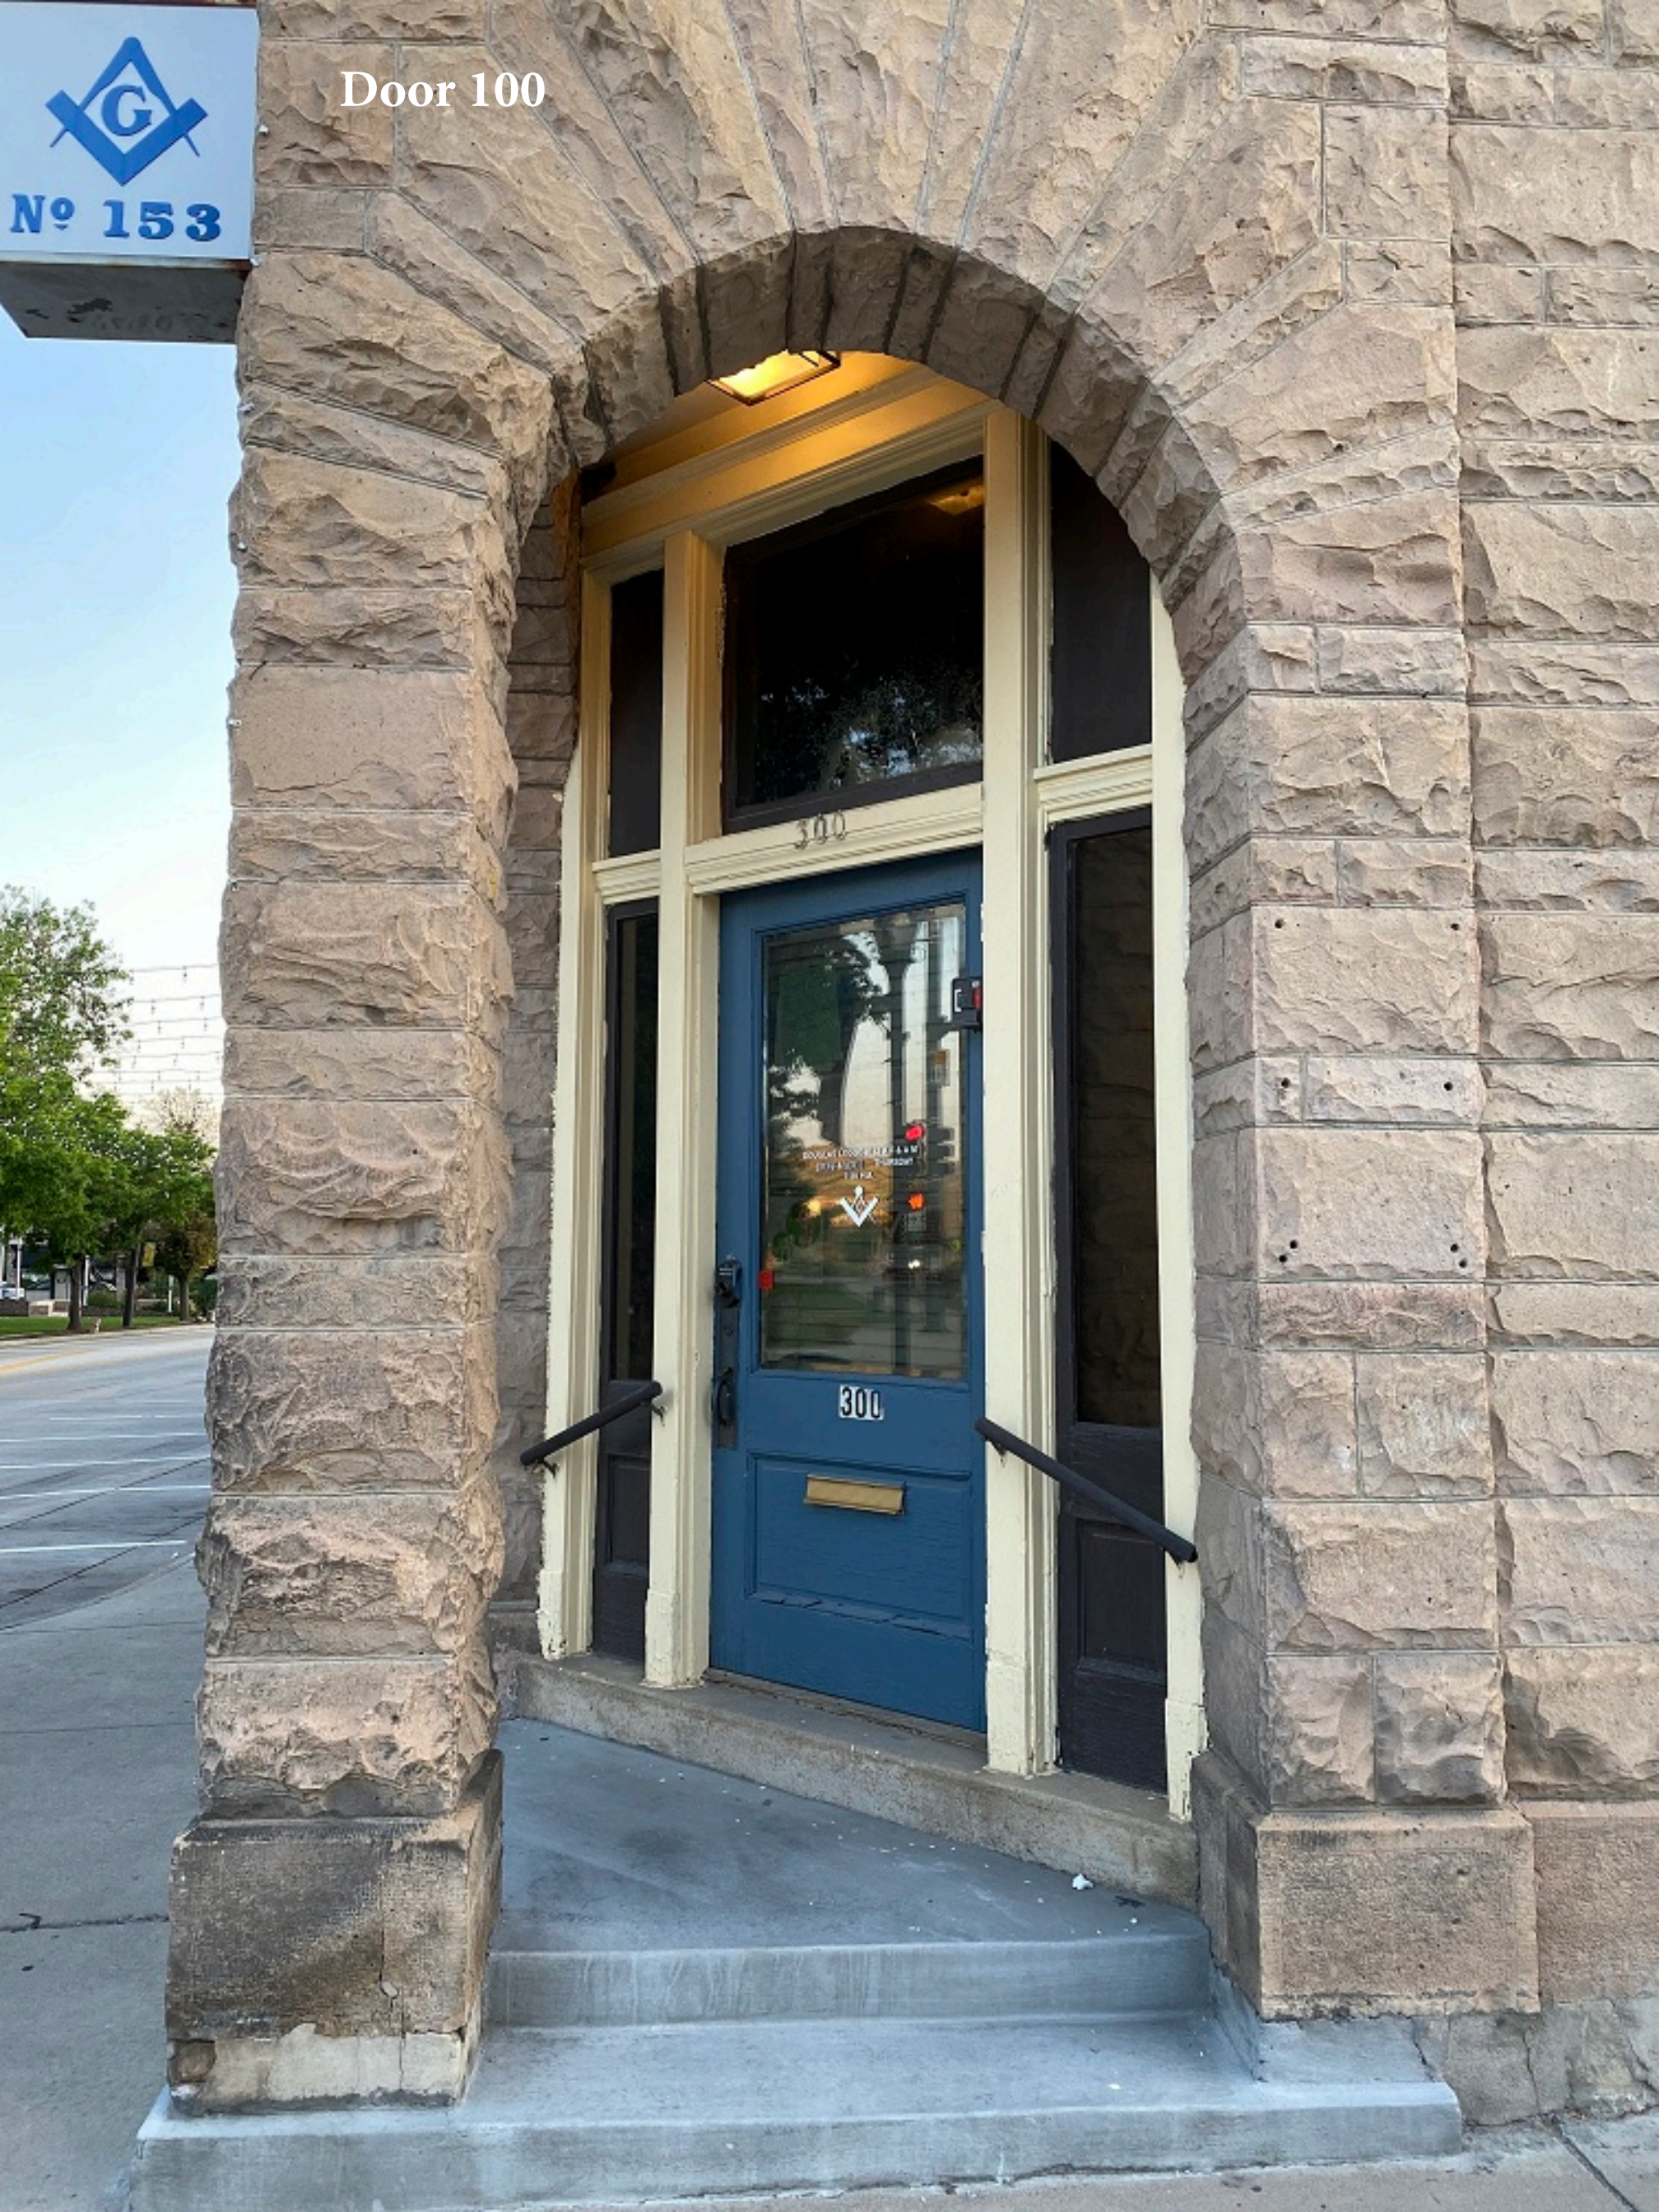
4.0 Door 100 - Head Trim Was Lowered When the Ceiling Was Lowered Ceiling Was Raised as a Part of Grant 2020-01-035. This Grant Will Reproduce the Trim and Raise the Head Trim To Its Original Location. See Photo 27 for Area of Raised Ceiling

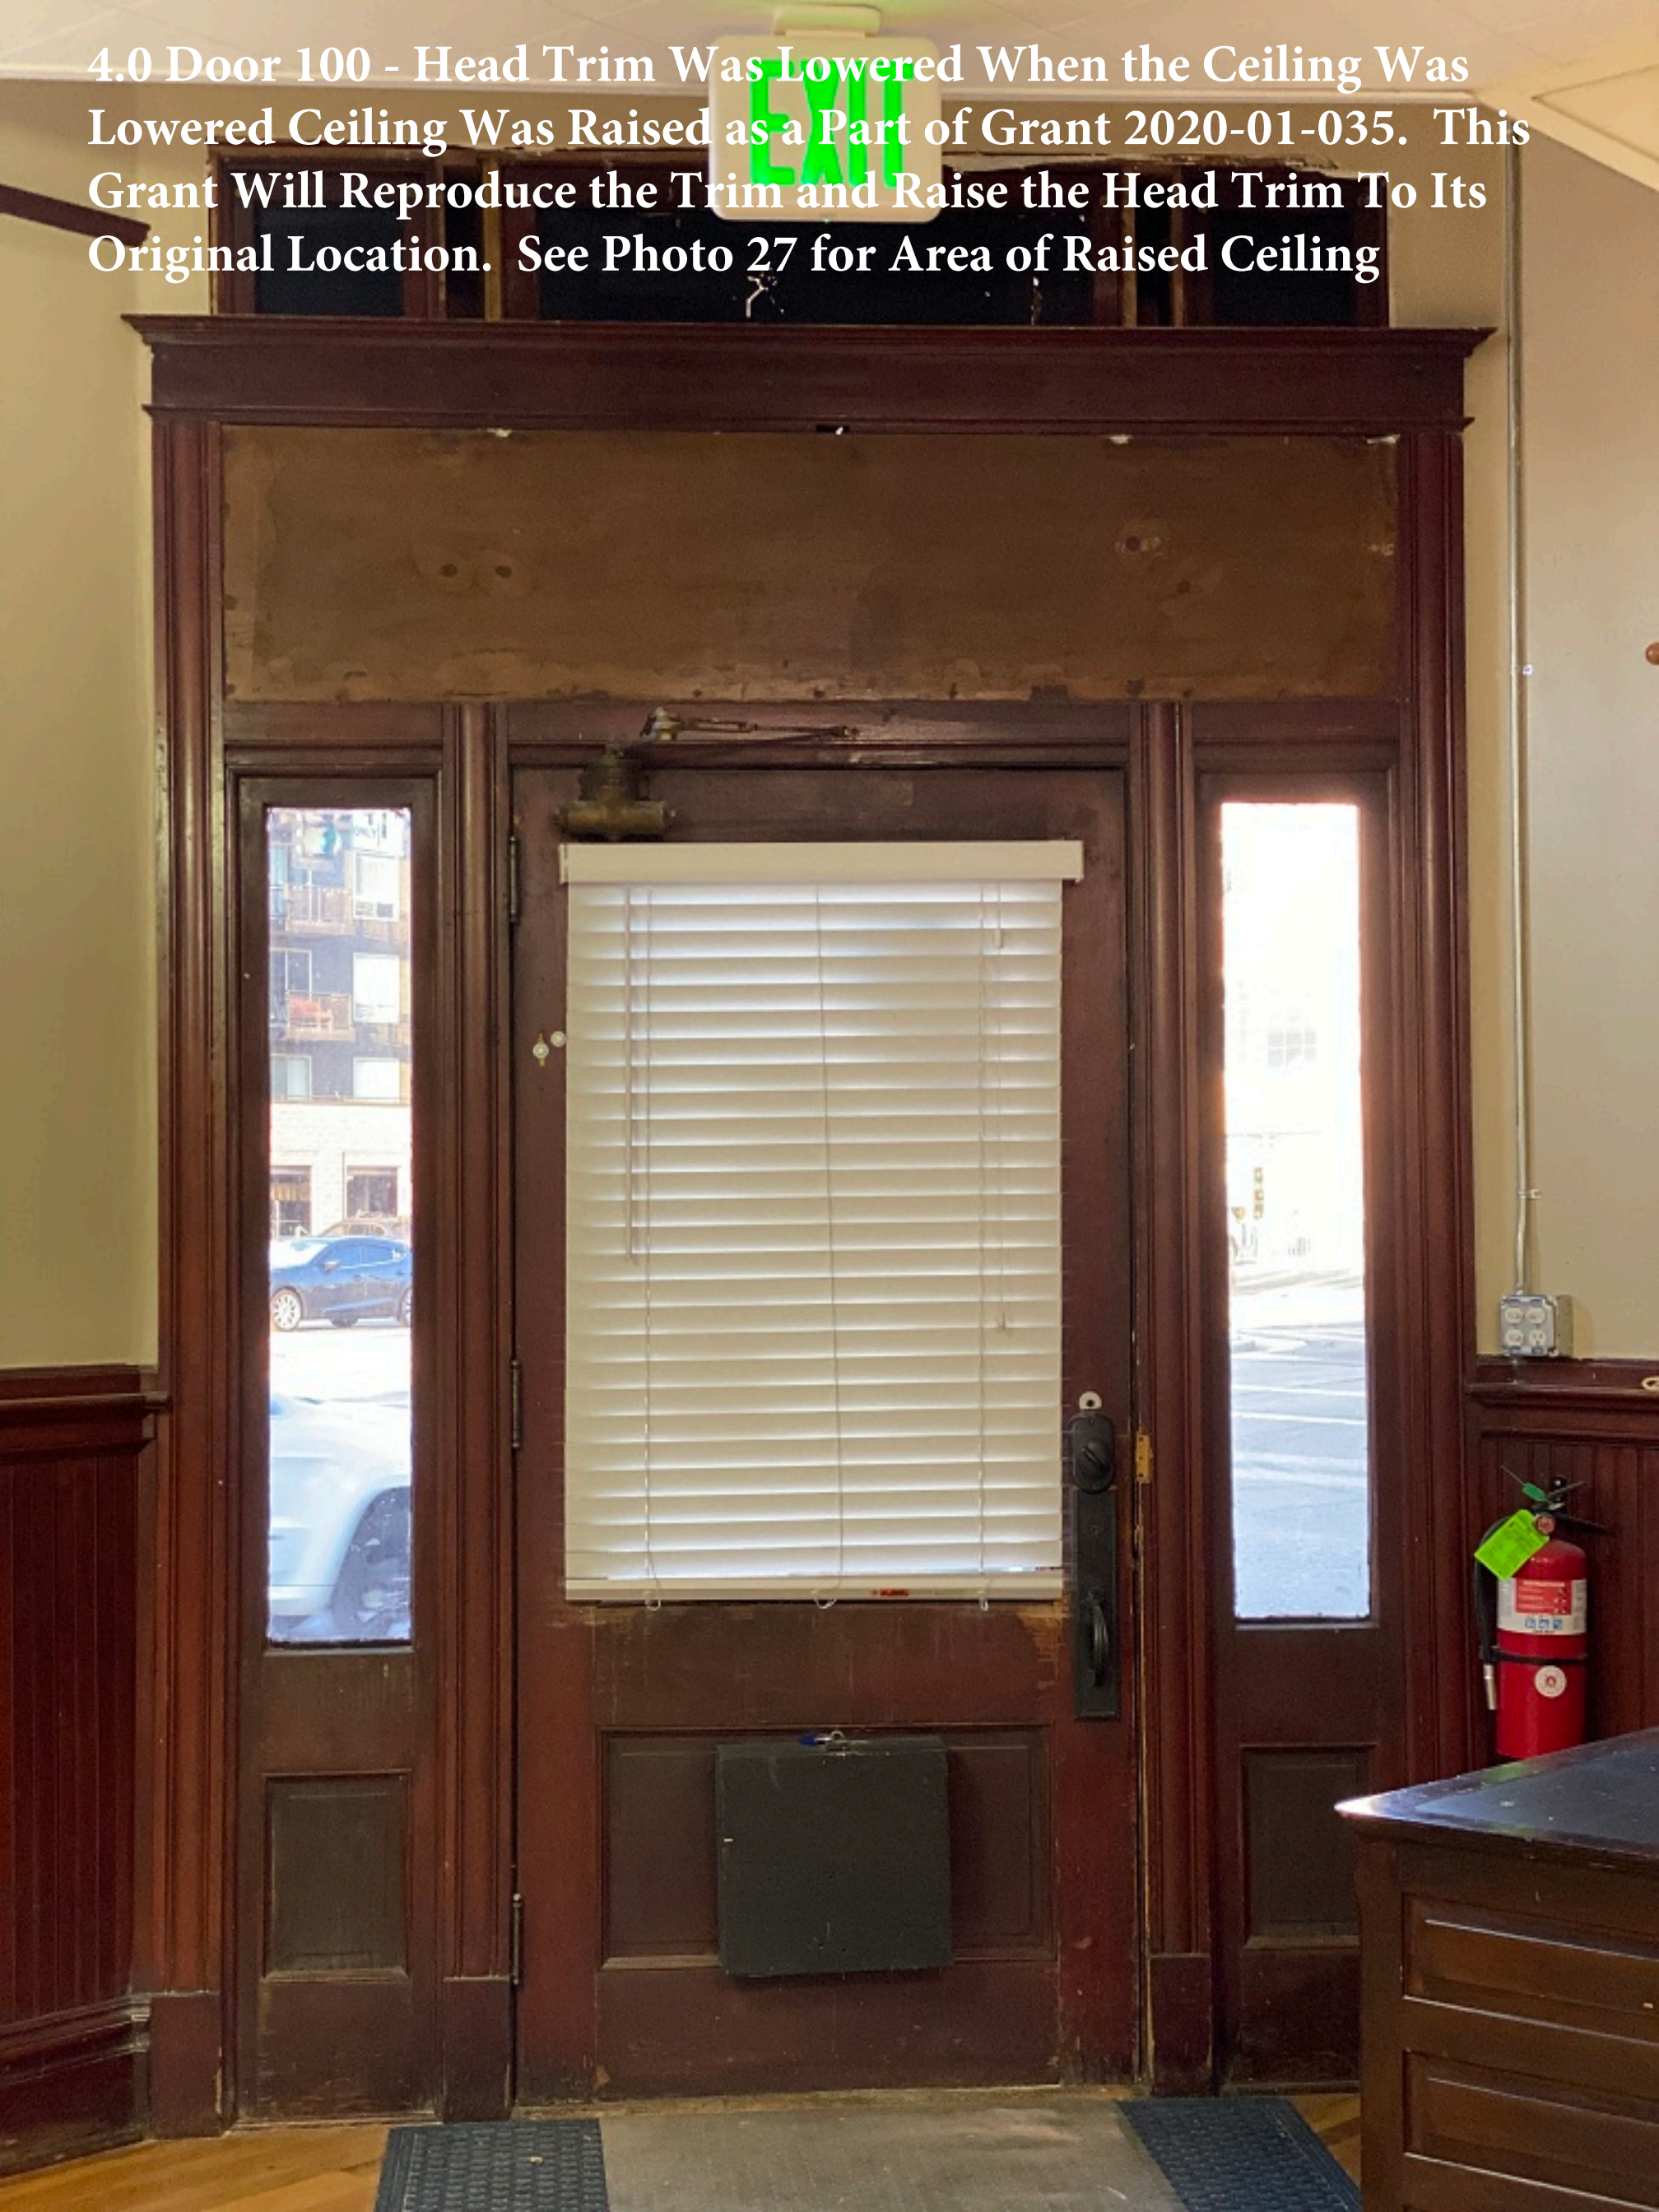
## 5.0 Door 101 - Note Covered Transom

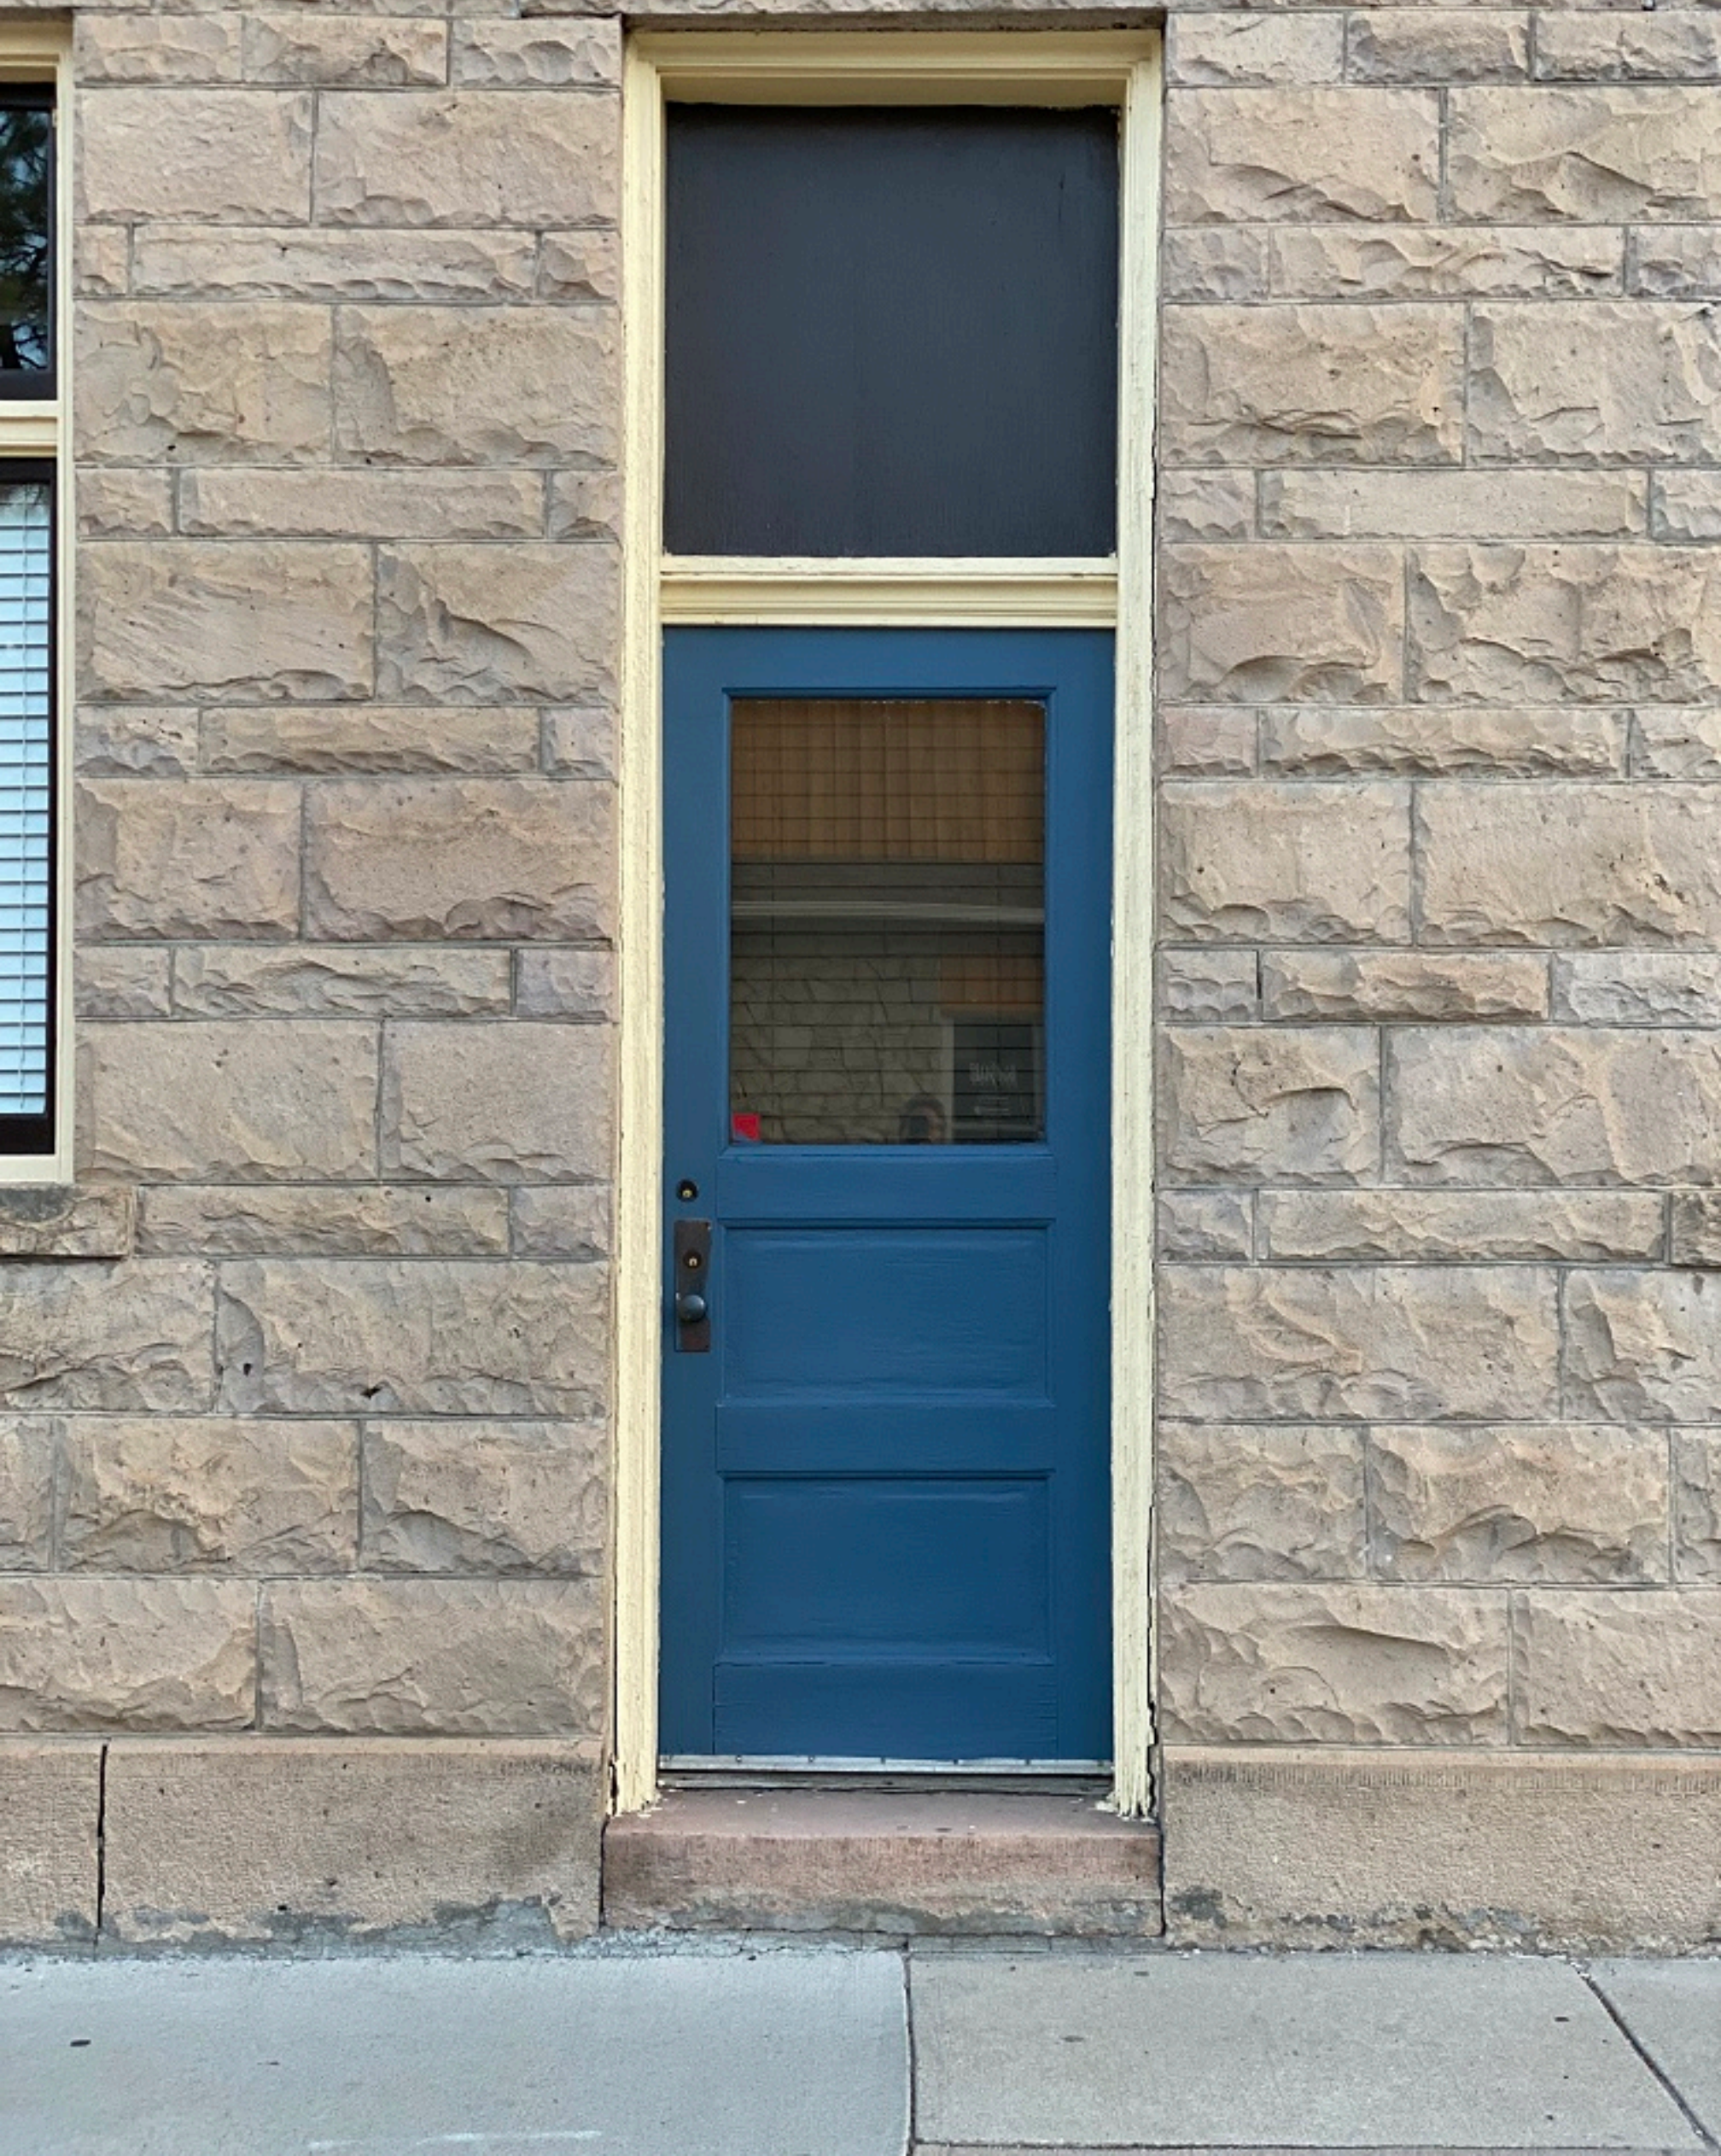
6.0 Door 101 - Head Trim Lowered When Ceiling Was Lowered  
This Grant Will Reproduce Trim and Reinstall Head Trim at  
Original Height

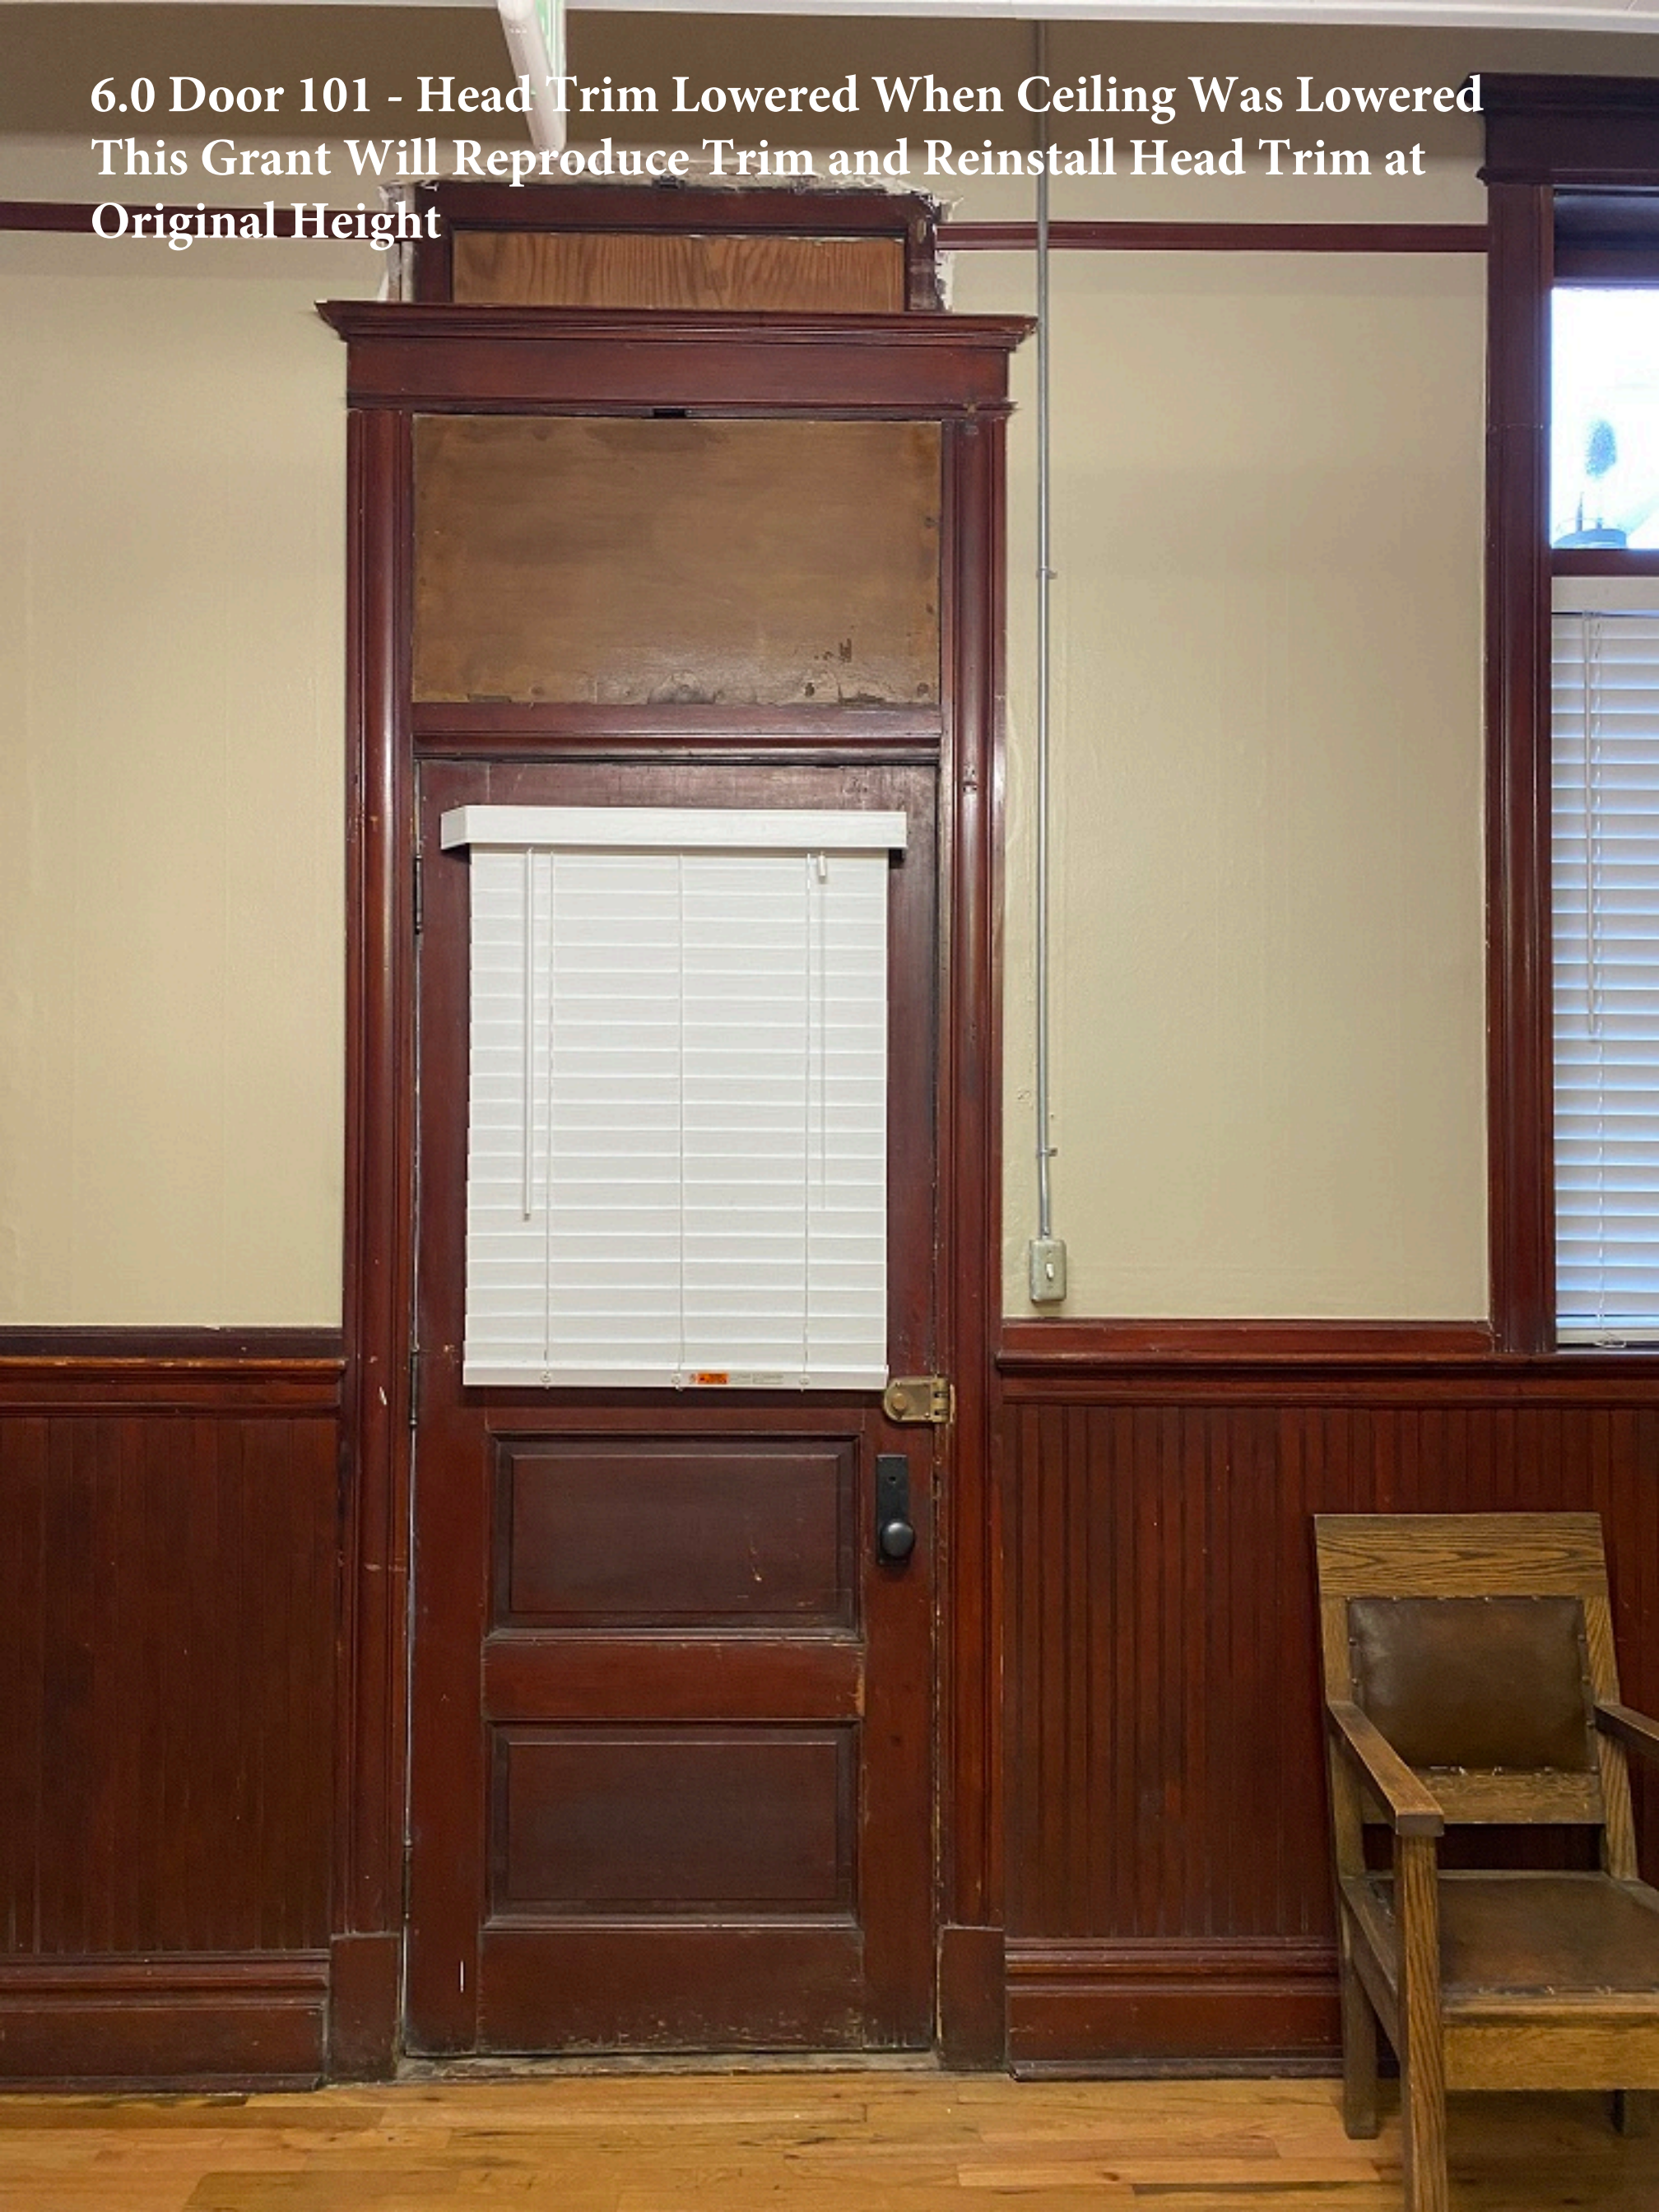
7.0 Door 102 - Note Exhaust Vent In Tranoms, Missing Glass In Door and Missing Hardware

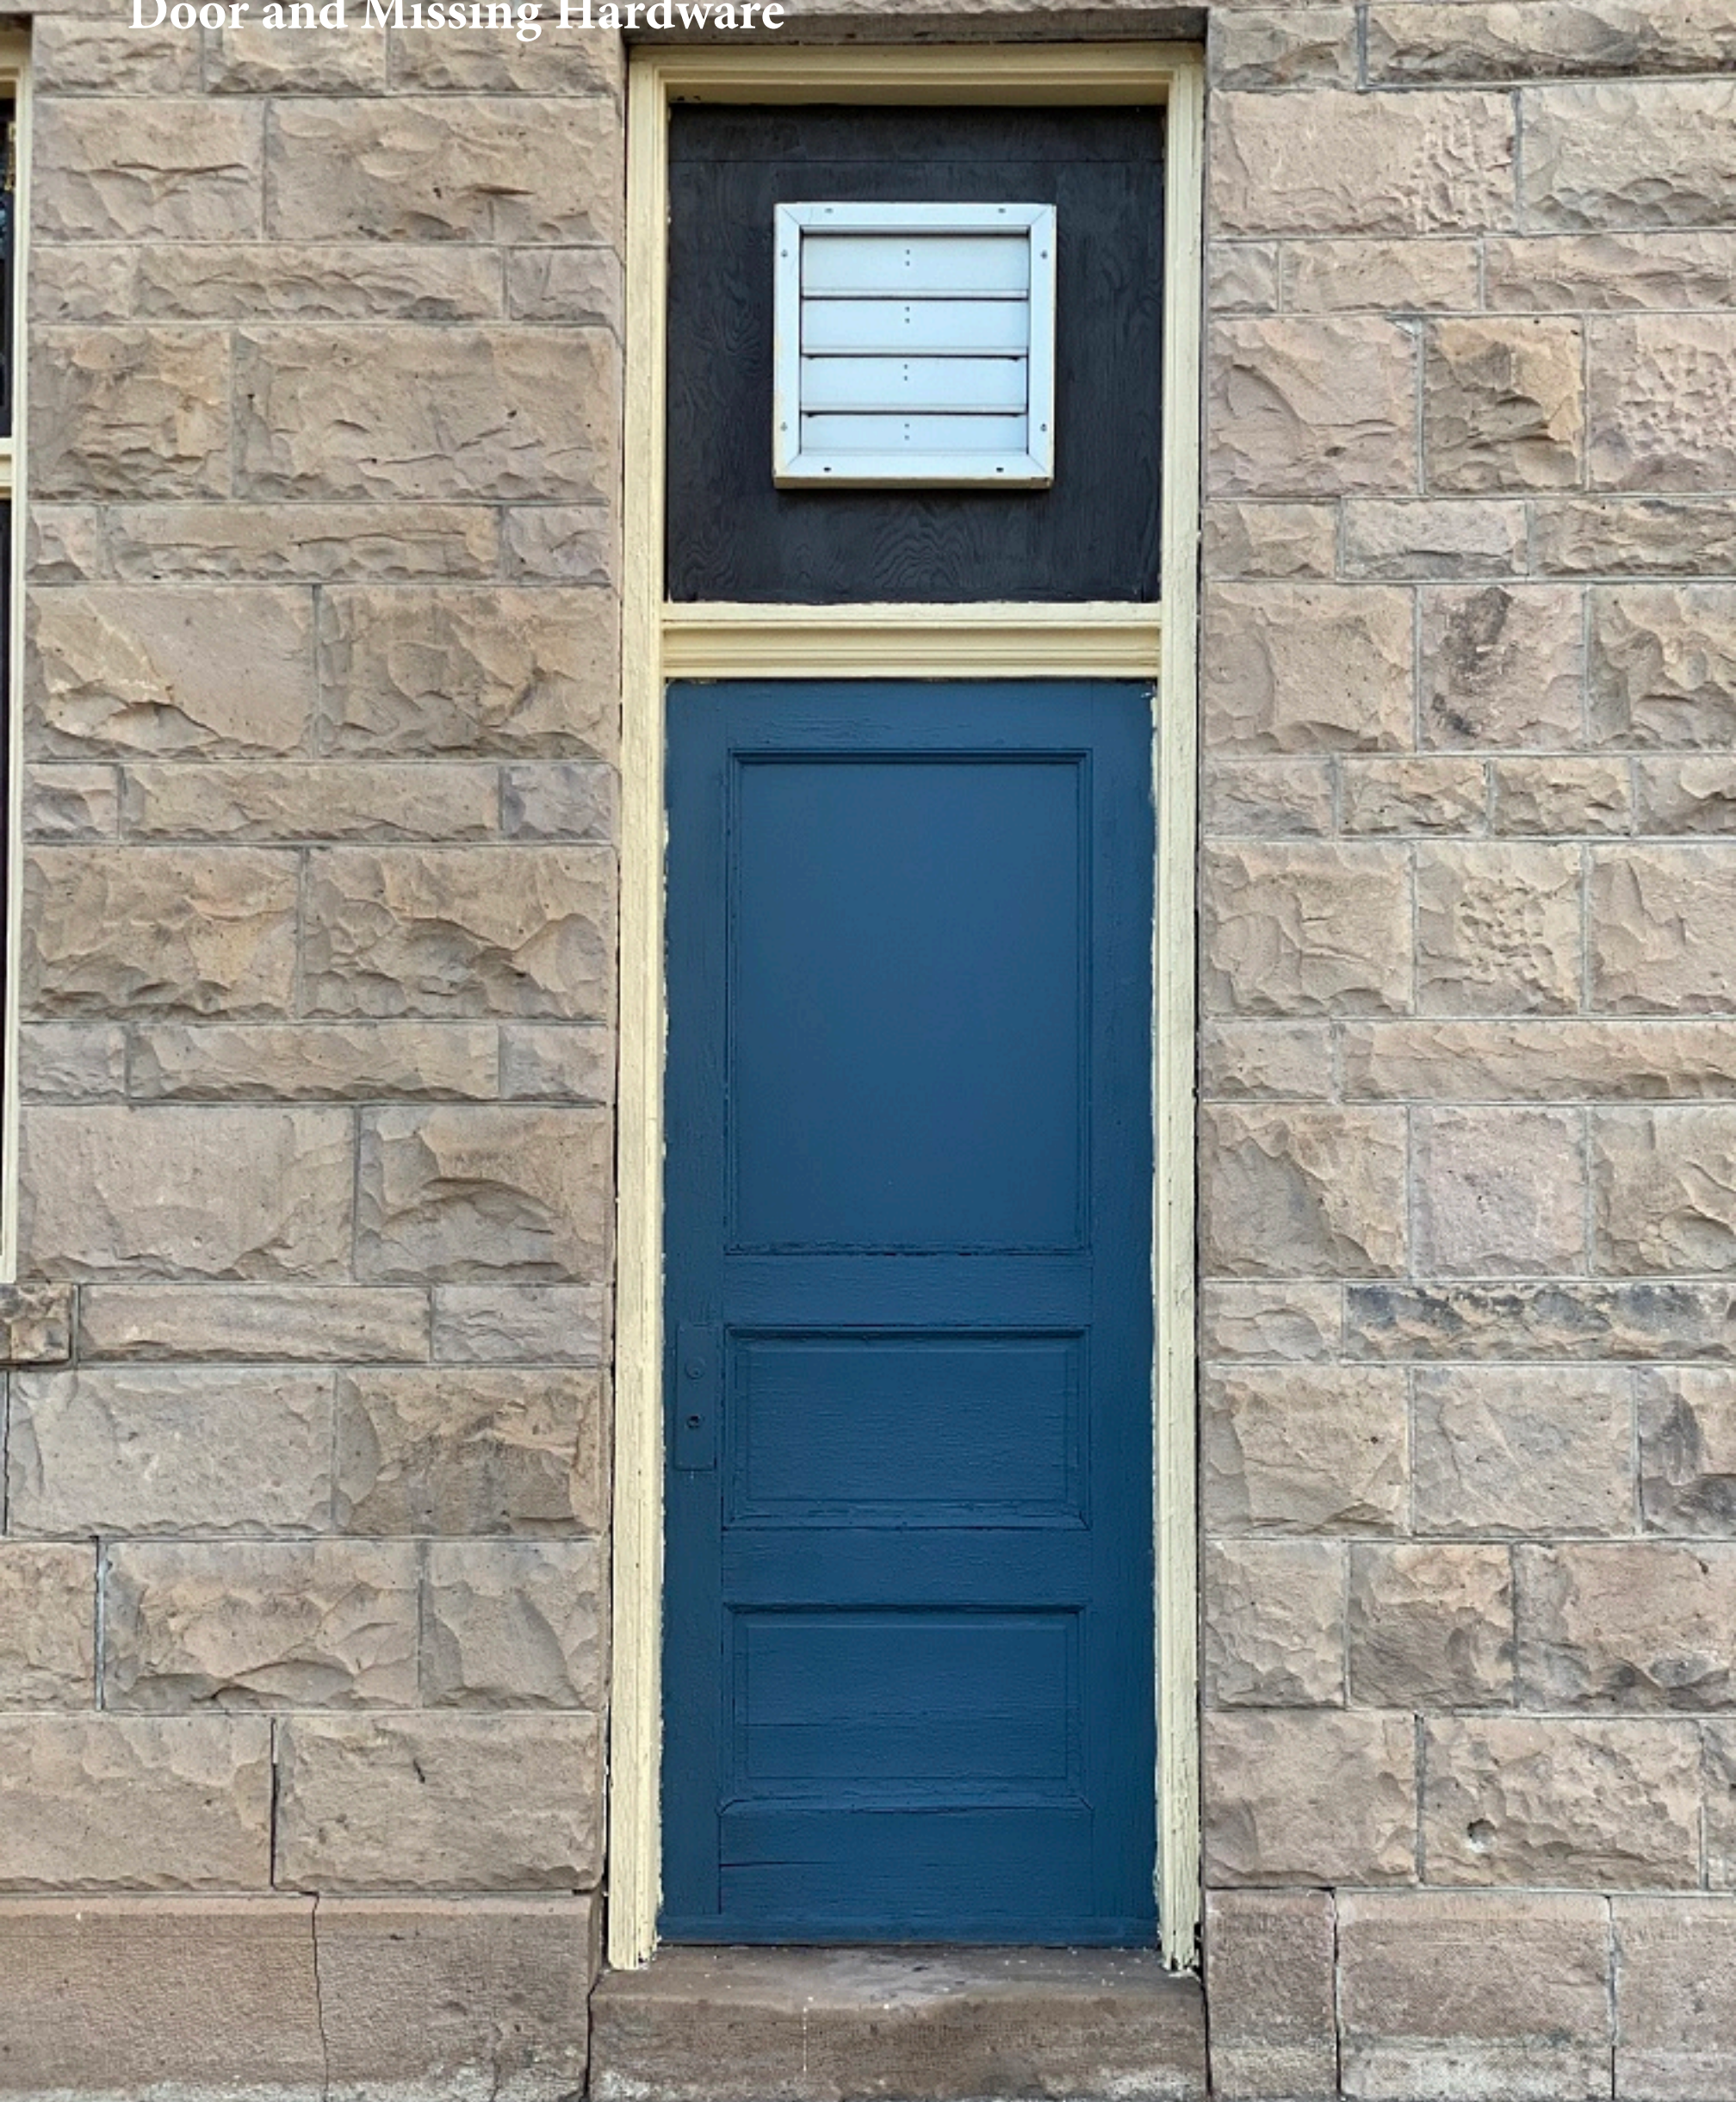
**8.0 Door 102 - Behind Kitchen Cabinets - Note Exhaust Fan is Where Door is Located. Door Will Not Be Exposed on the Interior in this Grant - It Will Only Be Restored on the Exterior**

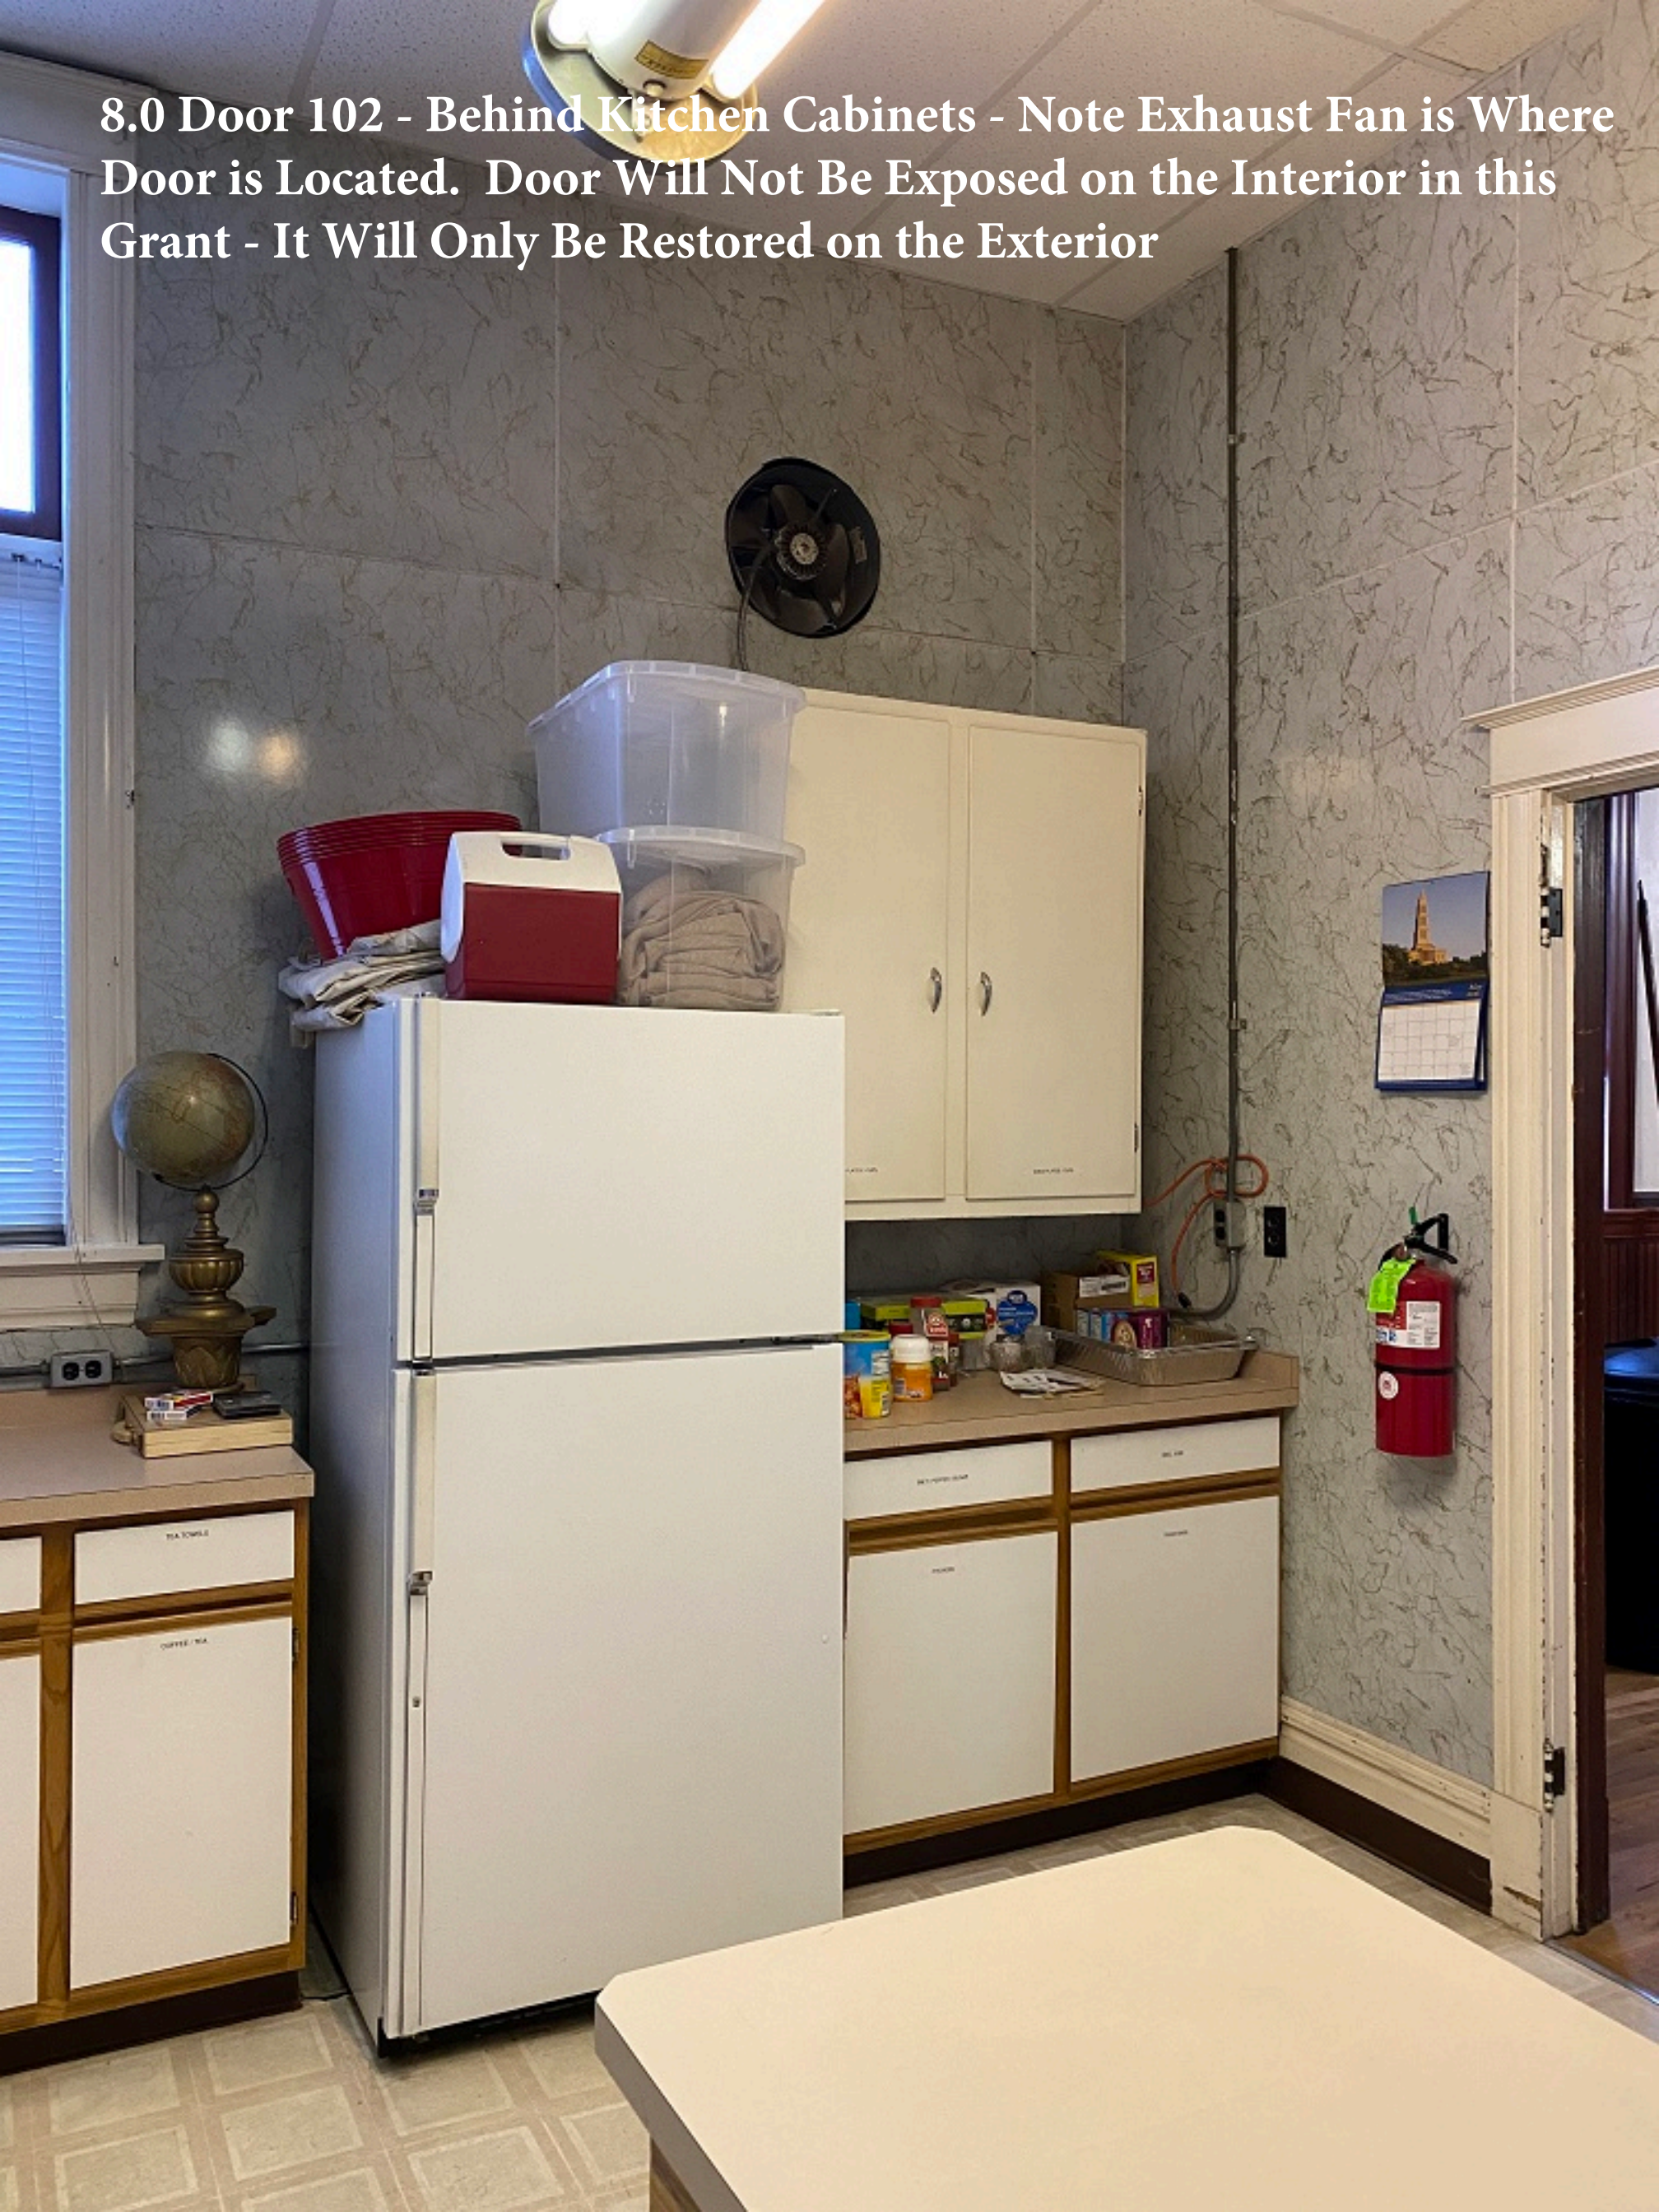
## 9.0 Door 103 - Note Transom Window is Covered with a Board
