## HISTORIC PRESERVATION BOARD APPLICATION

PROJECT NAME: Window and Door Restoration for the Douglas Masonic LodgePROPERTY ADDRESS / GENERAL LOCATION: 300 Wilcox StreetLEGAL DESCRIPTION: Range 8, Township 67, Block 19, Lot 7 in Castle Rock, ColoradoPROJECT DESCRIPTION: Please see enclosed Project Description, floor plan & photos to better understand the scope of work.  
The project will include exterior door restoration and window restoration. See Attachment A and Budget Worksheet.

DOUGLAS MASONIC  
LODGE  
NO. 153 A.F. & A.M.

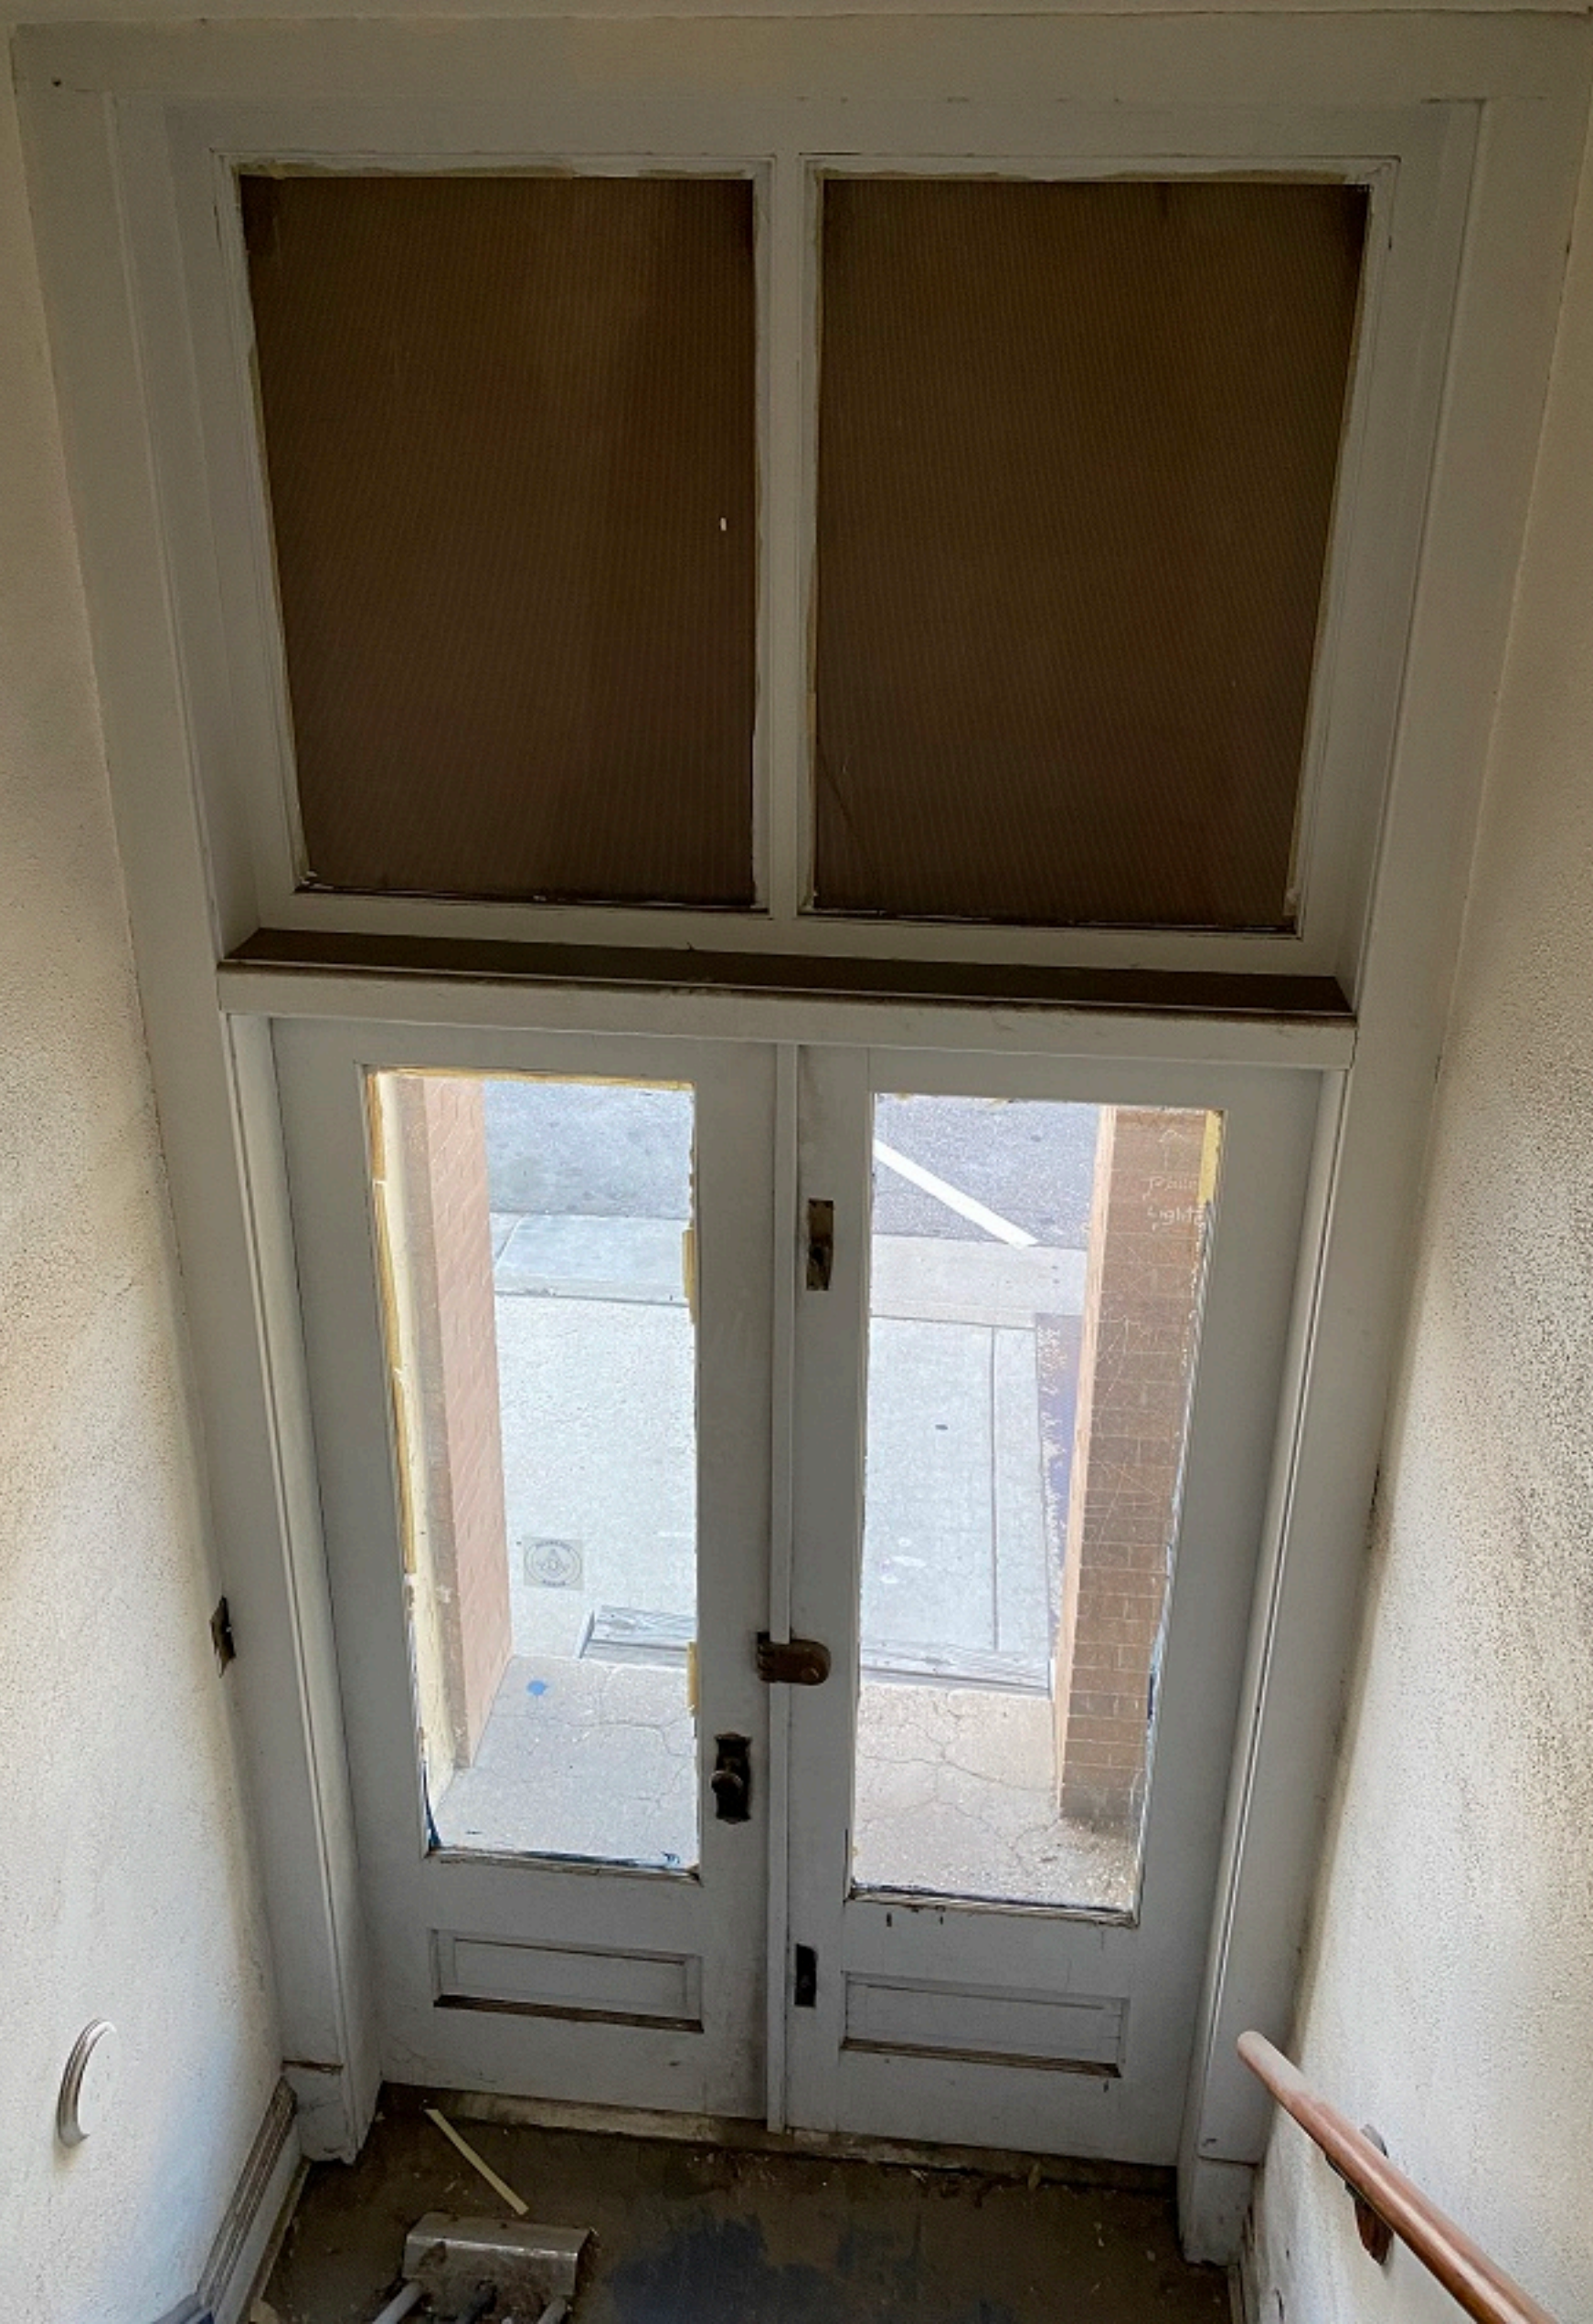
## 10.0 Transom Window at Door 103 - Note Broken Glass

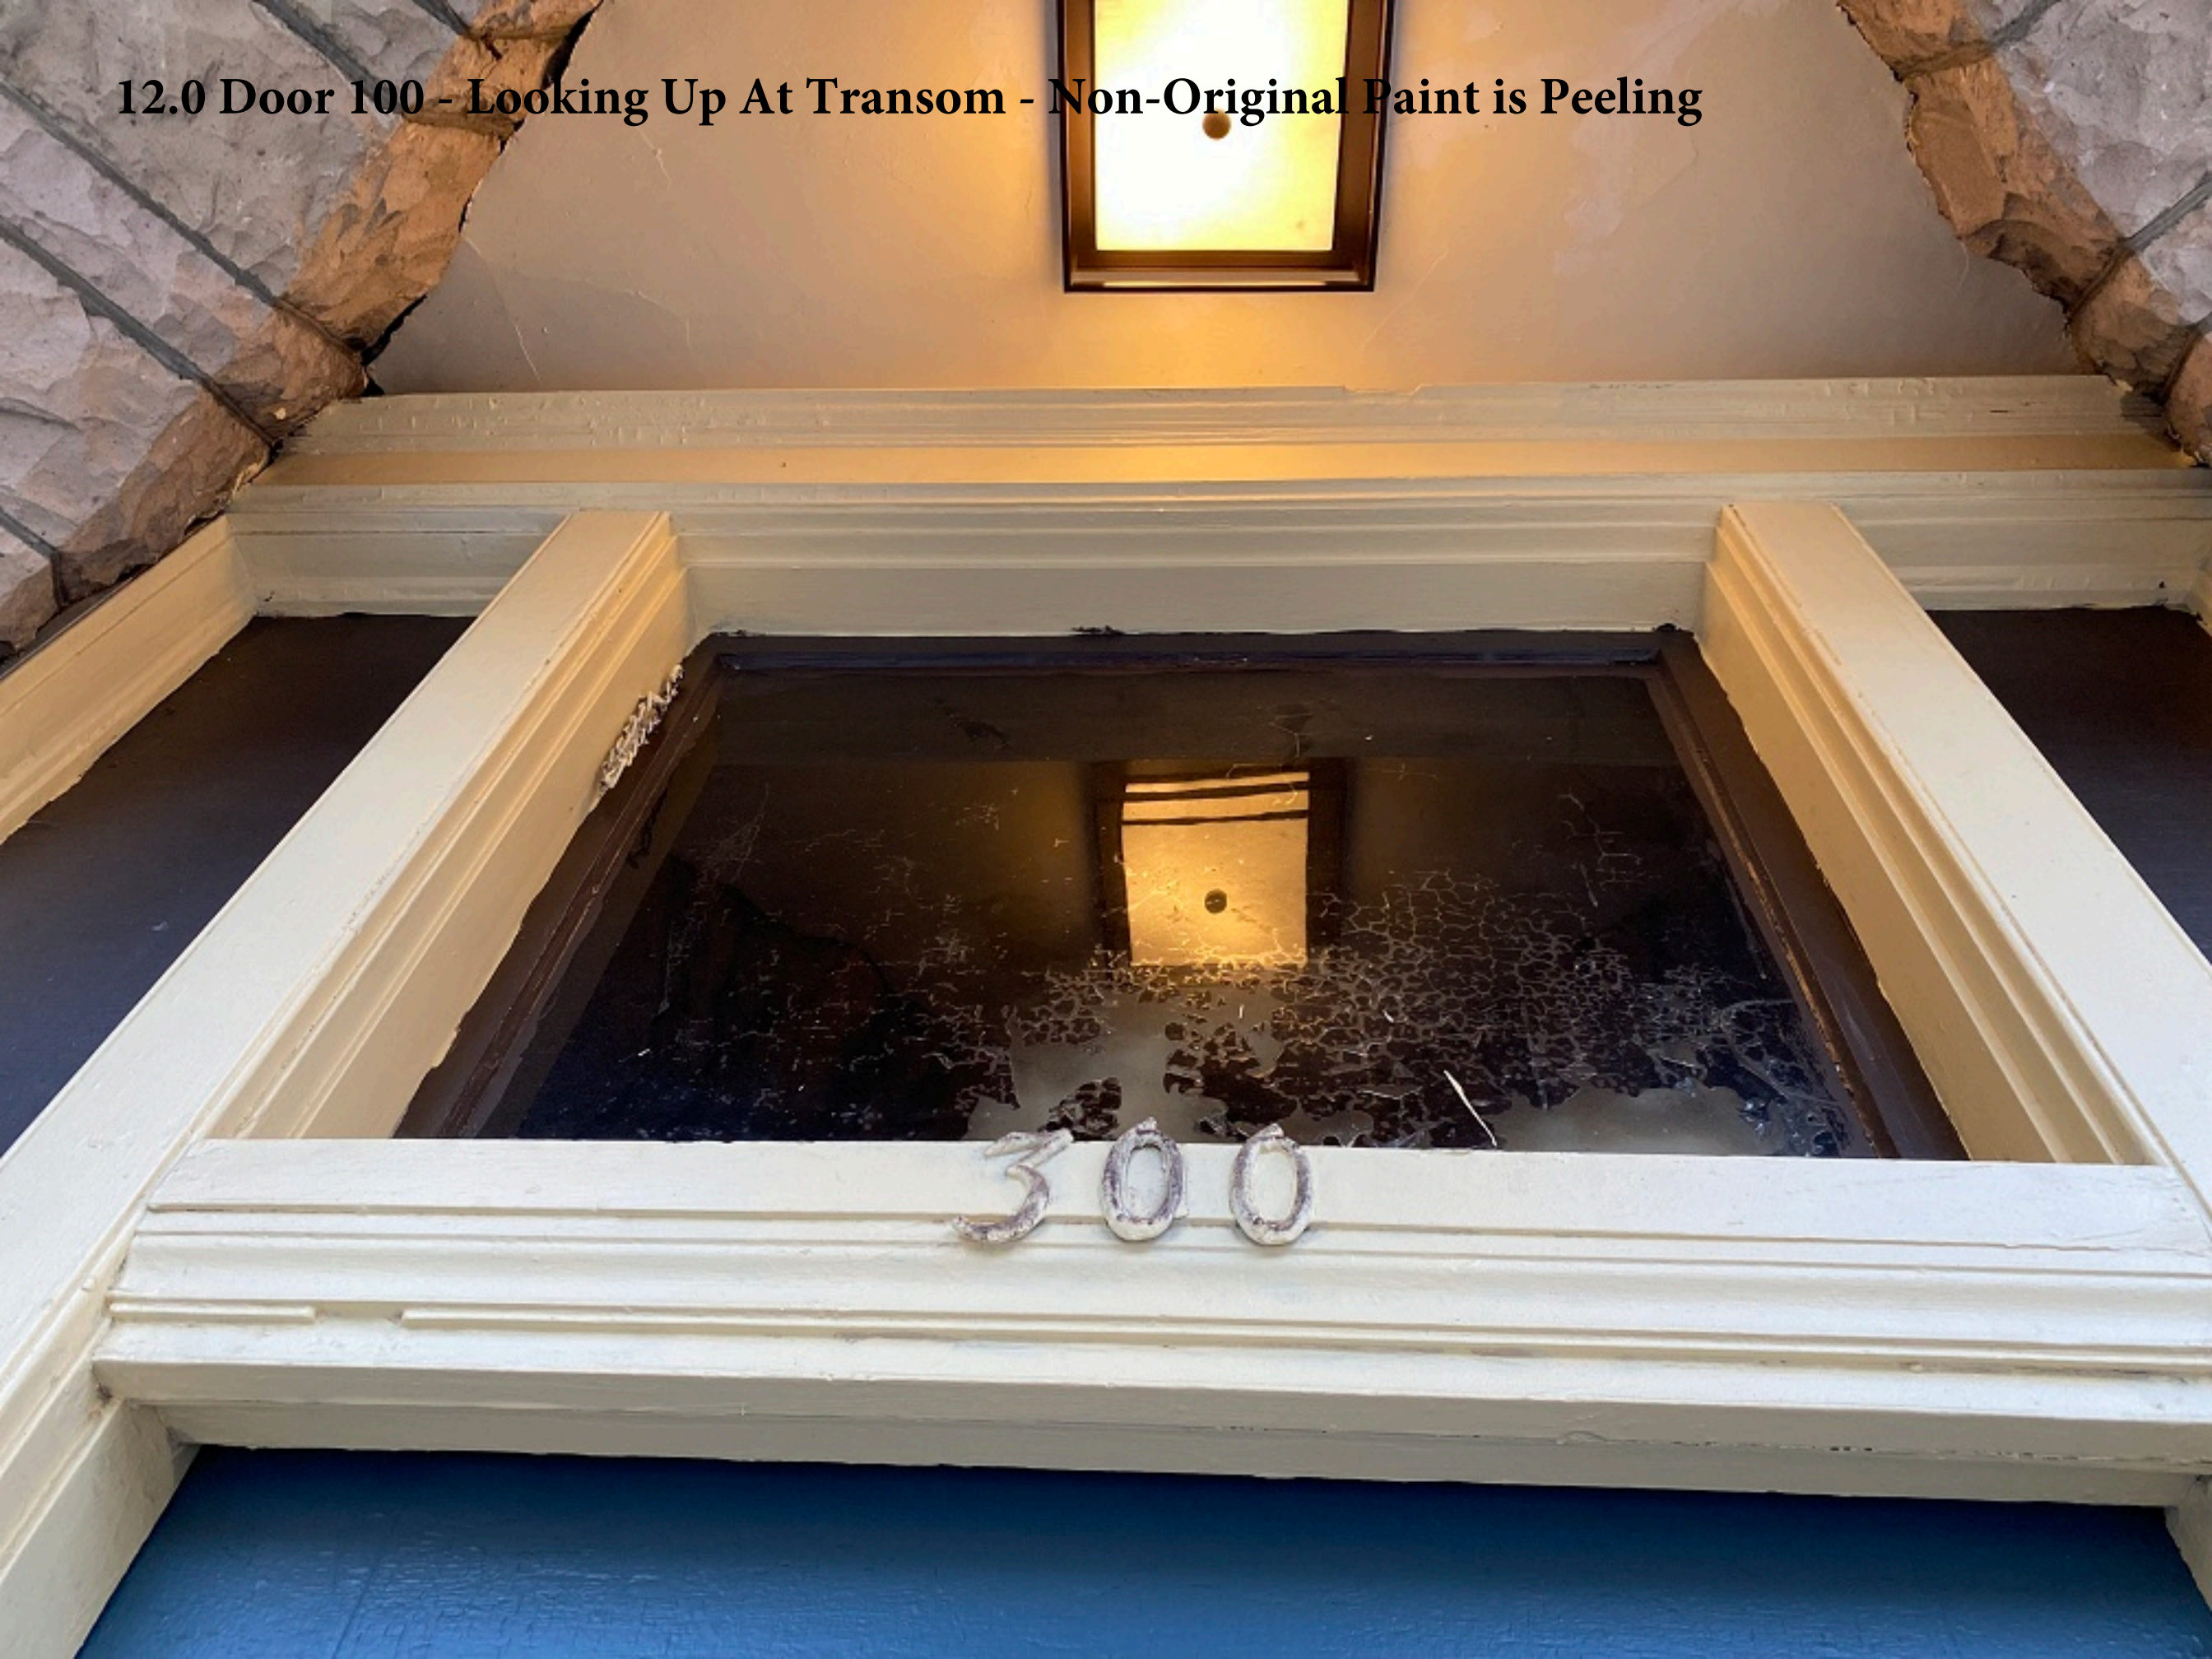
**13.0 Sidelite Panel at Door 100 - Note Cracks and Deterioration and Discoloration - Typical at All Doors**

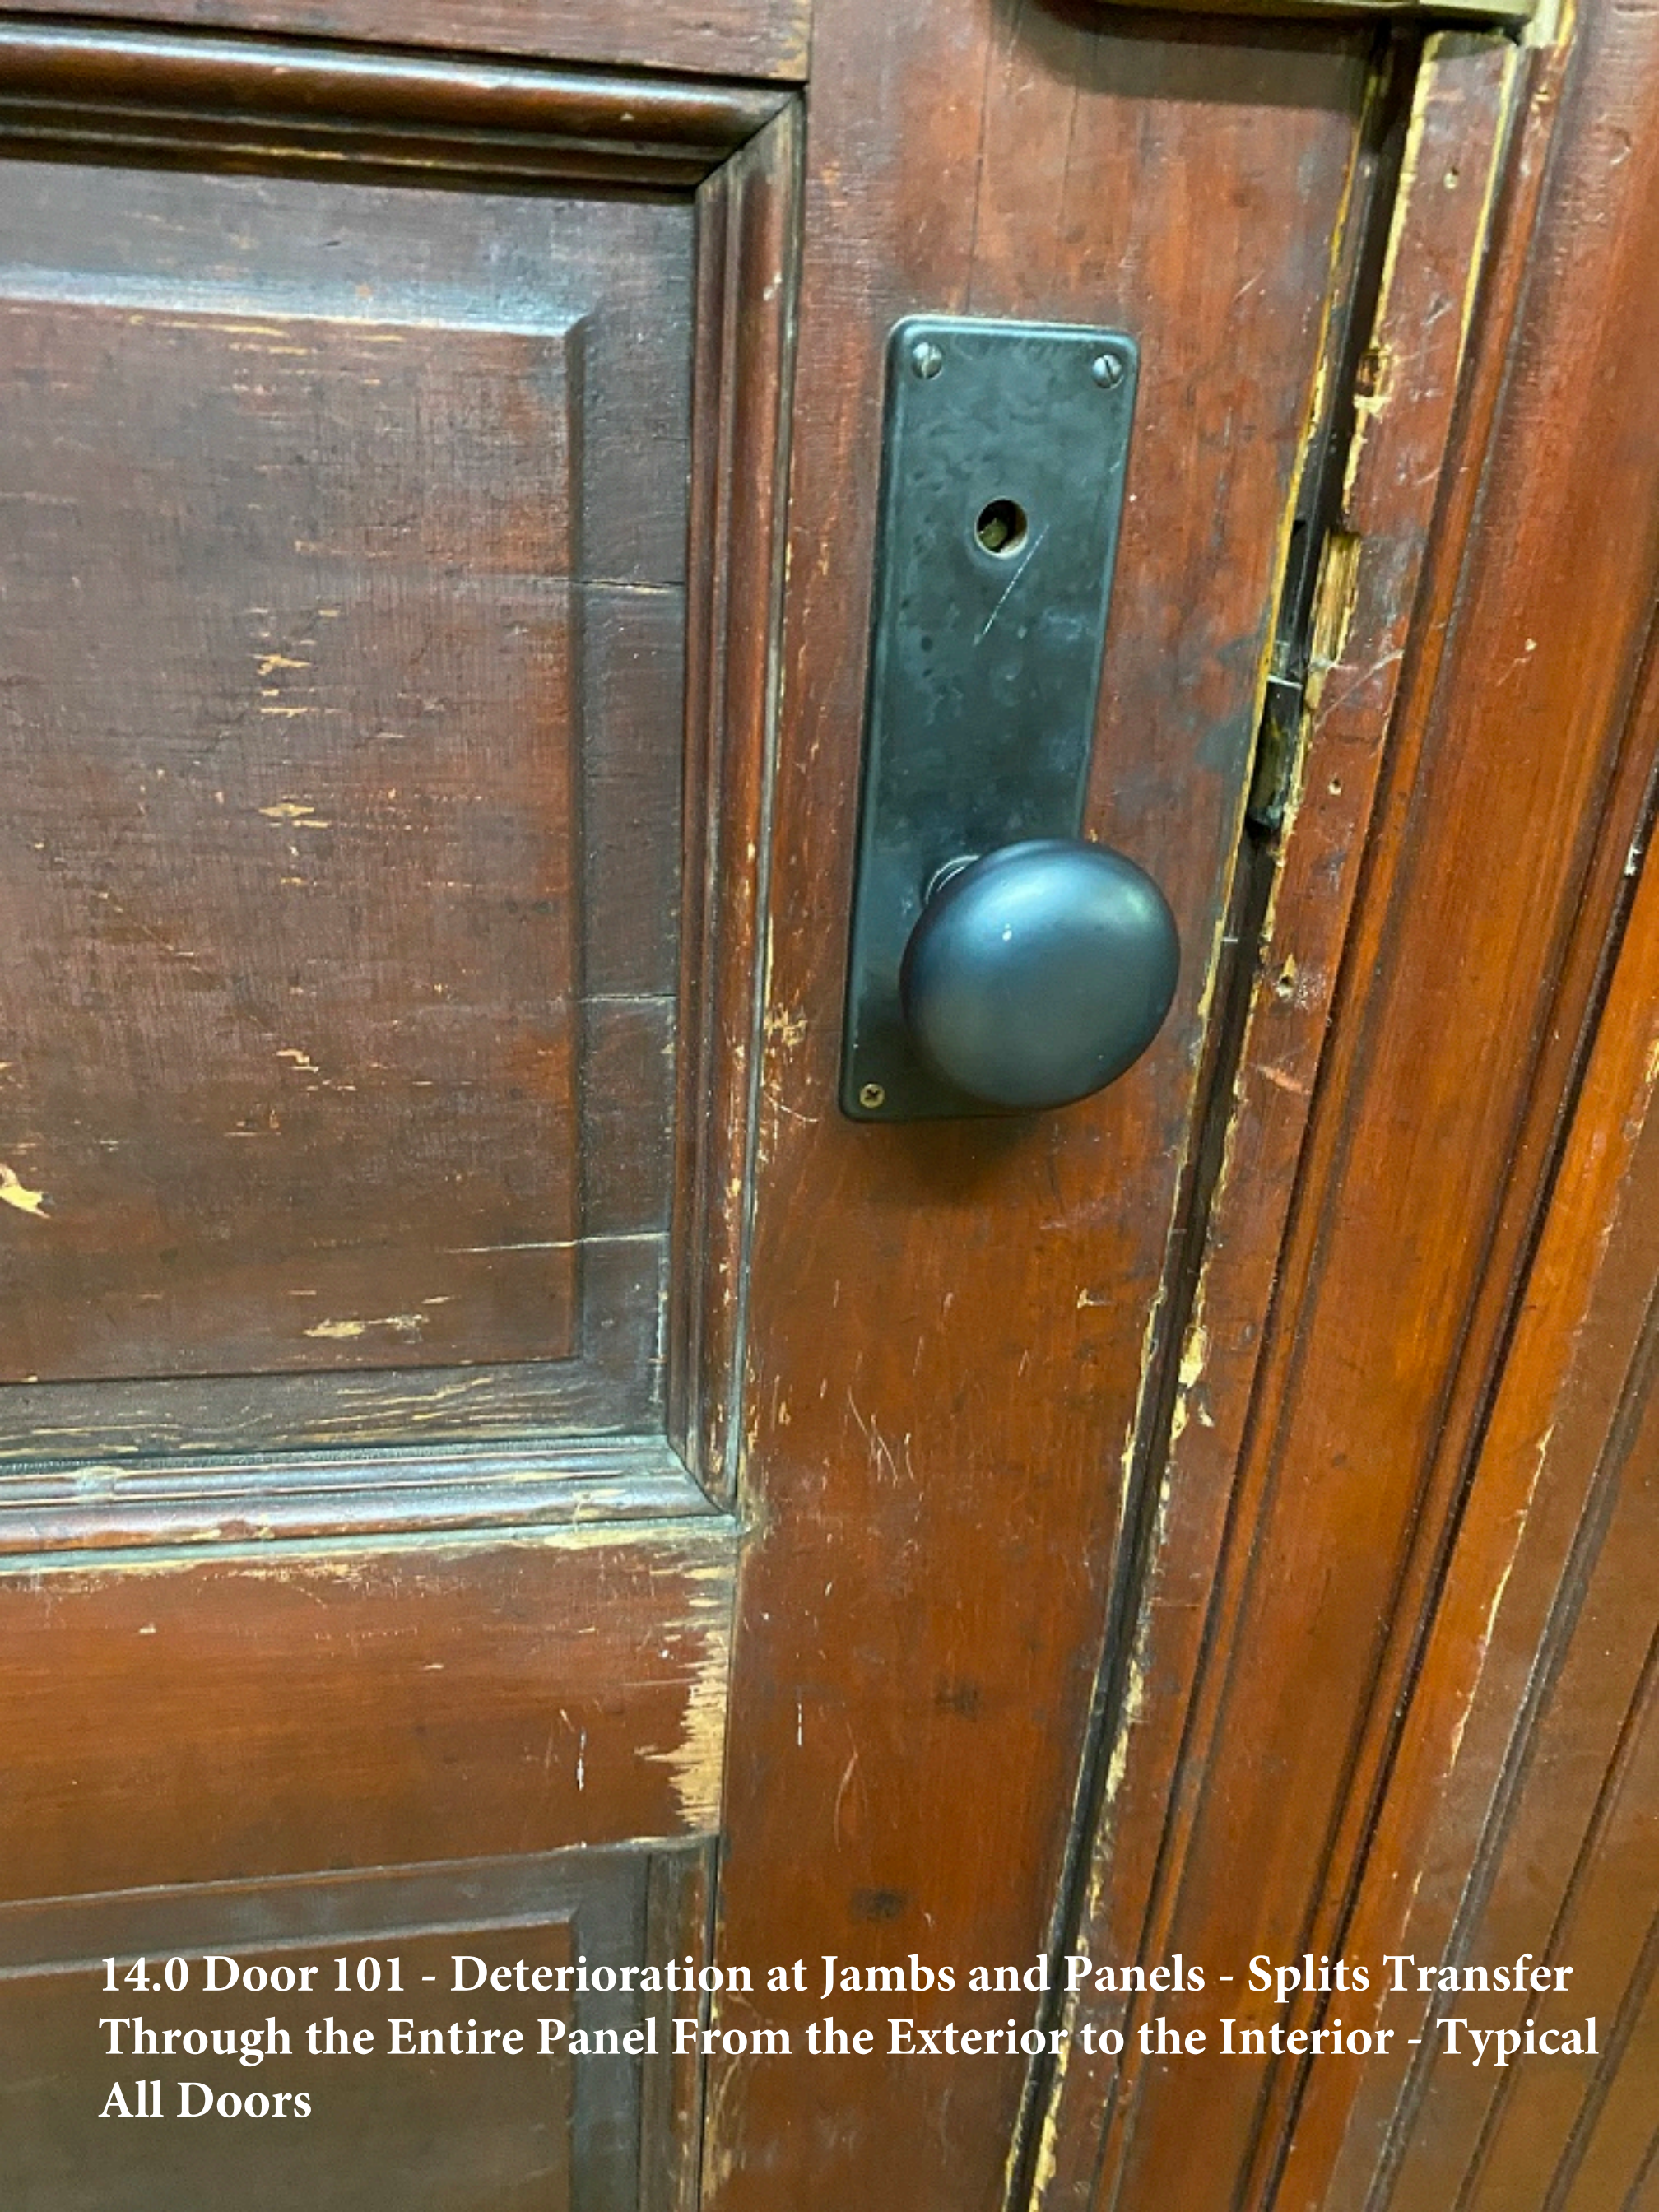
**14.0 Door 101 - Deterioration at Jambs and Panels - Splits Transfer Through the Entire Panel From the Exterior to the Interior - Typical All Doors**

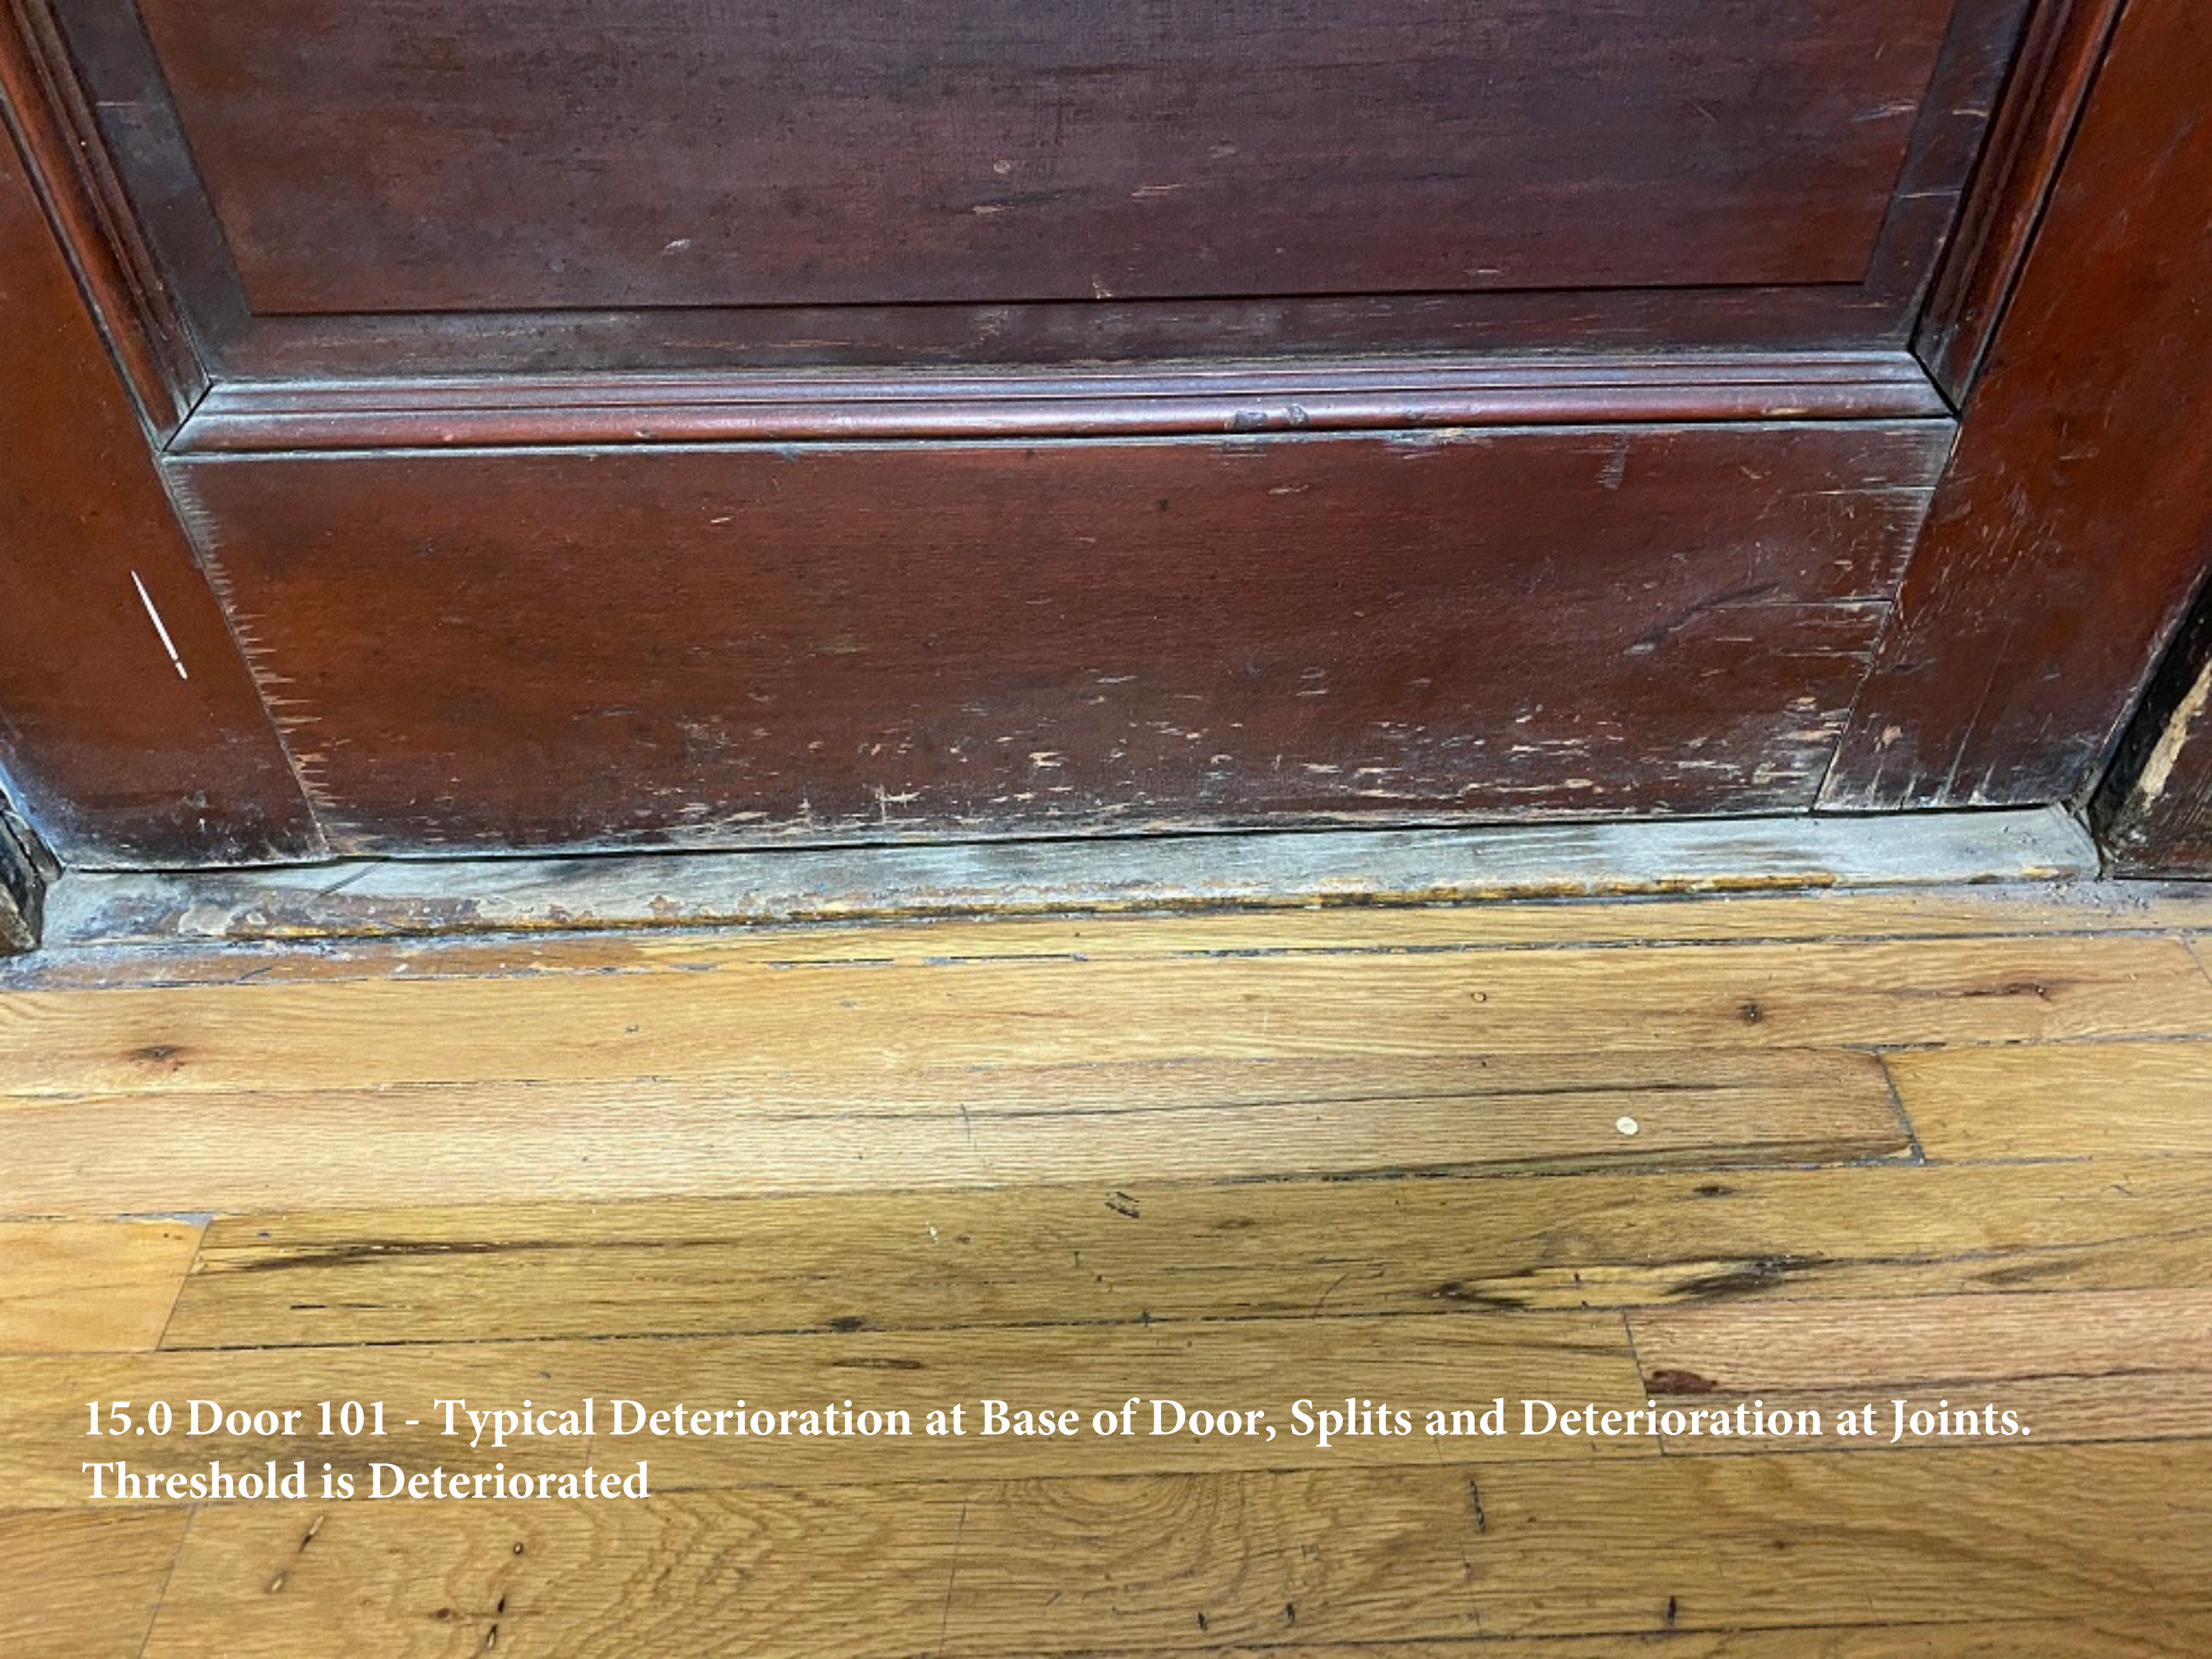
15.0 Door 101 - Typical Deterioration at Base of Door, Splits and Deterioration at Joints.  
Threshold is Deteriorated

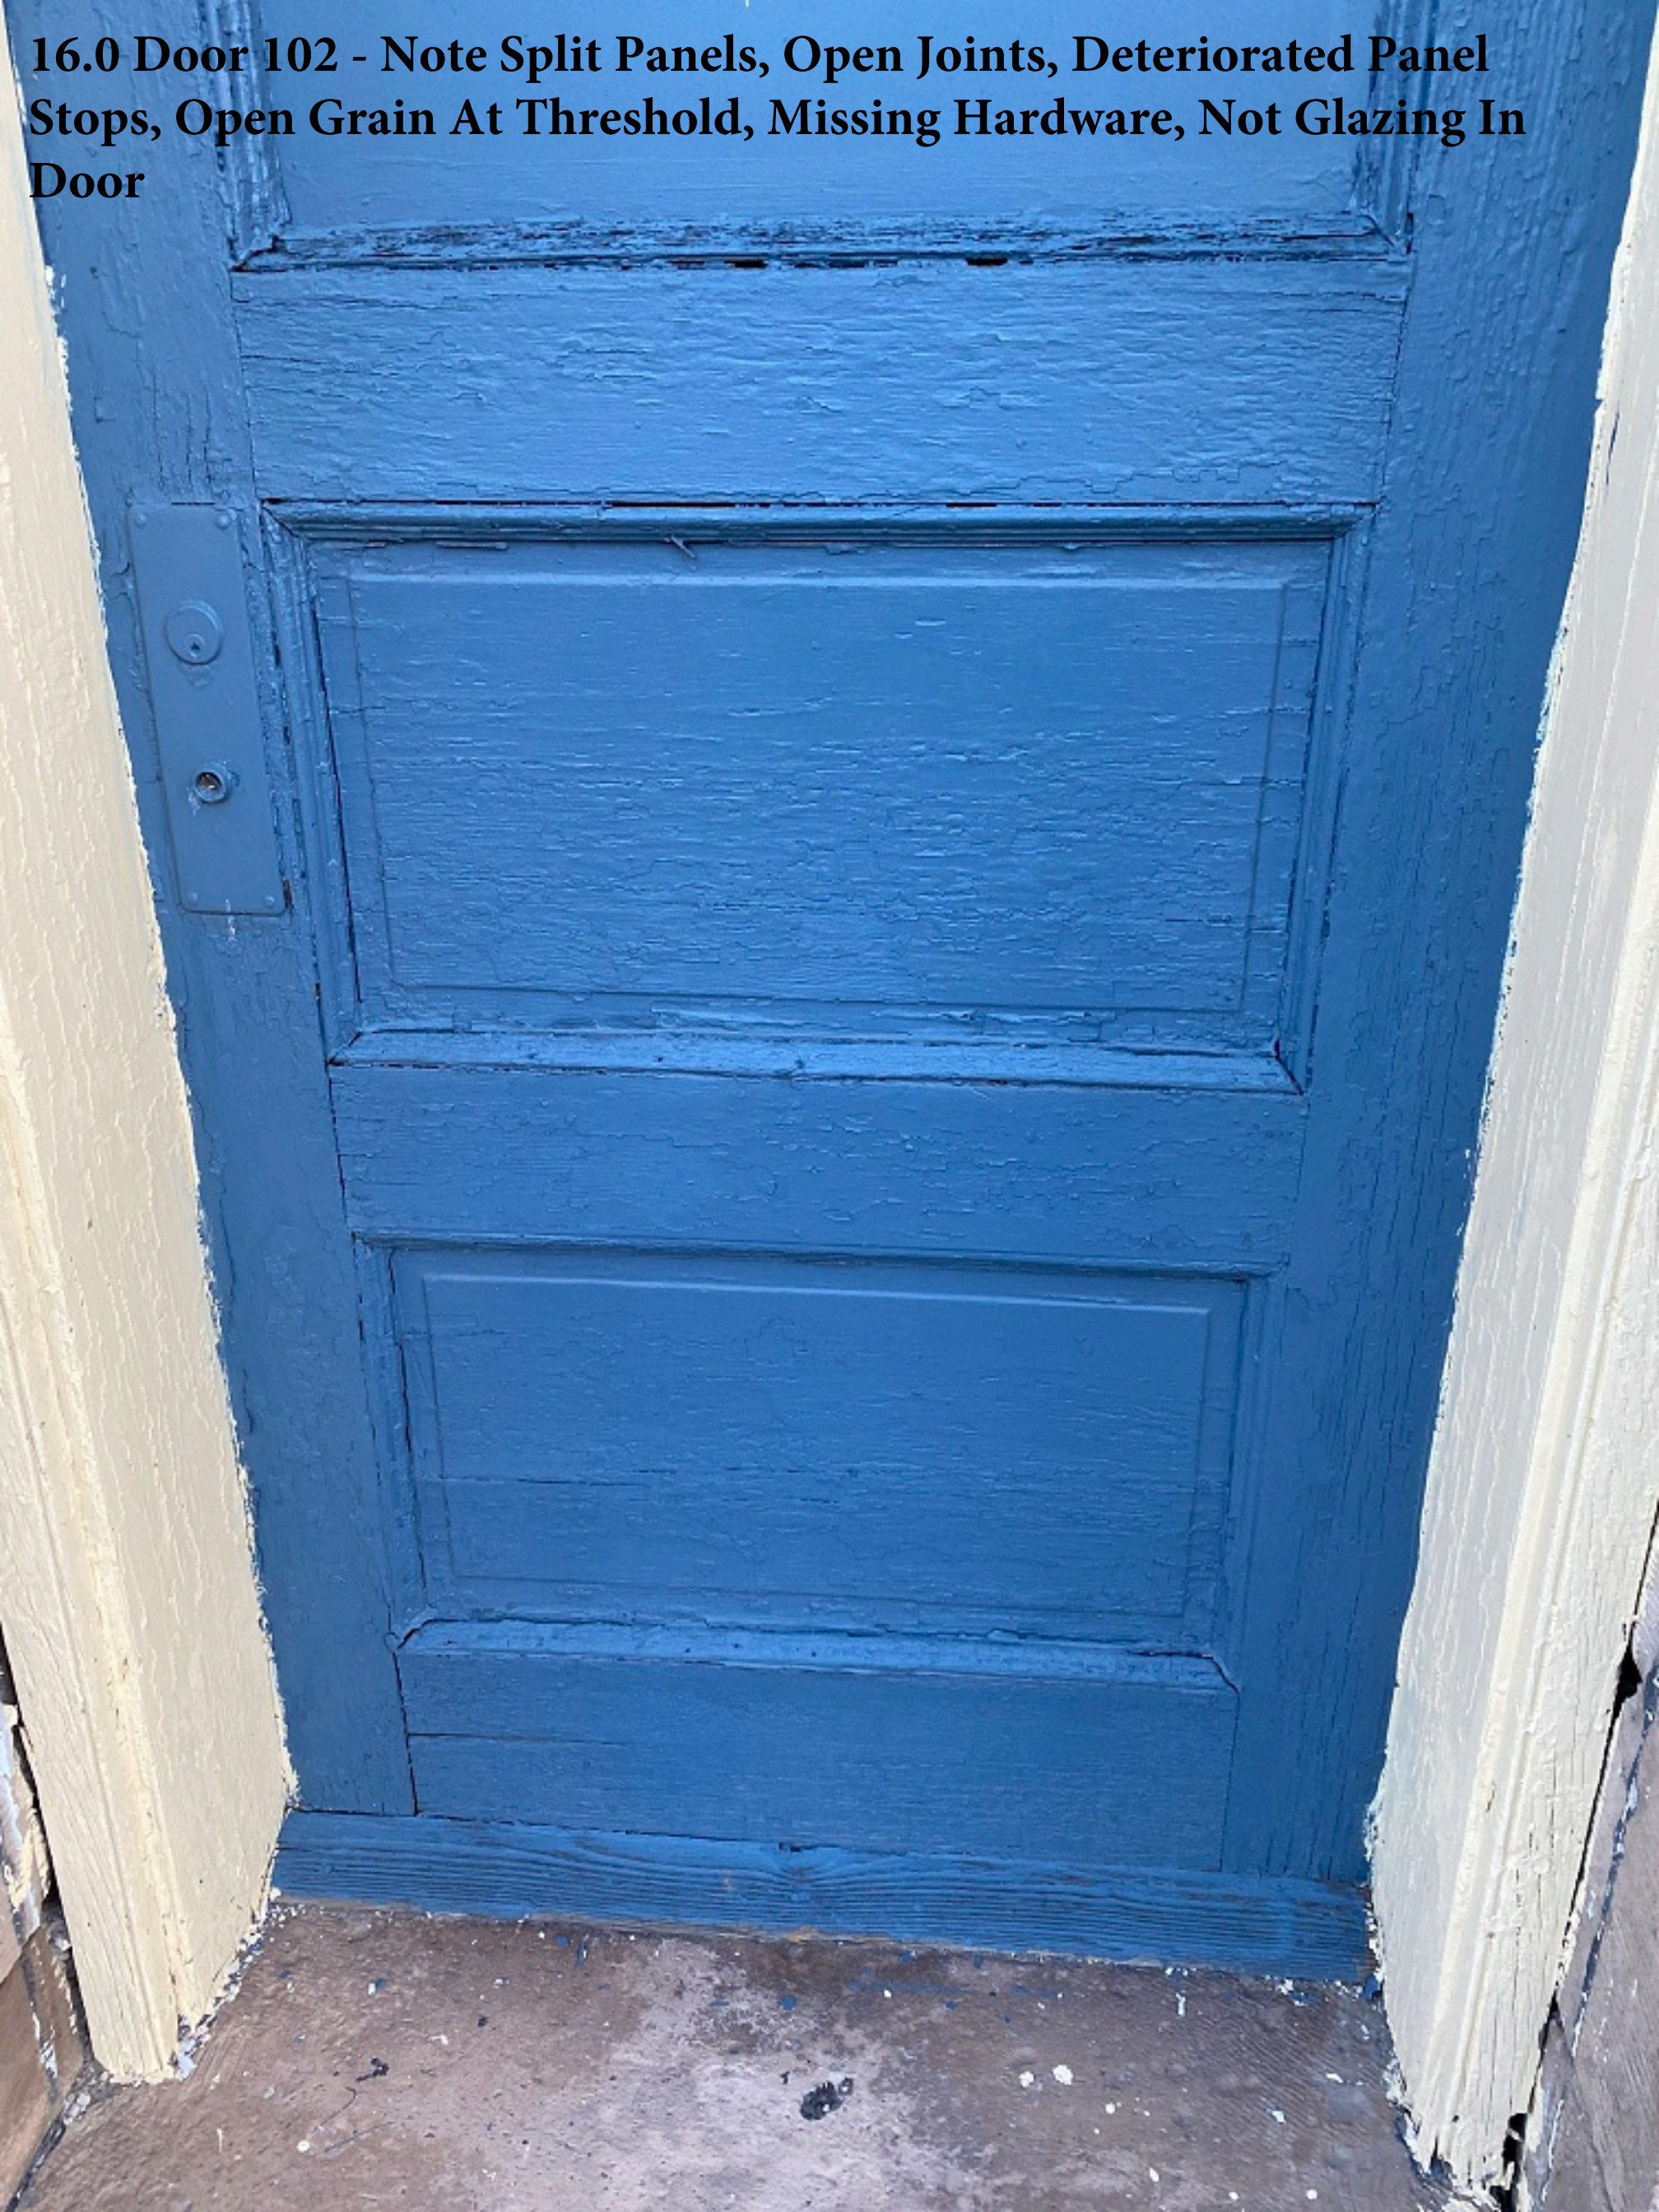
**16.0 Door 102 - Note Split Panels, Open Joints, Deteriorated Panel Stops, Open Grain At Threshold, Missing Hardware, Not Glazing In Door**

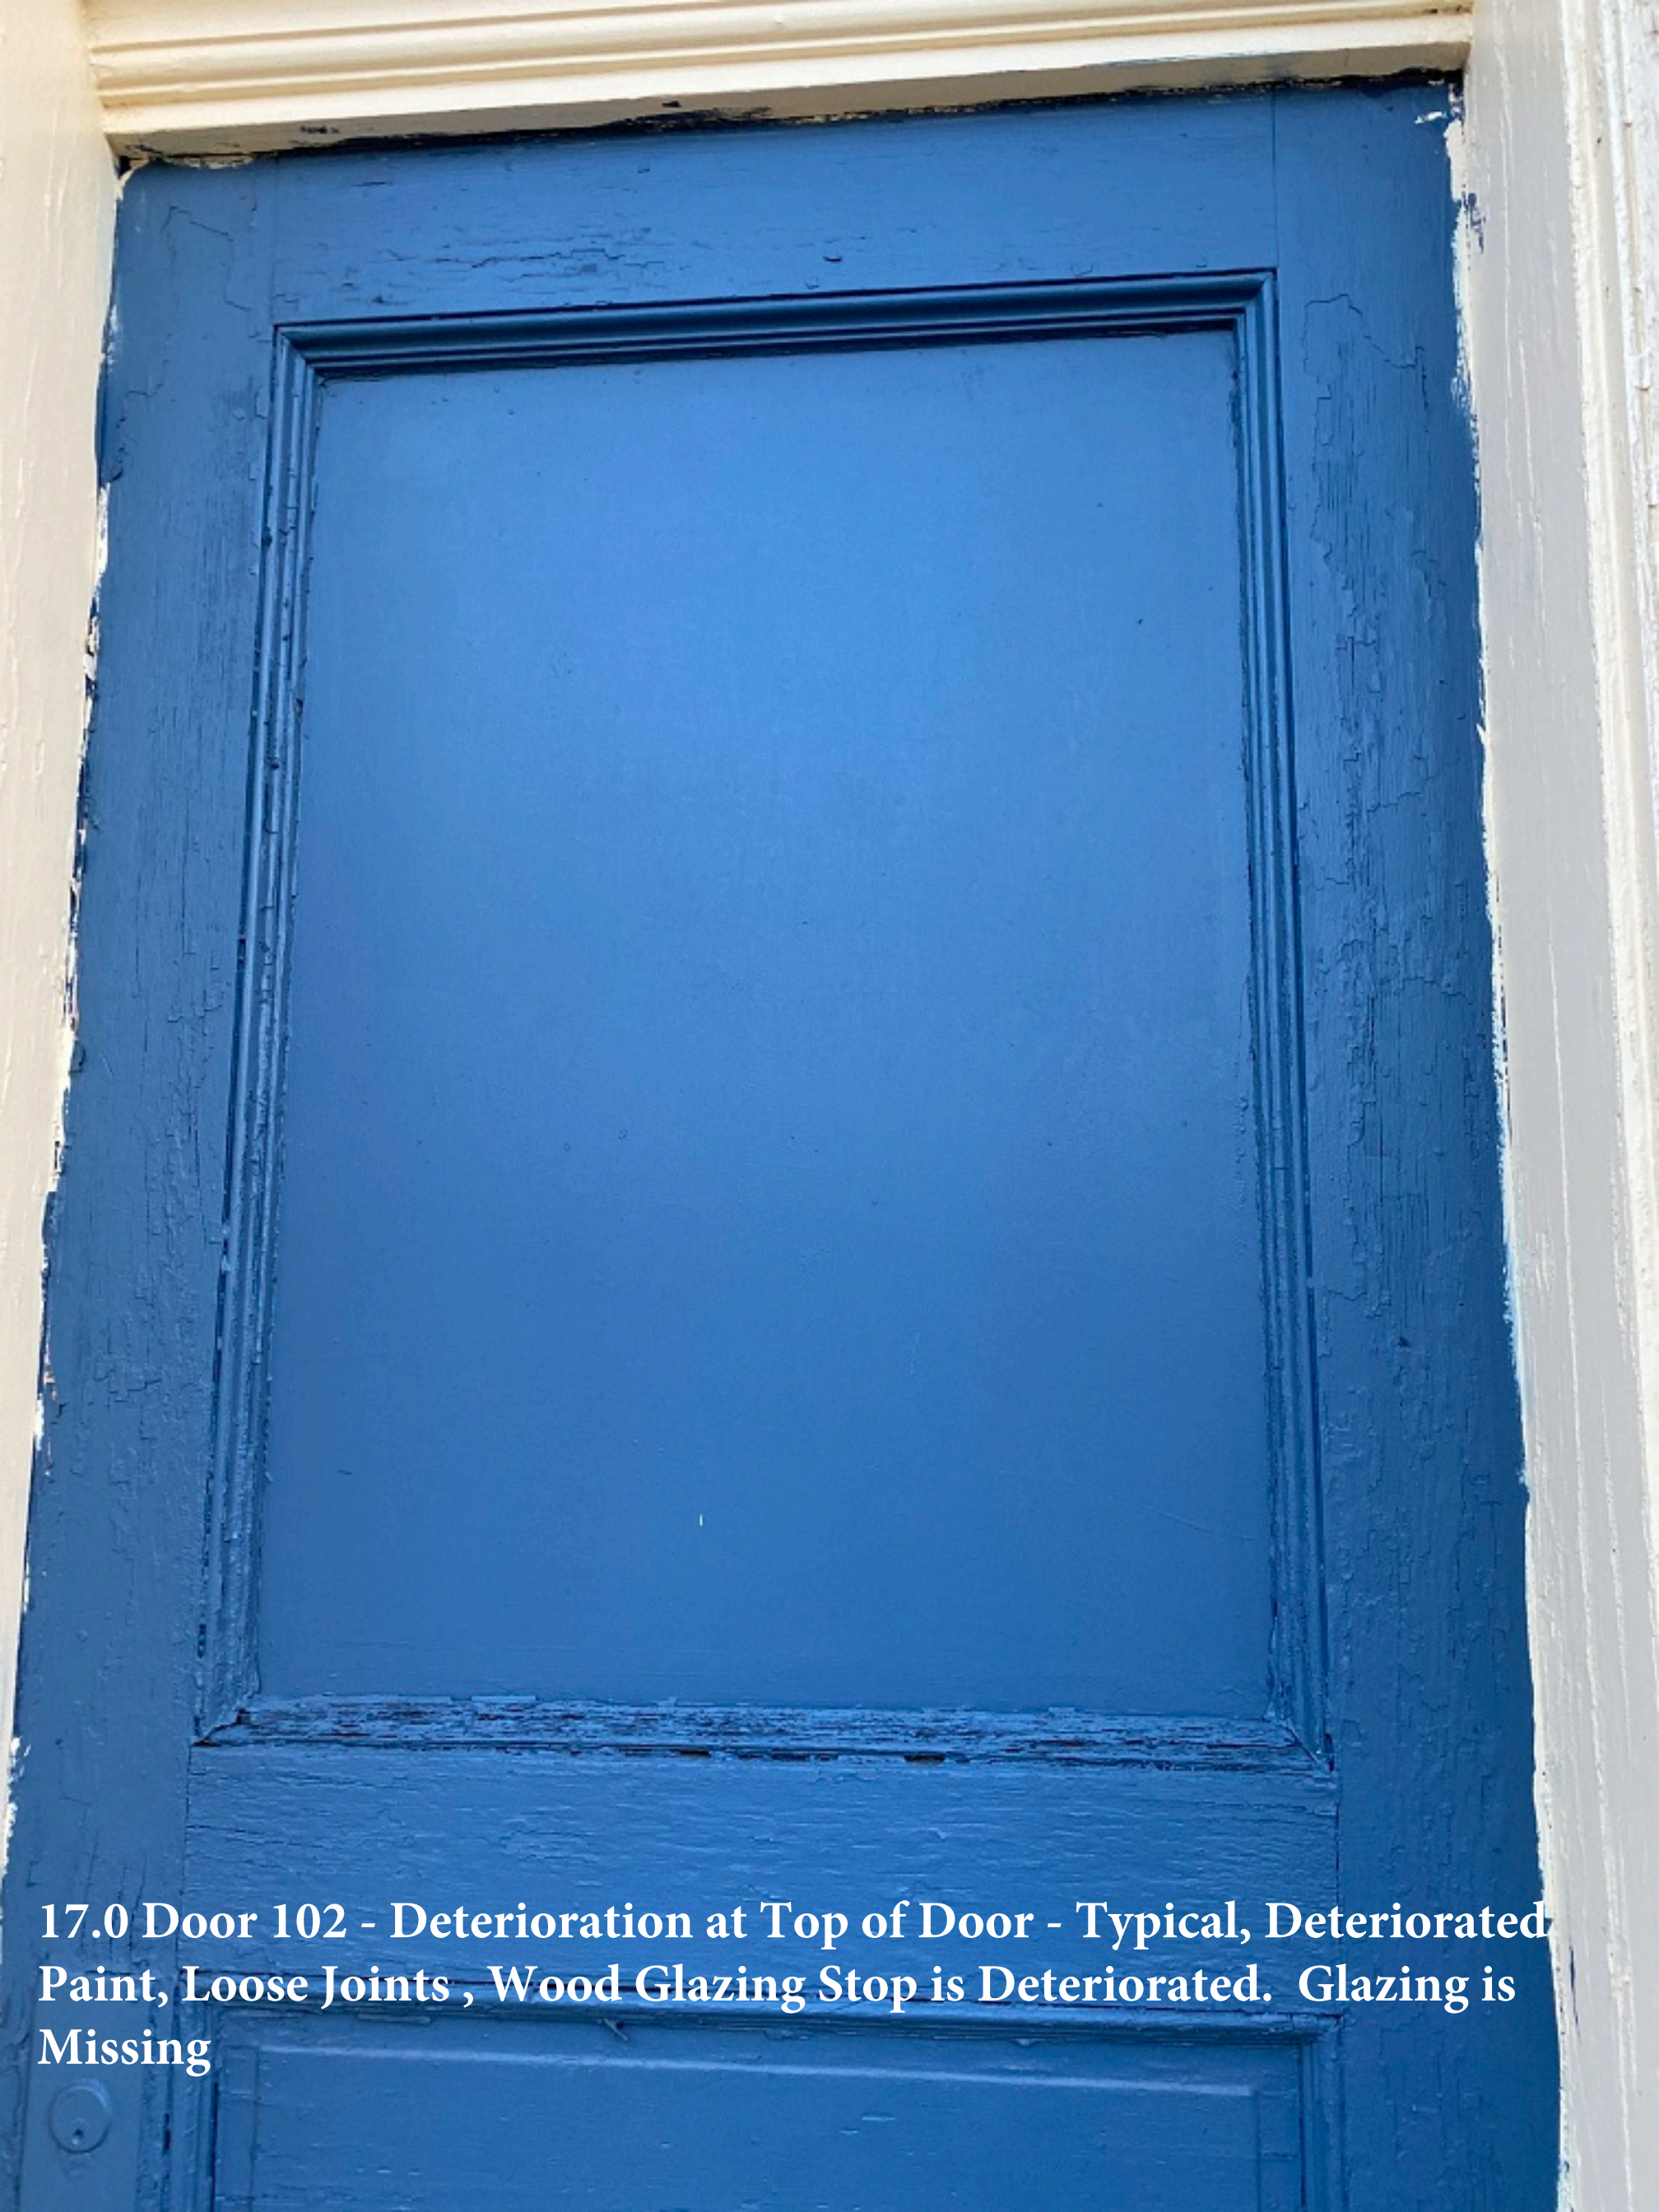
**17.0 Door 102 - Deterioration at Top of Door - Typical, Deteriorated Paint, Loose Joints , Wood Glazing Stop is Deteriorated. Glazing is Missing**
