## HISTORIC PRESERVATION BOARD APPLICATION

PROJECT NAME: Window and Door Restoration for the Douglas Masonic LodgePROPERTY ADDRESS / GENERAL LOCATION: 300 Wilcox StreetLEGAL DESCRIPTION: Range 8, Township 67, Block 19, Lot 7 in Castle Rock, ColoradoPROJECT DESCRIPTION: Please see enclosed Project Description, floor plan & photos to better understand the scope of work.  
The project will include exterior door restoration and window restoration. See Attachment A and Budget Worksheet.

DOUGLAS MASONIC  
LODGE  
NO. 153 A.F. & A.M.

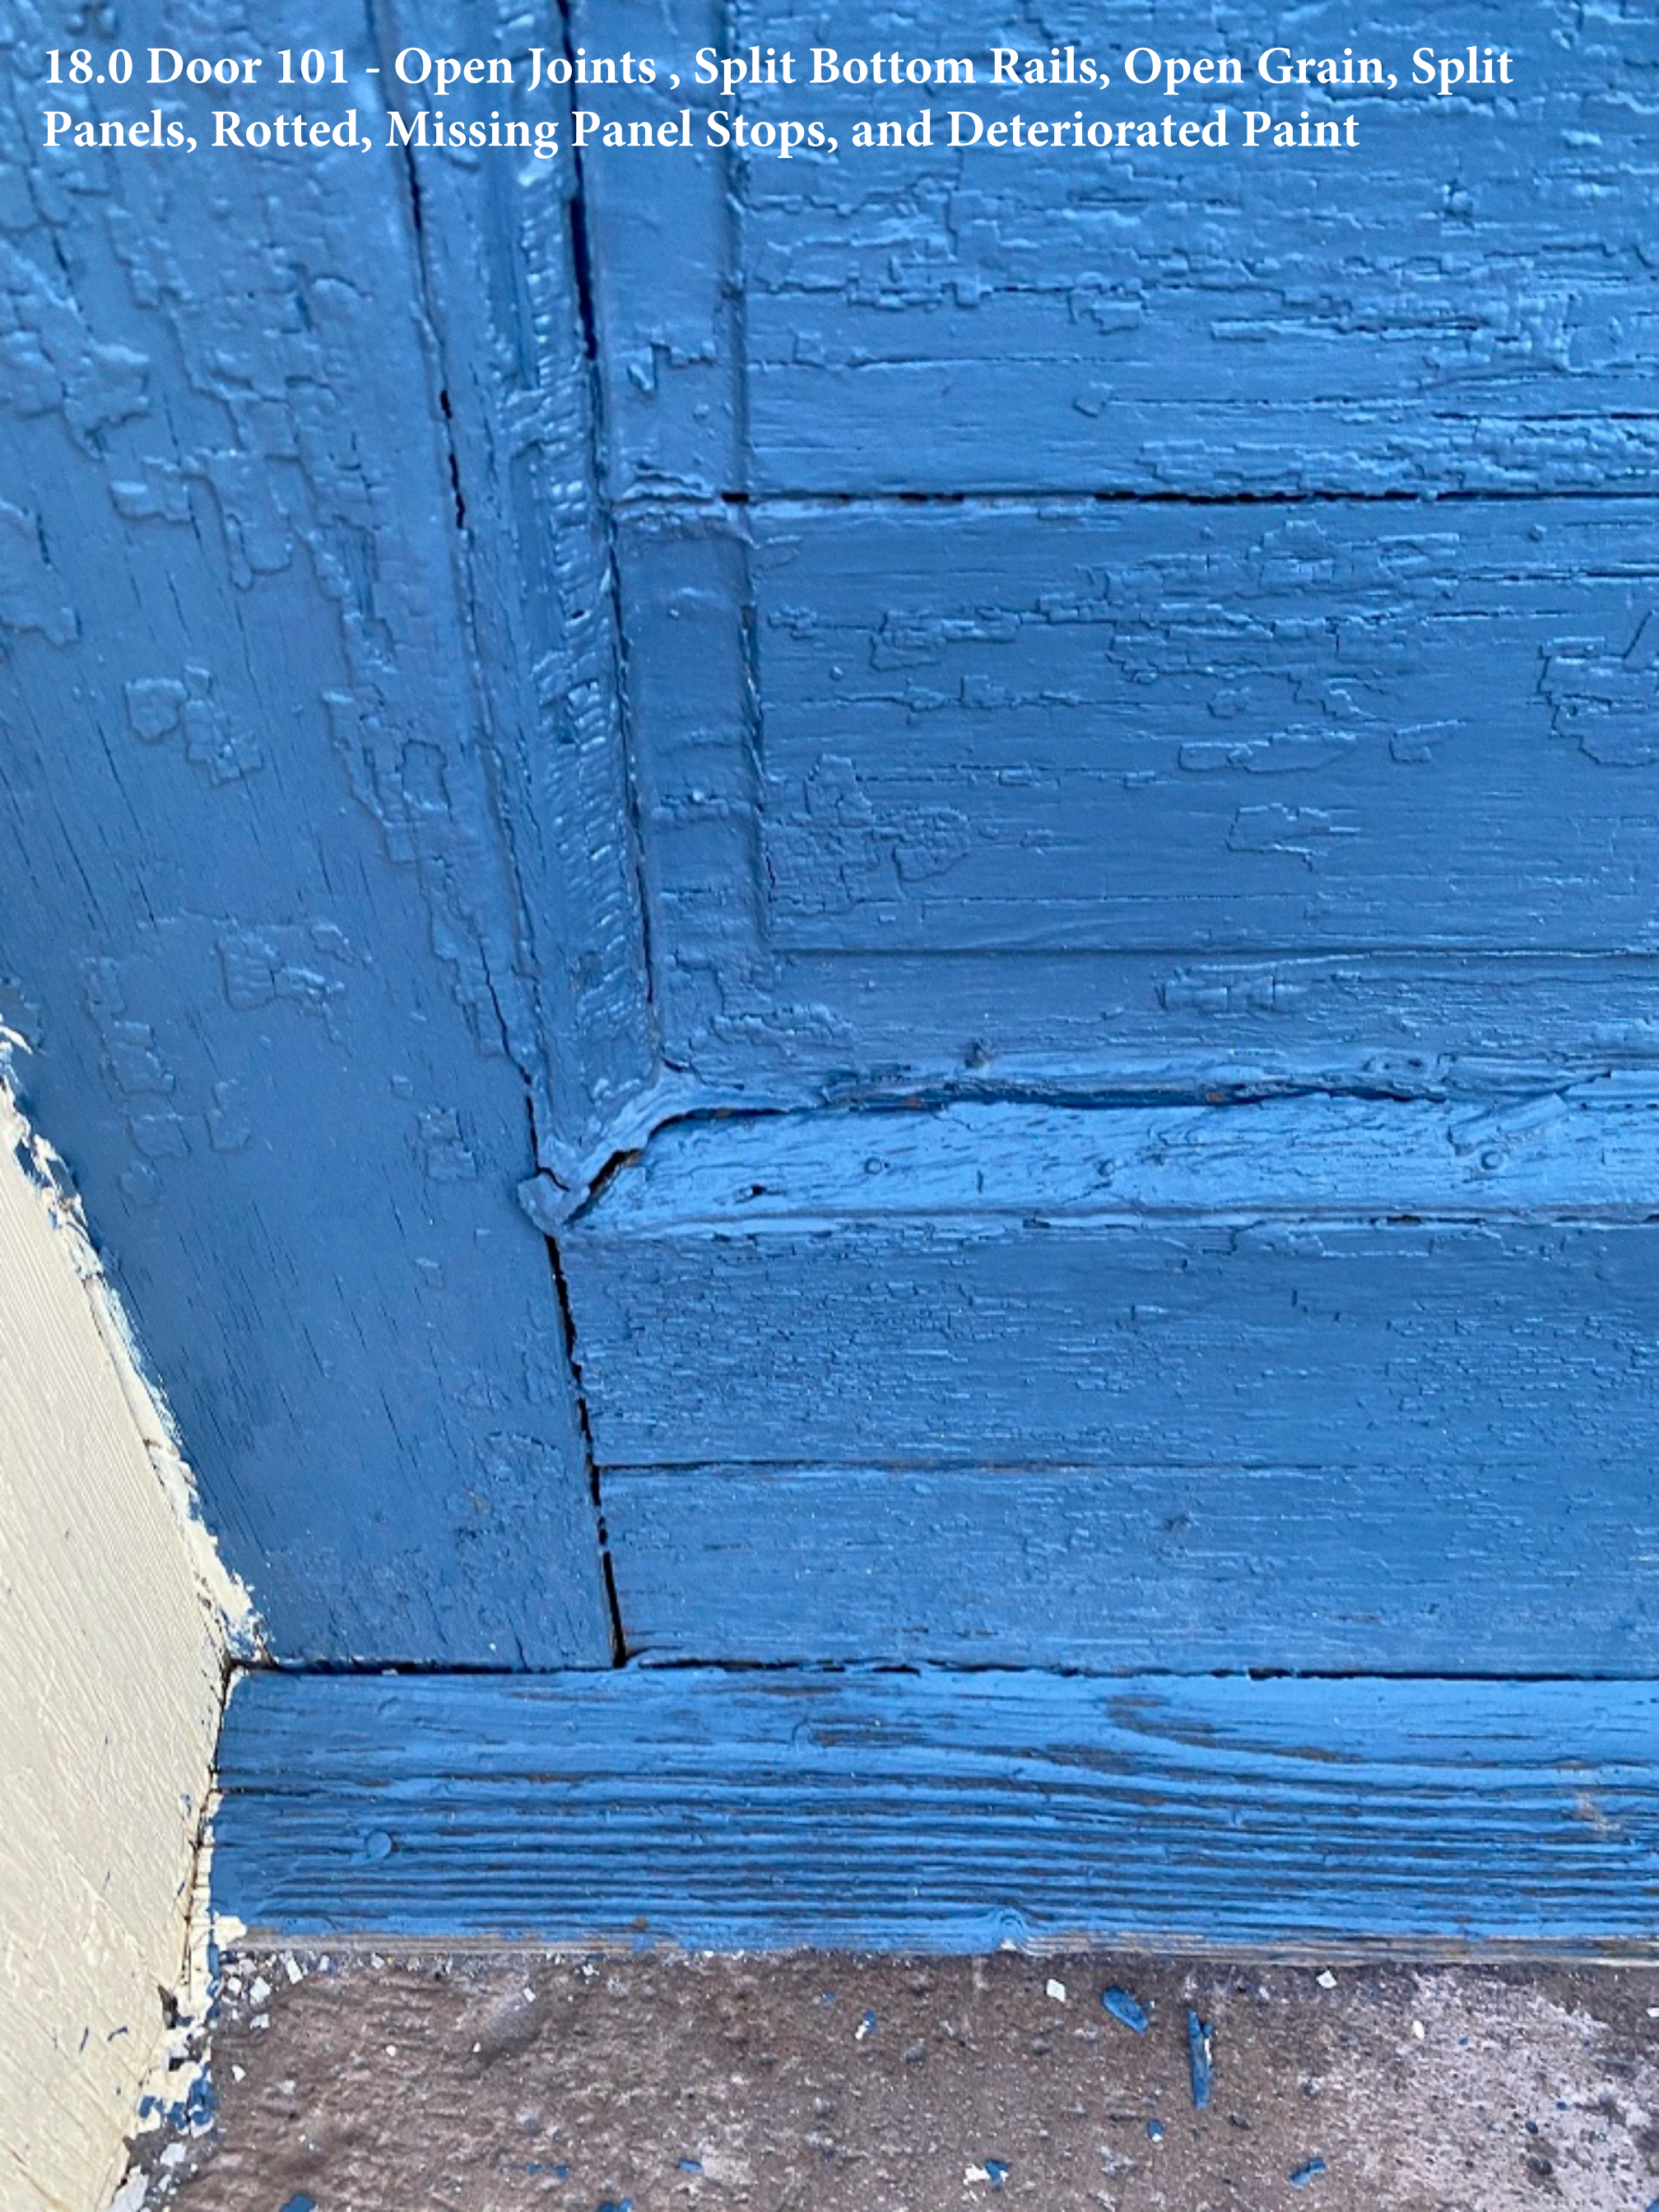
## 18.0 Door 101 - Open Joints , Split Bottom Rails, Open Grain, Split Panels, Rotted, Missing Panel Stops, and Deteriorated Paint

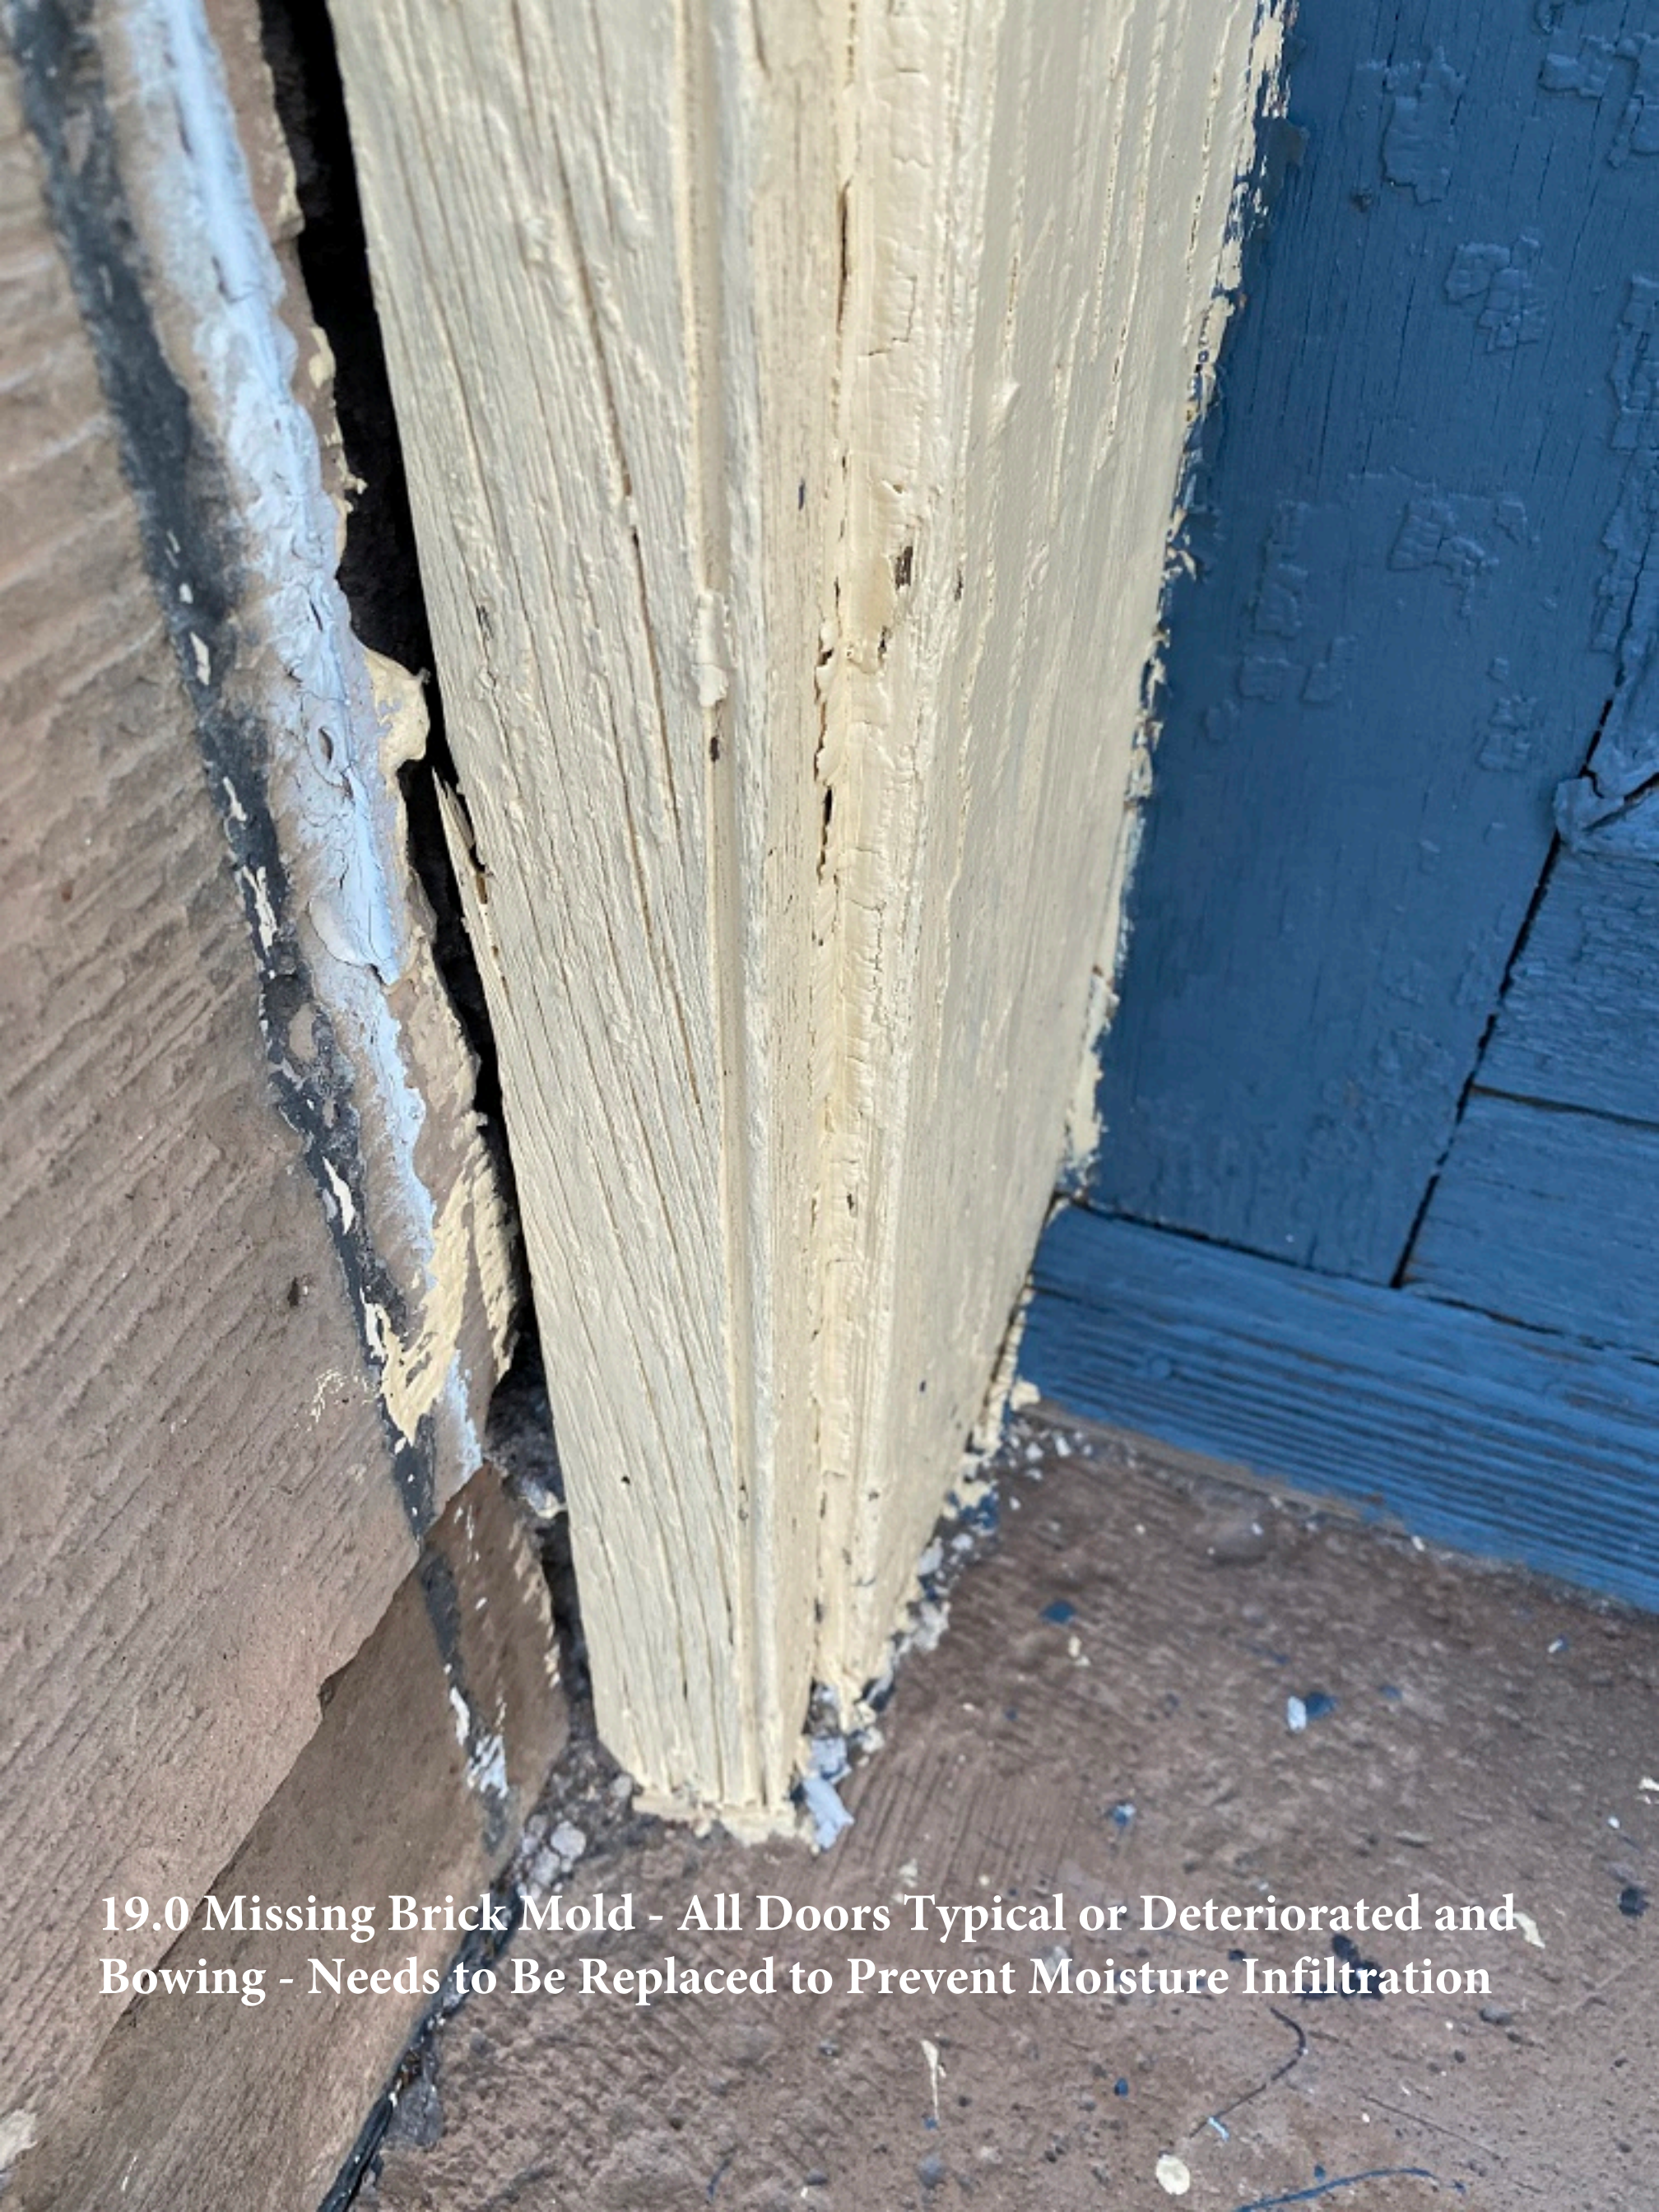
19.0 Missing Brick Mold - All Doors Typical or Deteriorated and Bowing - Needs to Be Replaced to Prevent Moisture Infiltration

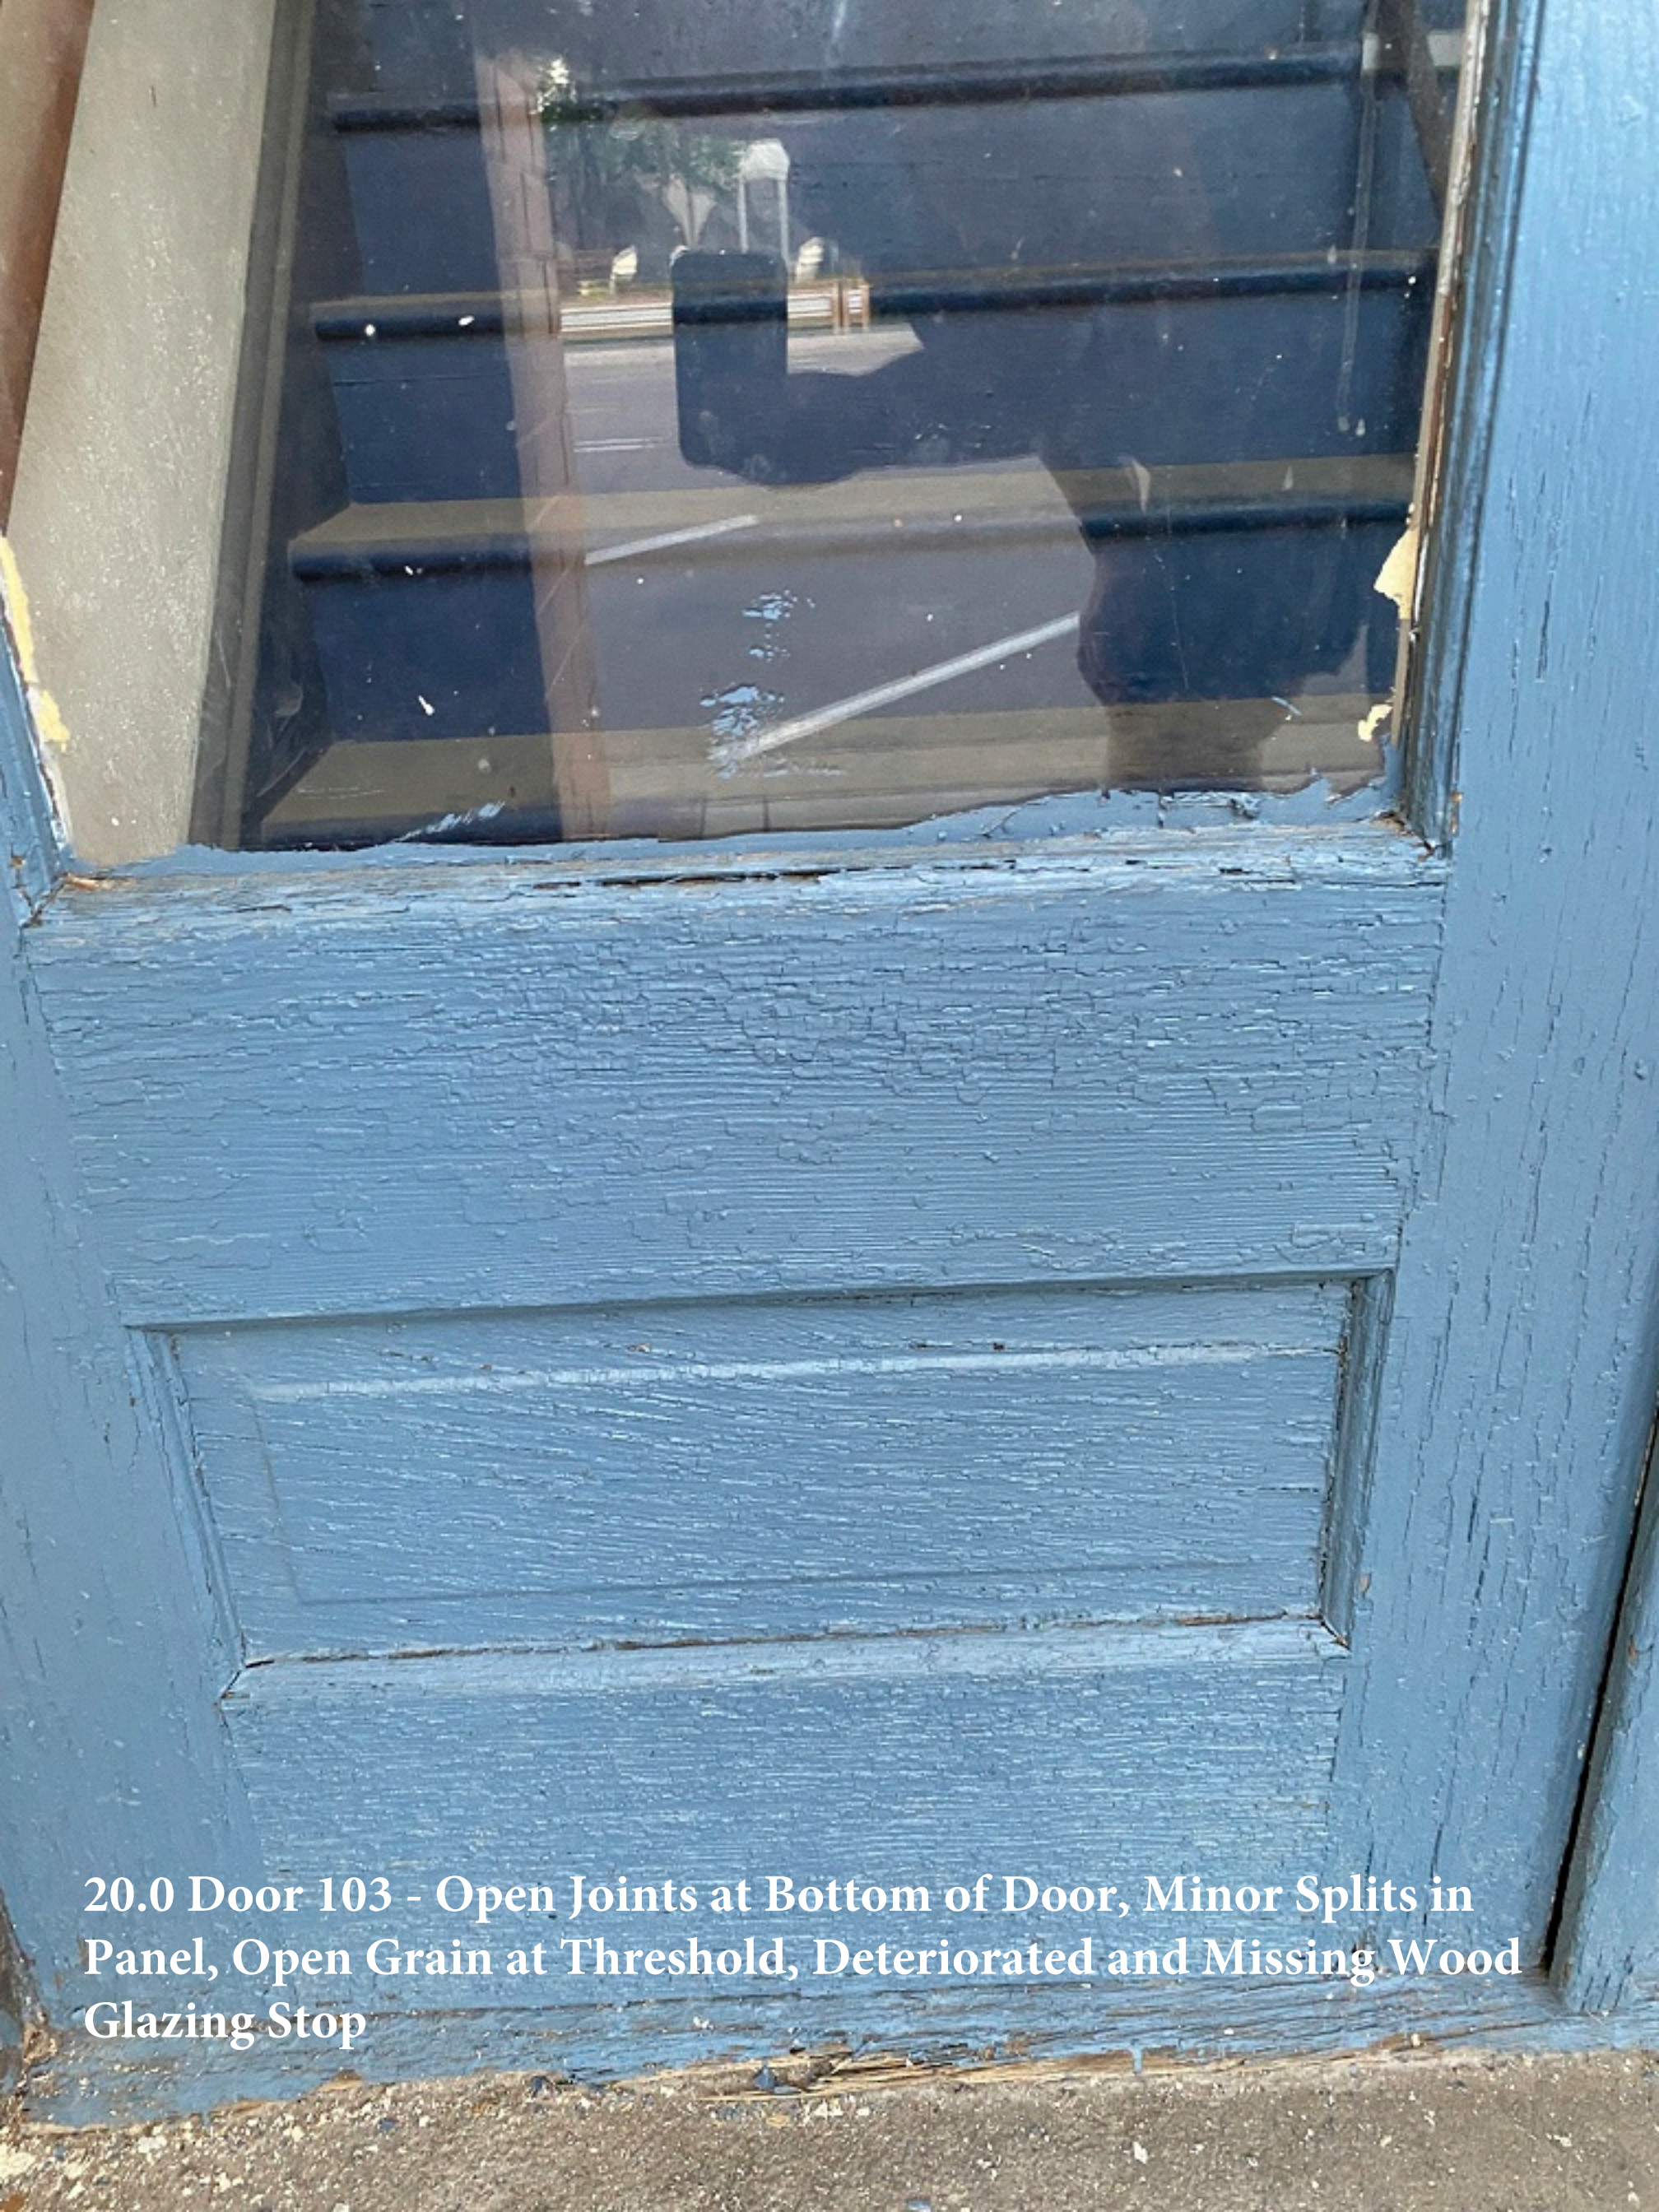
20.0 Door 103 - Open Joints at Bottom of Door, Minor Splits in Panel, Open Grain at Threshold, Deteriorated and Missing Wood Glazing Stop

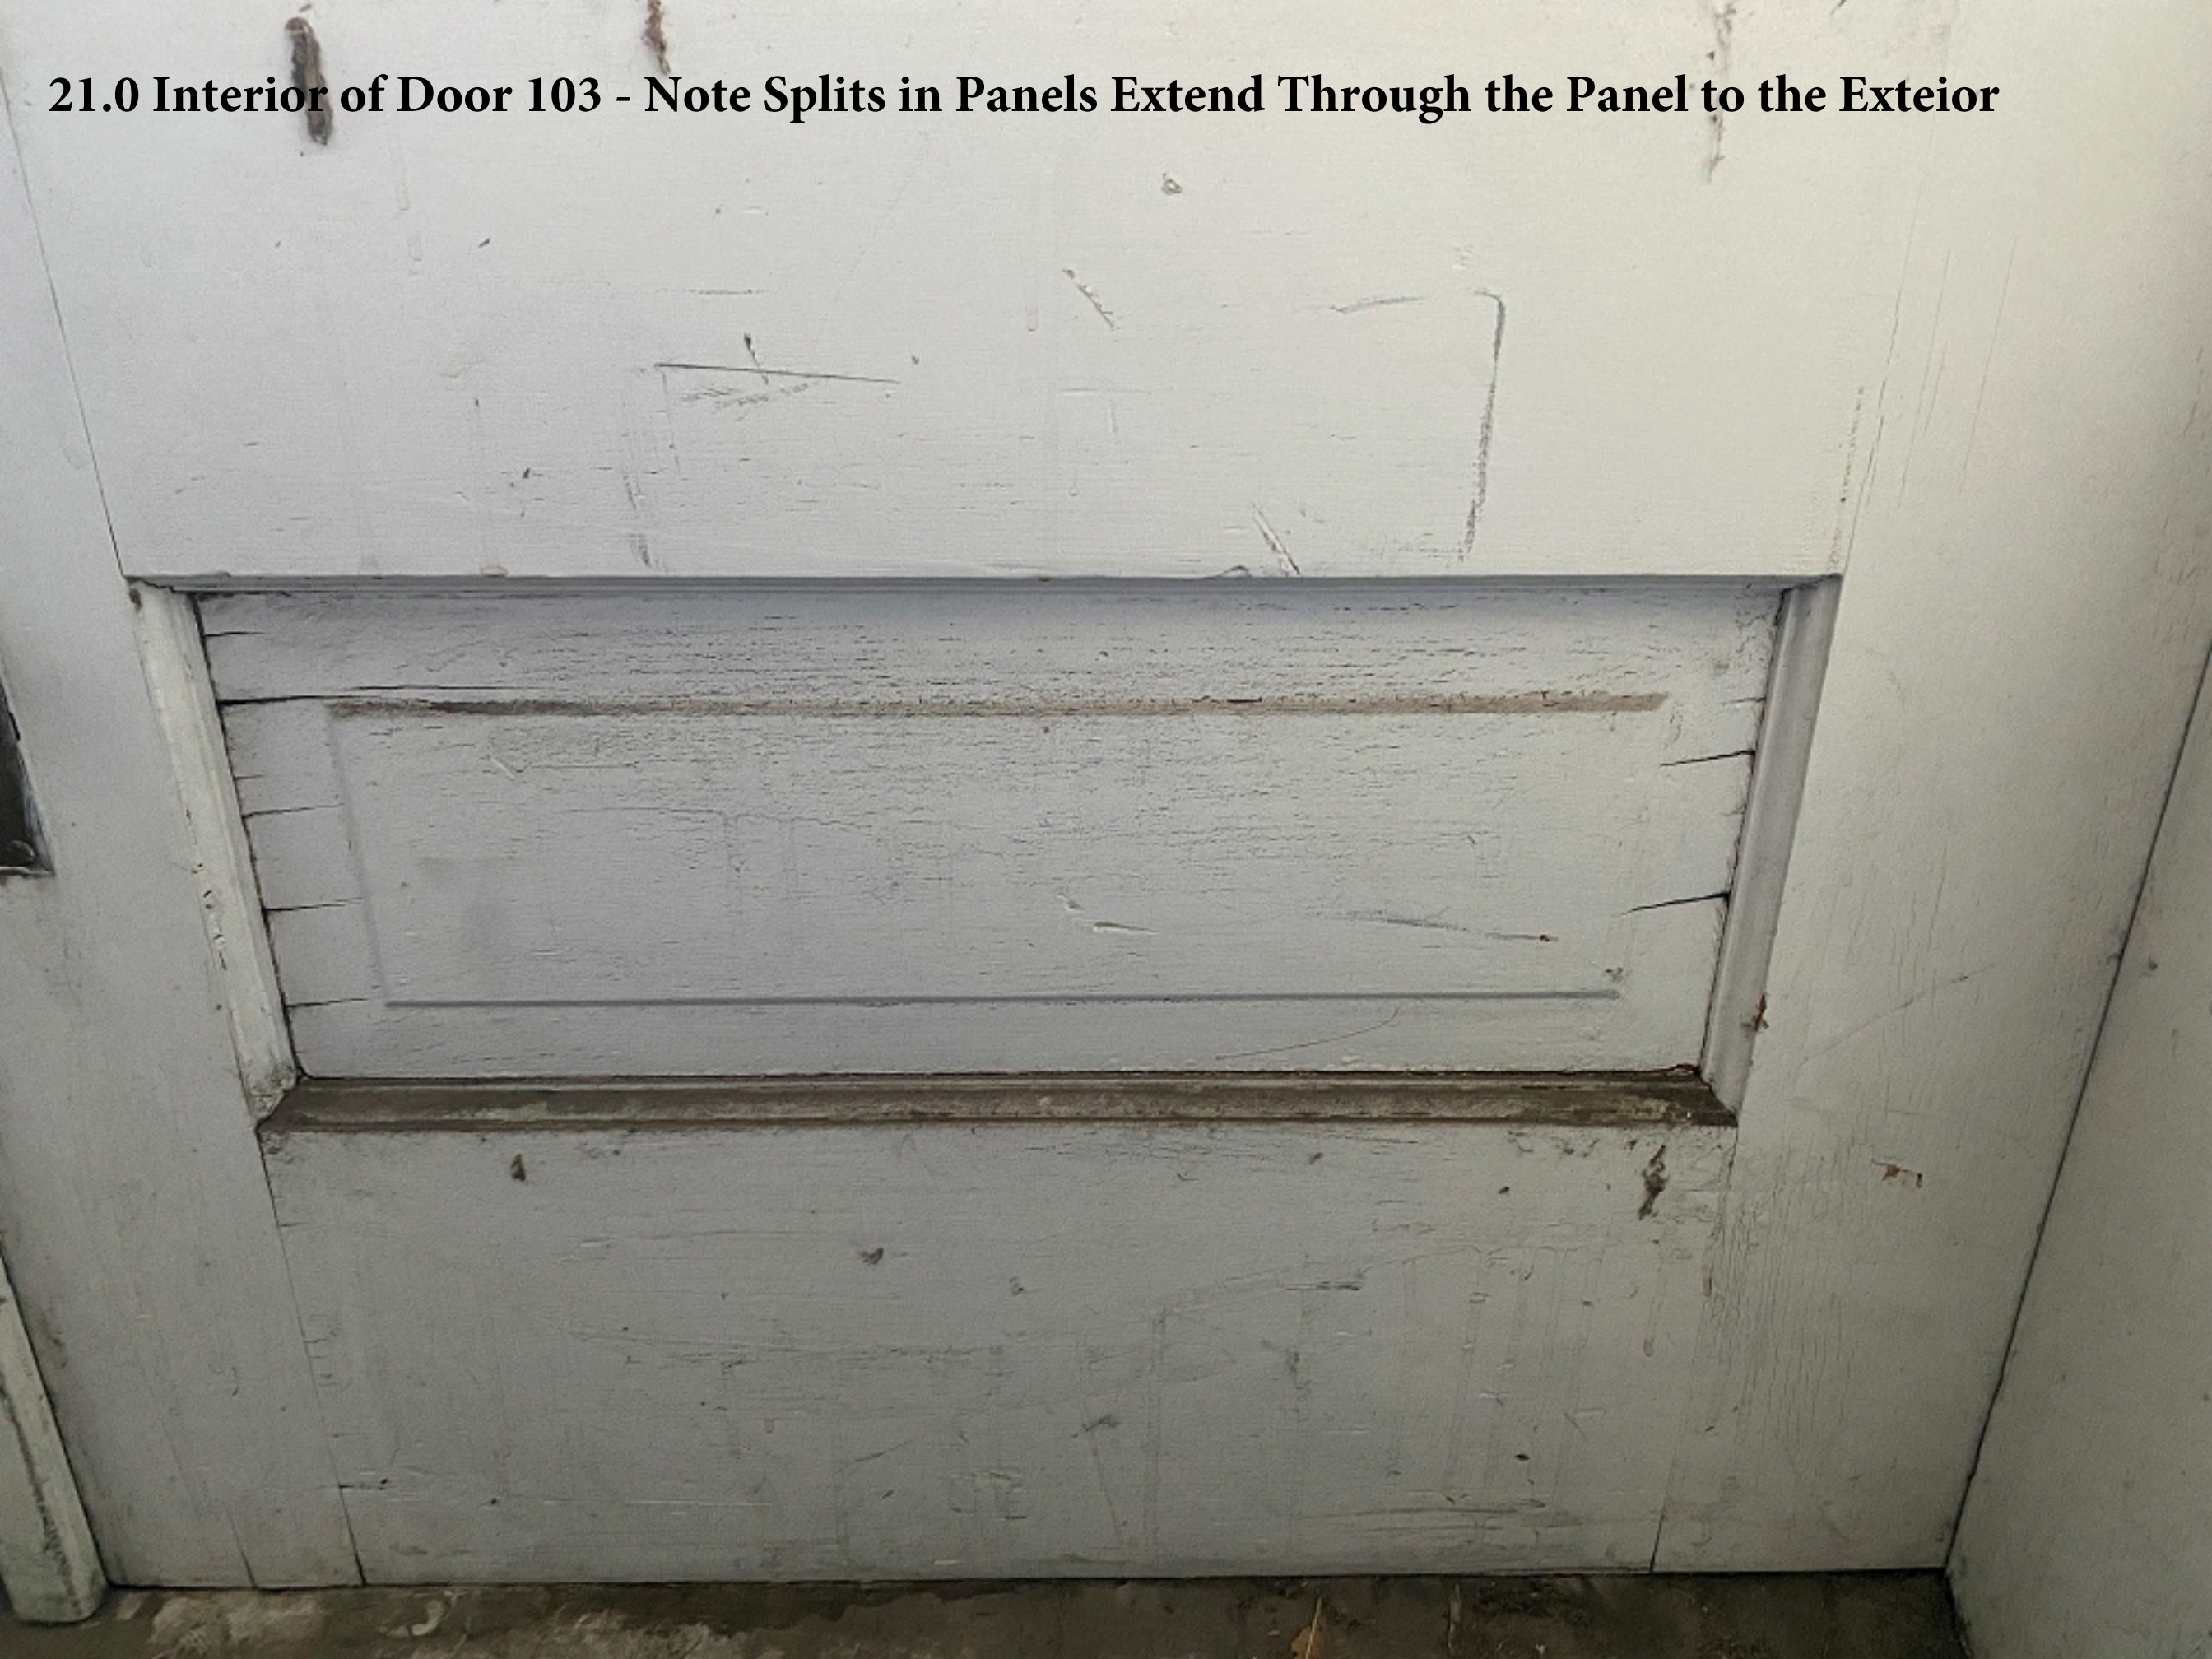
**21.0 Interior of Door 103 - Note Splits in Panels Extend Through the Panel to the Exterior**

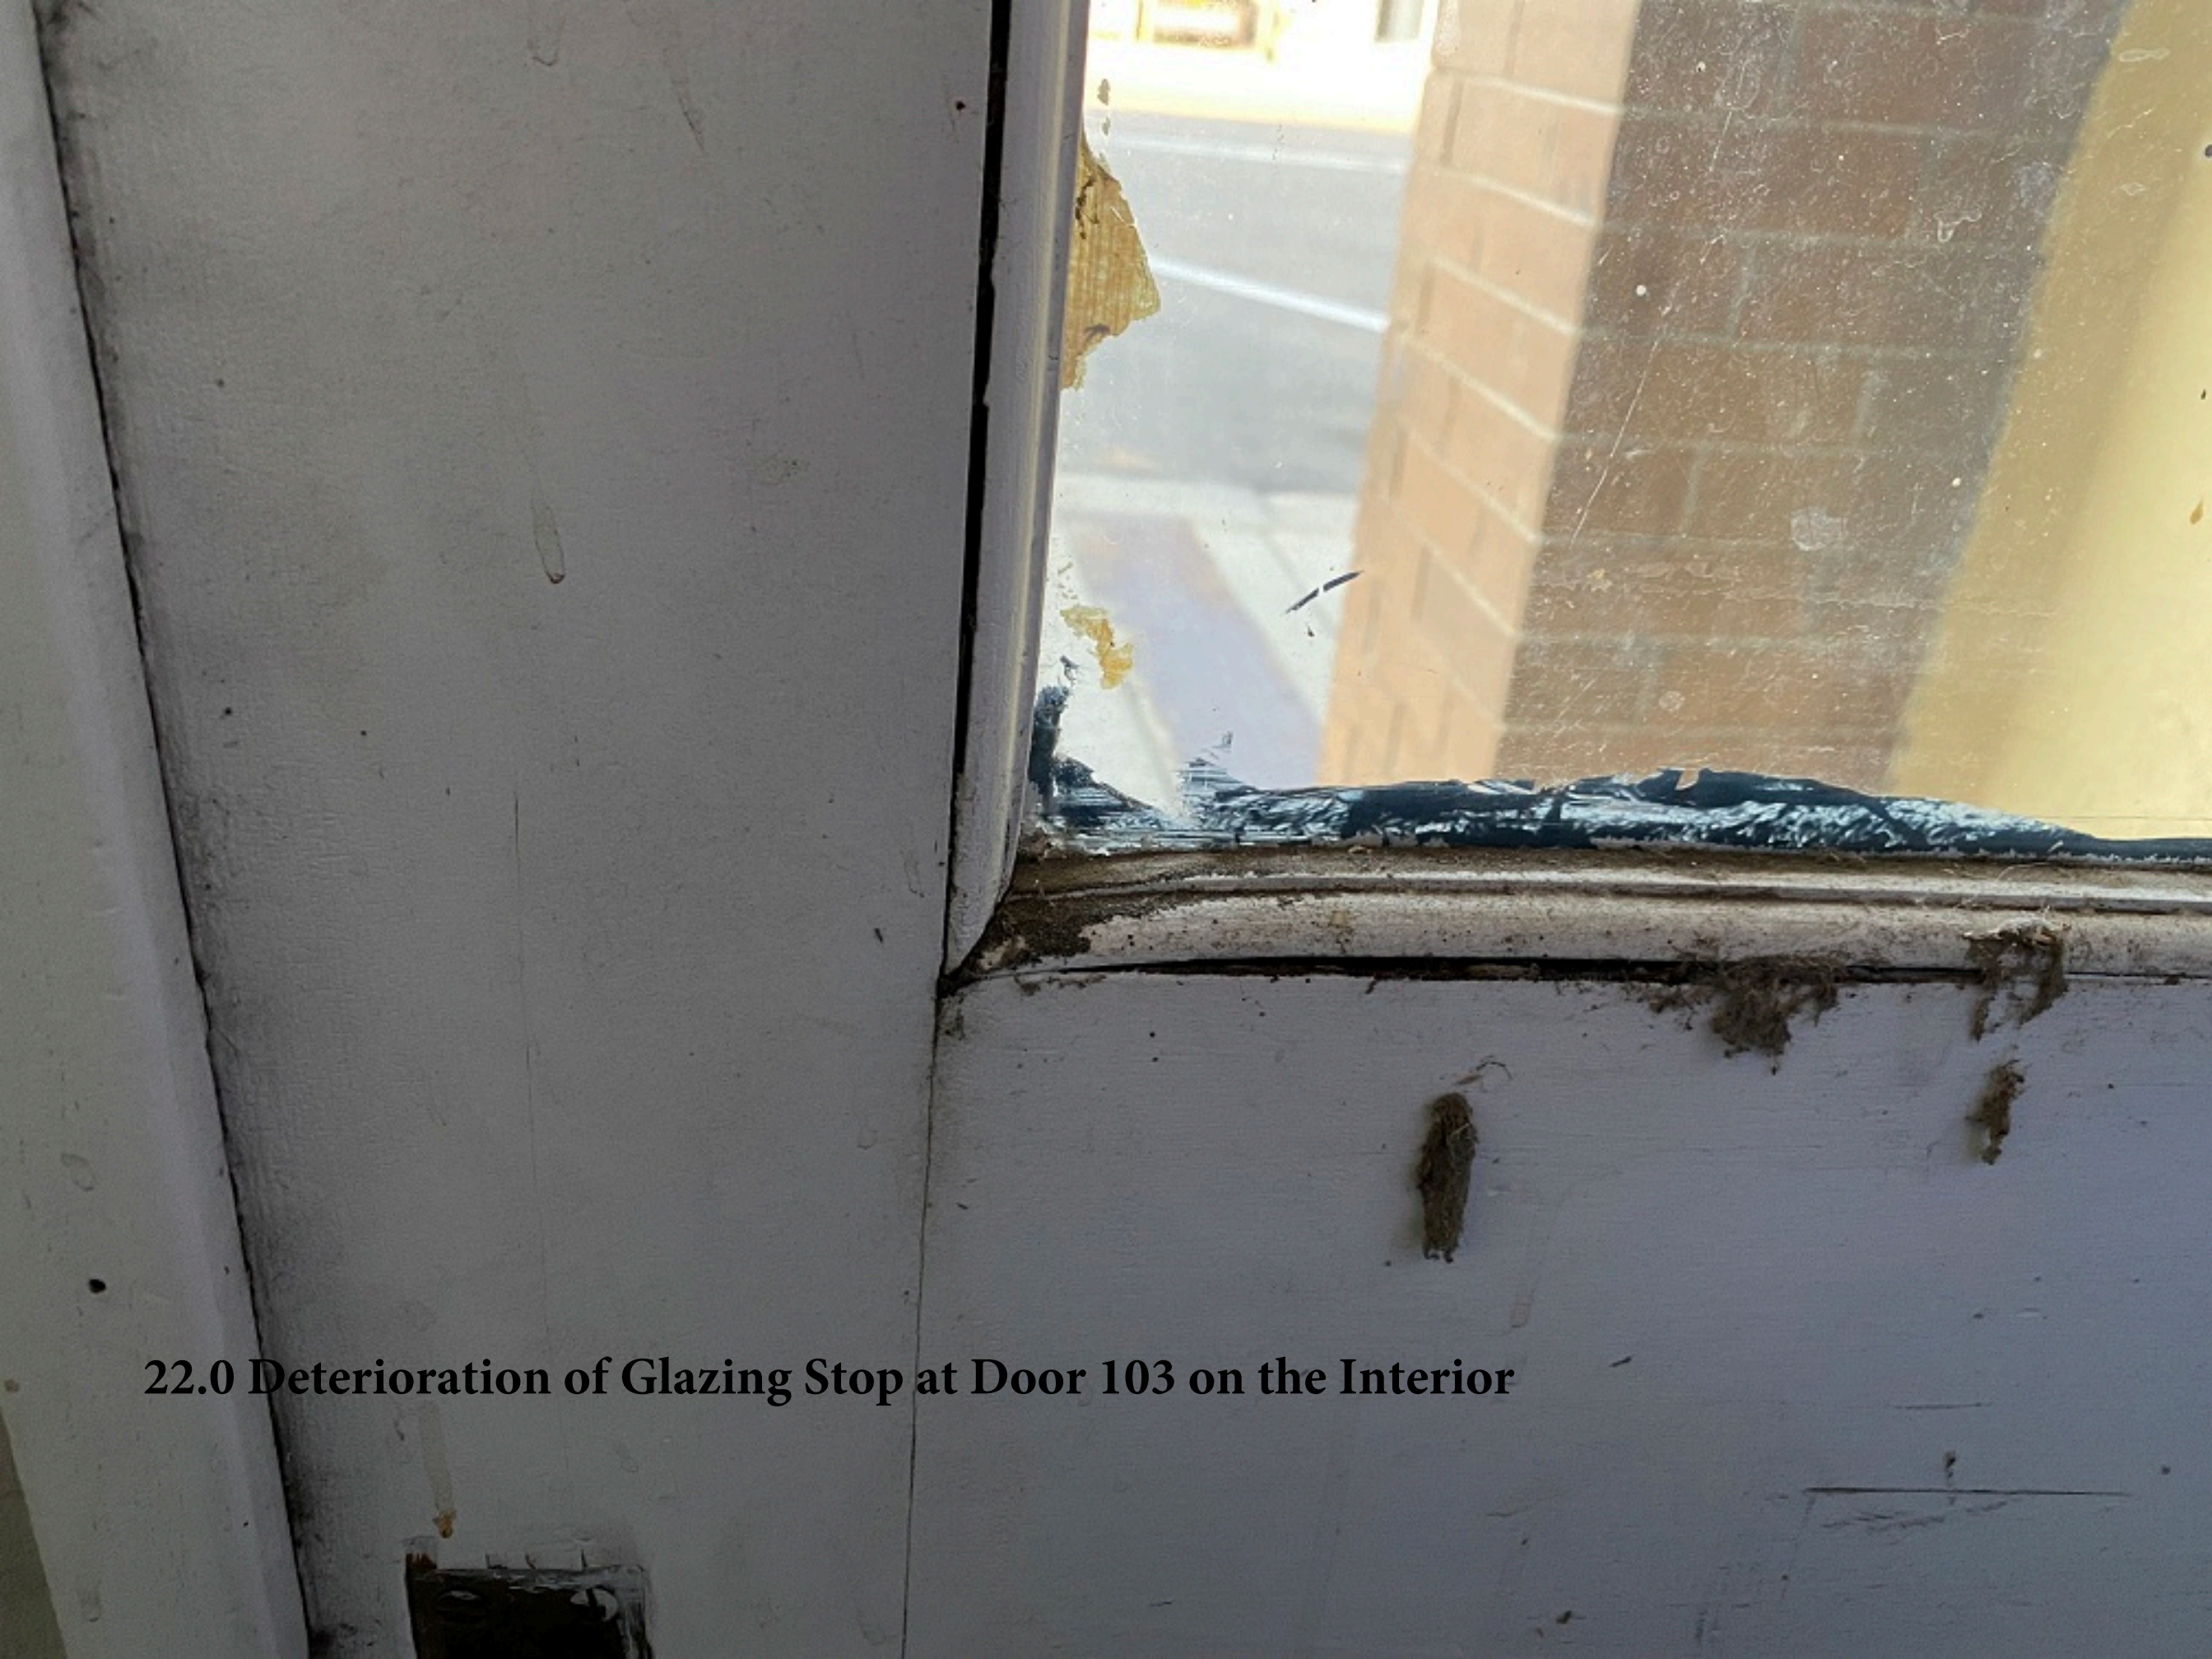
**22.0 Deterioration of Glazing Stop at Door 103 on the Interior**

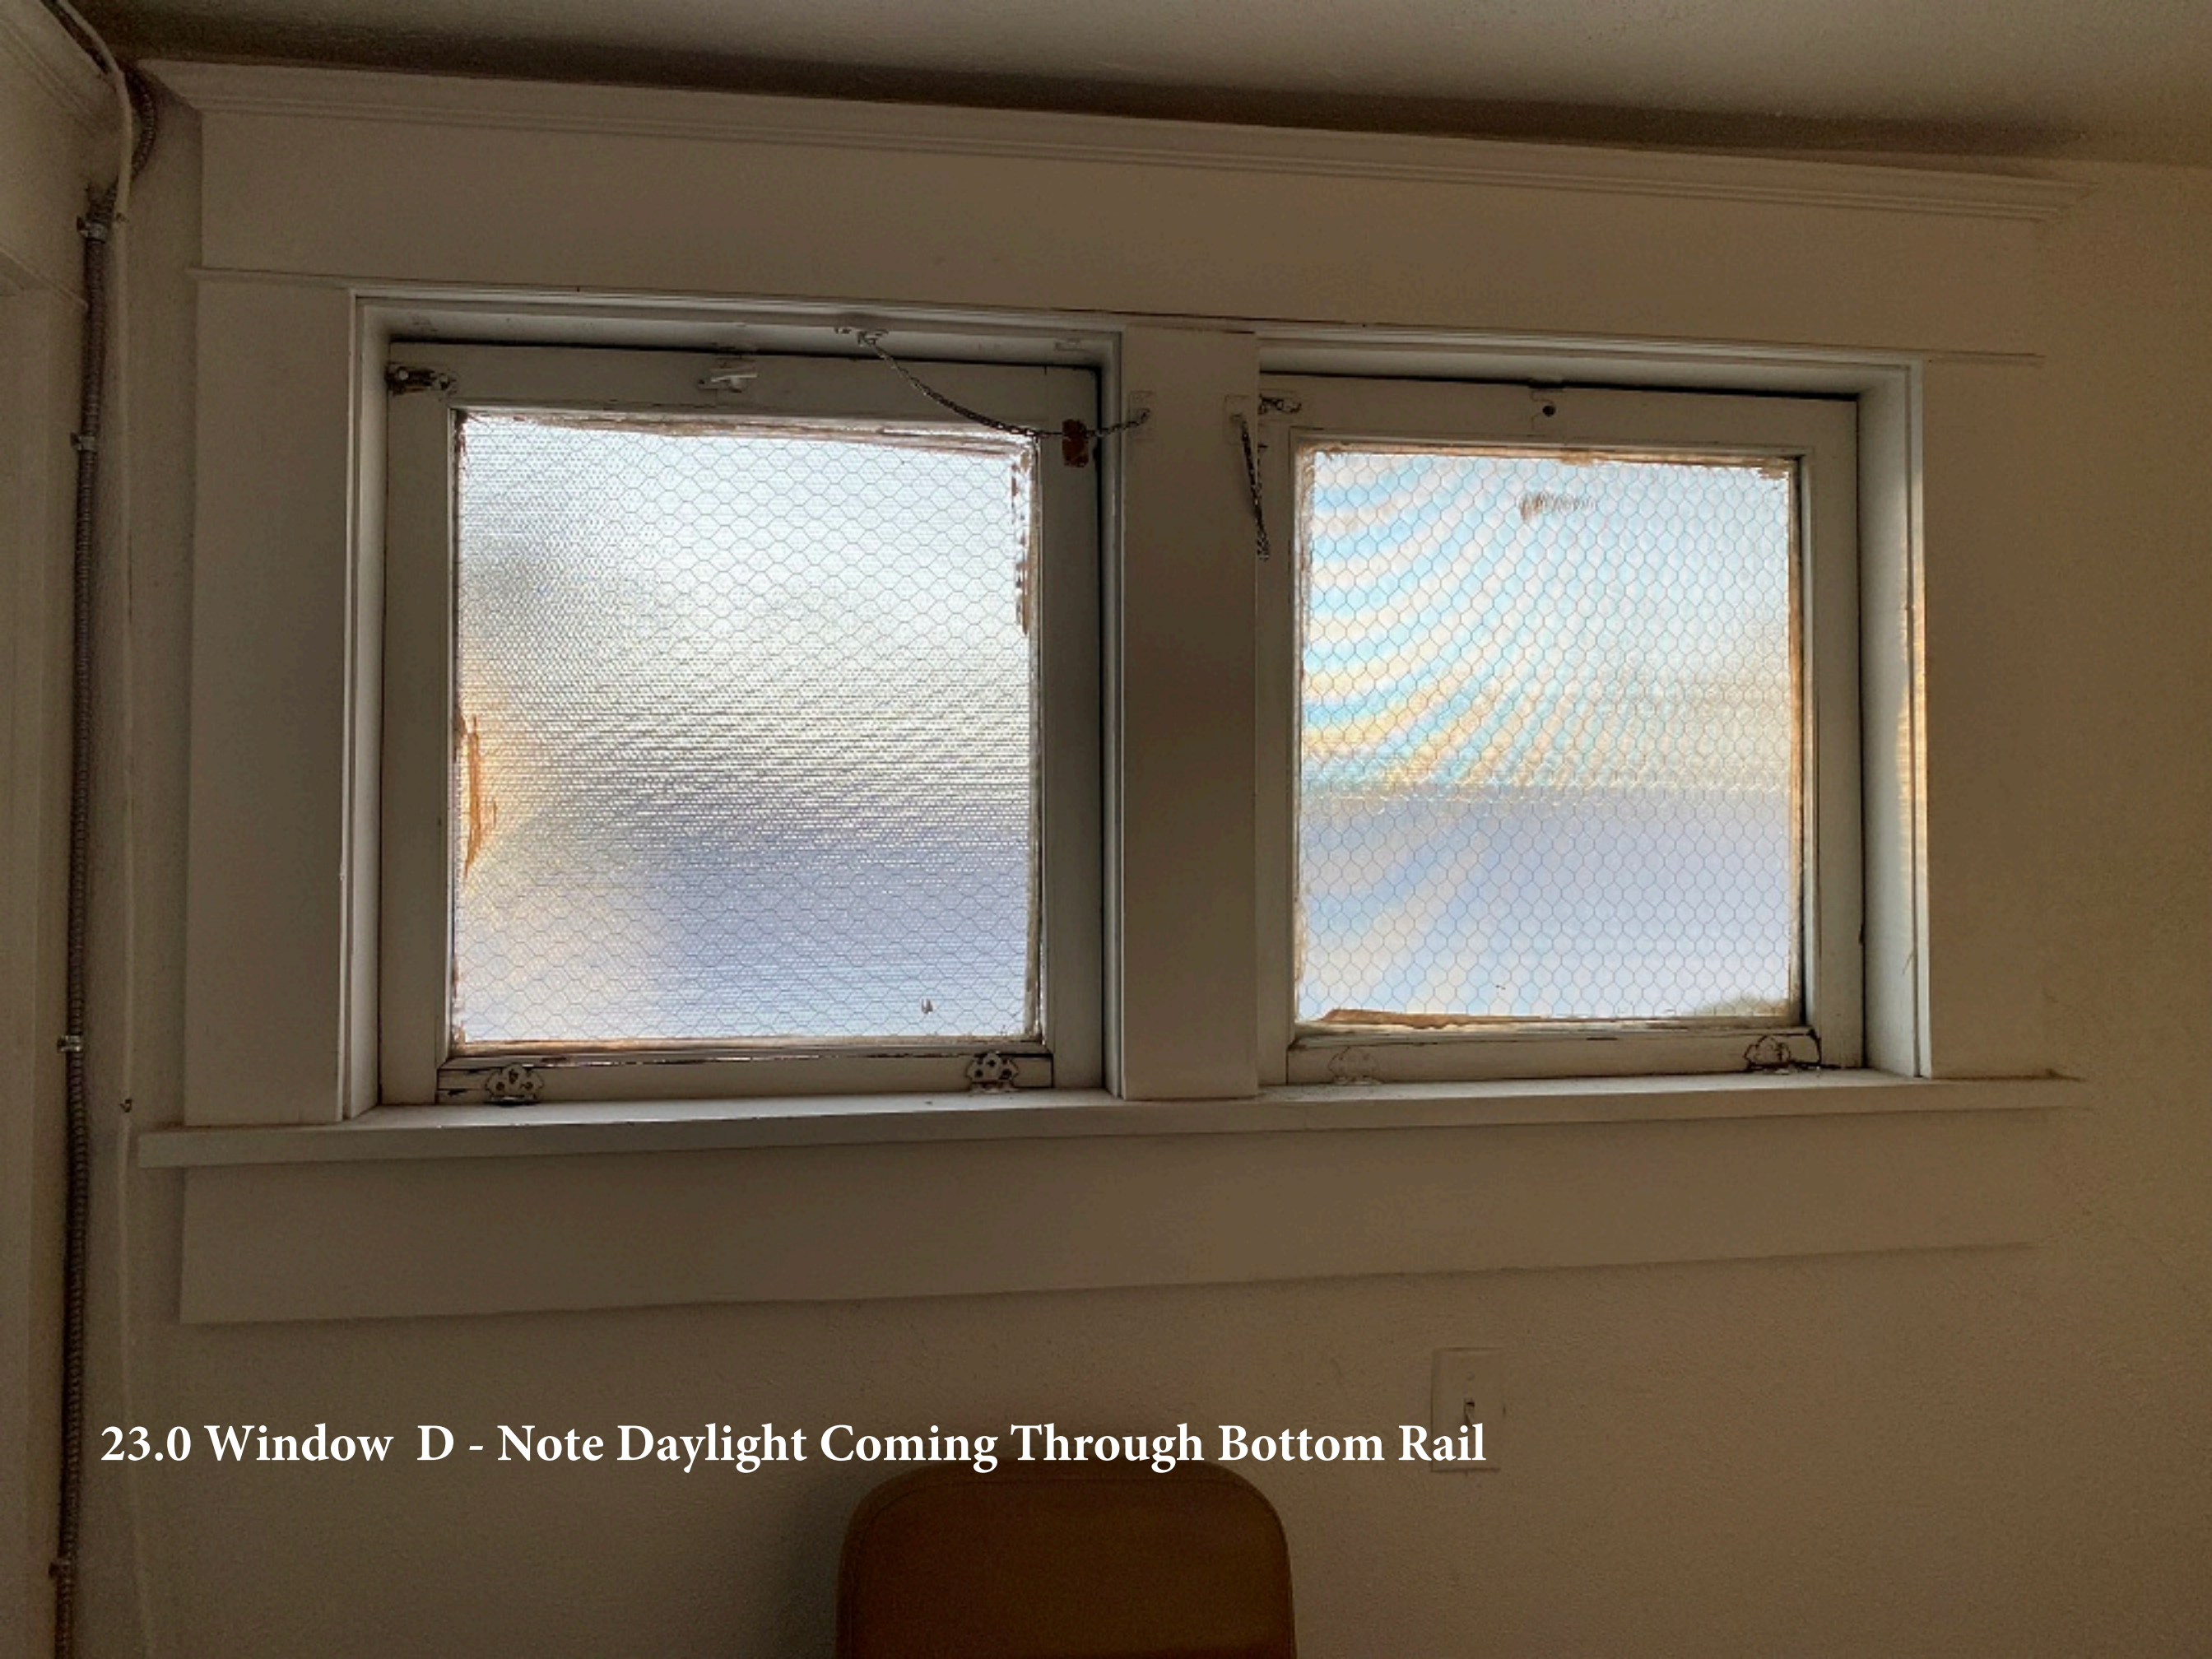
There are a pair of windows in the second-floor restroom, Windows E and a pair windows in the second-floor east hallway, Windows D. The windows are adjacent to the roof of 307 Third Street and have been damaged numerous times due to break-ins. The bottom rails are rotted, with daylight showing through and the stiles have significant damage at the bottom. The hardware is no longer secure due to the break-ins.

23.0 Window D - Note Daylight Coming Through Bottom Rail

Windows D & E will be restored, completing Class I, Class II and Class III Repairs. There will be some dutchmen repairs required at the bottom rail due to rot and new roof flashing will be installed to flash into the adjacent roofing on the exterior. The window hardware will be replaced with replica hardware where it has been damaged and restored where possible. The windows will be painted the historic color on the exterior and painted white on the interior as they were historically.
