## HISTORIC PRESERVATION BOARD APPLICATION

PROJECT NAME: Window and Door Restoration for the Douglas Masonic LodgePROPERTY ADDRESS / GENERAL LOCATION: 300 Wilcox StreetLEGAL DESCRIPTION: Range 8, Township 67, Block 19, Lot 7 in Castle Rock, ColoradoPROJECT DESCRIPTION: Please see enclosed Project Description, floor plan & photos to better understand the scope of work.  
The project will include exterior door restoration and window restoration. See Attachment A and Budget Worksheet.

DOUGLAS MASONIC  
LODGE  
NO. 153 A.F. & A.M.

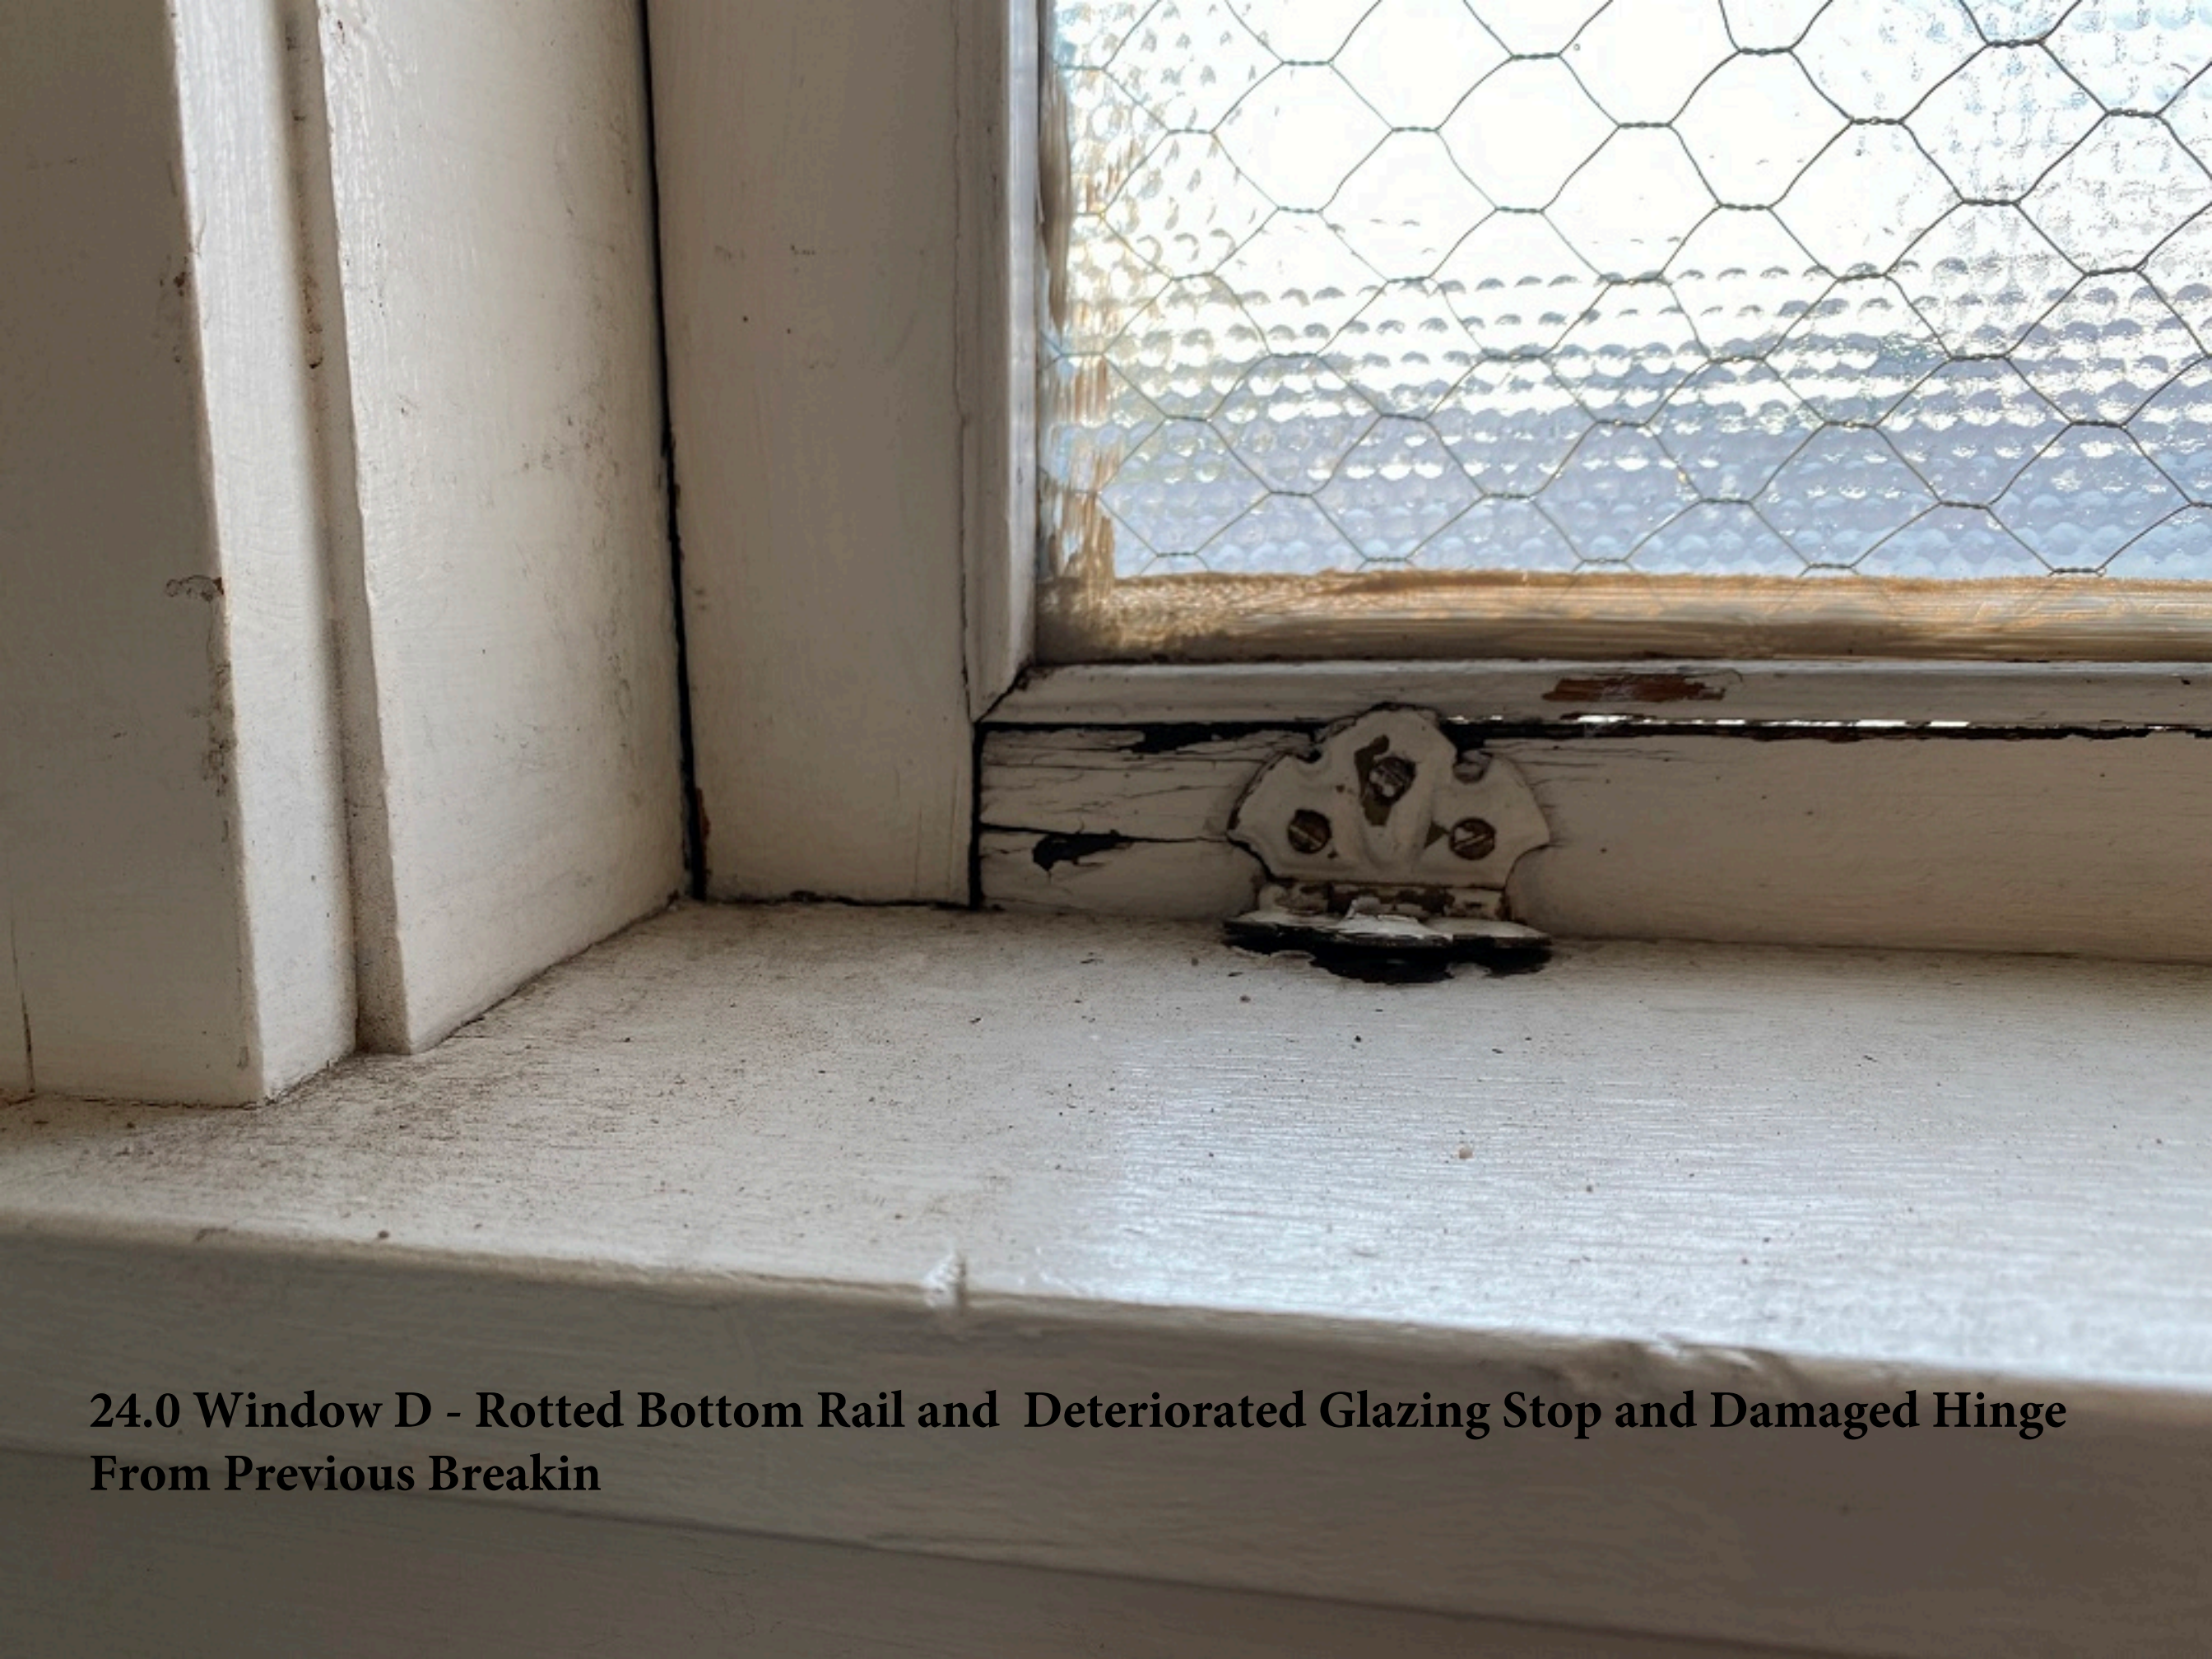
**24.0 Window D - Rotted Bottom Rail and Deteriorated Glazing Stop and Damaged Hinge From Previous Breakin**

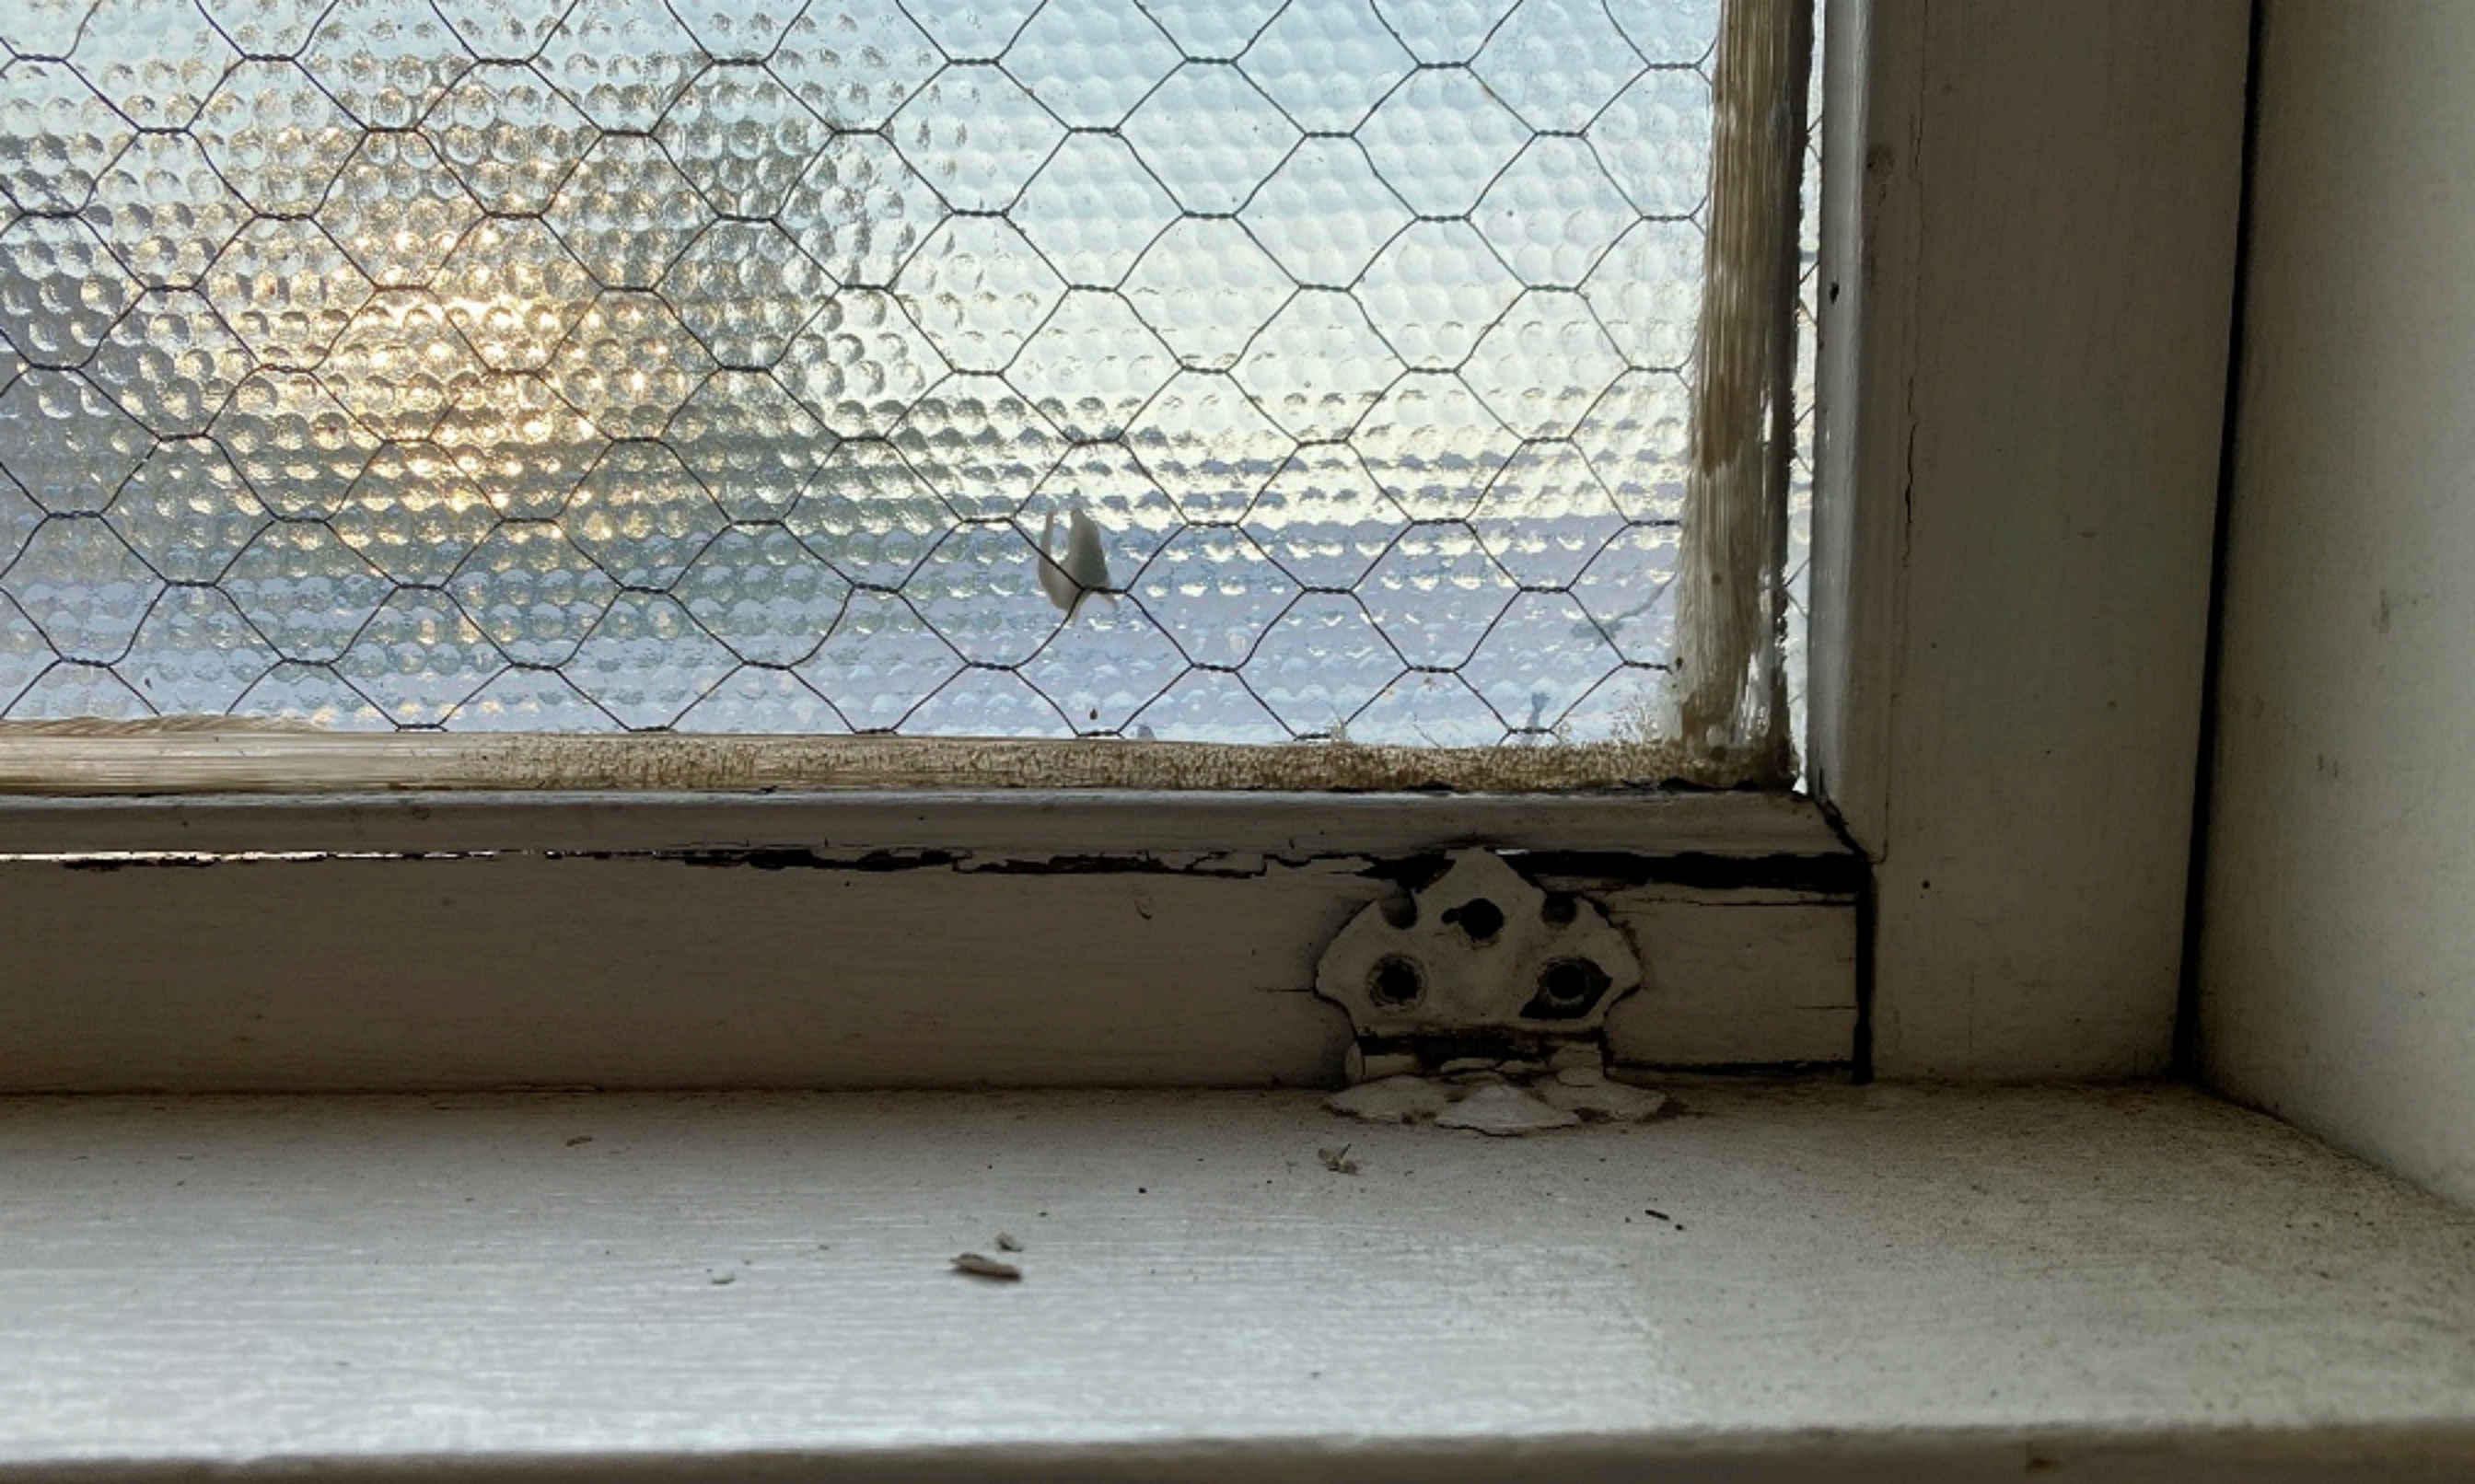
**26.0 Deteriorated Bottom Rail at Window E and Damaged Wood Glazing Stop at Window E**
