**Town of Castle Rock, CO
Castle Rock Recreation Center
2301 Woodlands Boulevard
Castle Rock, CO 80104**

Roof and Exterior Building Envelope Inspection

Re: Roof and Exterior Building Envelope Investigation

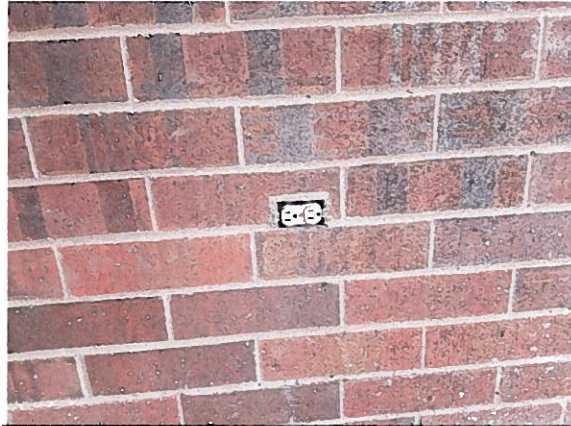
Photo #2:	Missing electric cover .
-----------	--------------------------

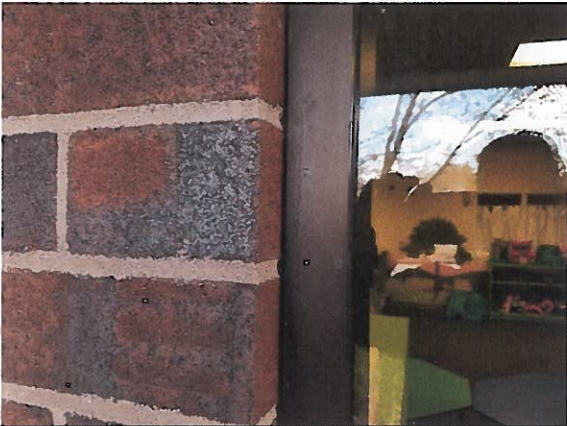
Photo #3:	No caulking around window.
-----------	----------------------------

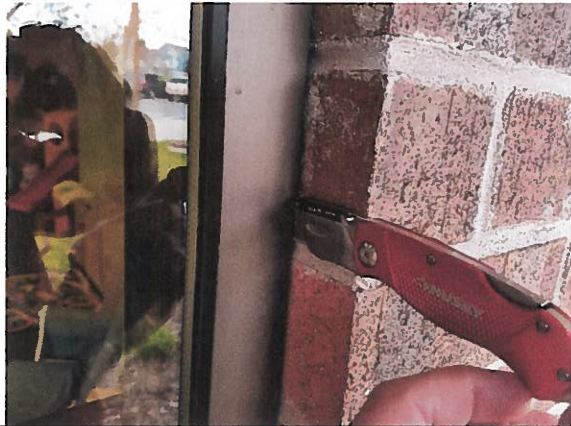
Photo #4:	No caulking.
-----------	--------------

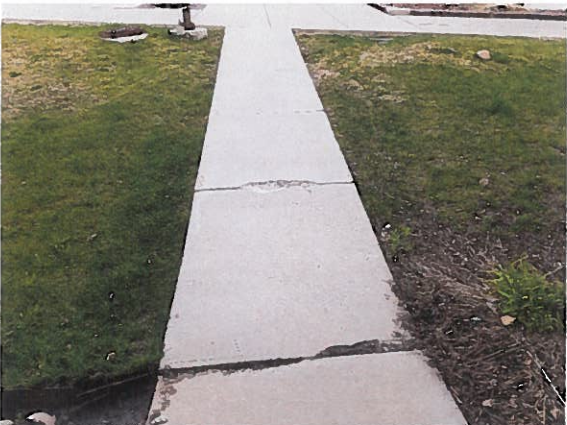
Photo #5:	Damage walk way is a trip hazard.
-----------	-----------------------------------

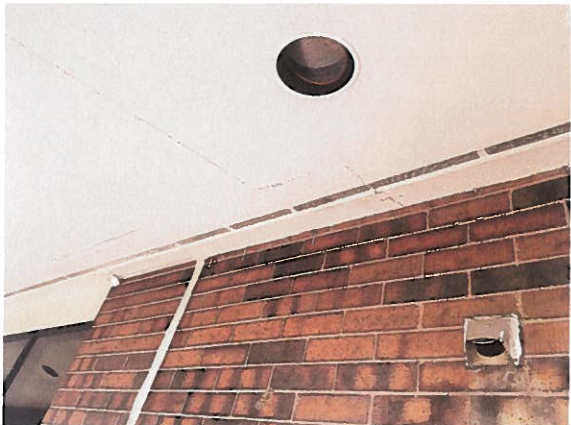
Photo #6:	Water damage.
-----------	---------------

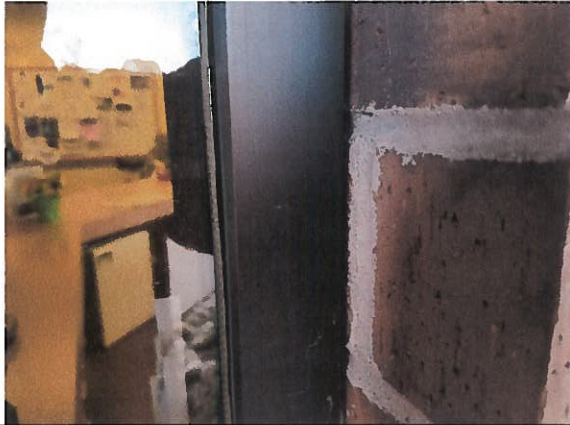
Photo #7: No caulking.

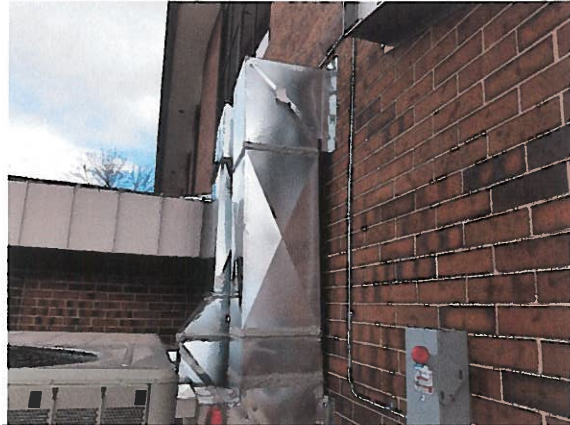
Photo #8: HVAC system on ground on side of building.

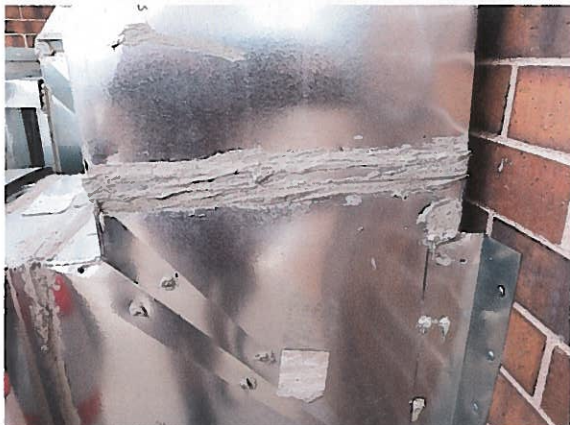
Photo #9: Joints in metal duct work could be sealed with peel & stick tape.

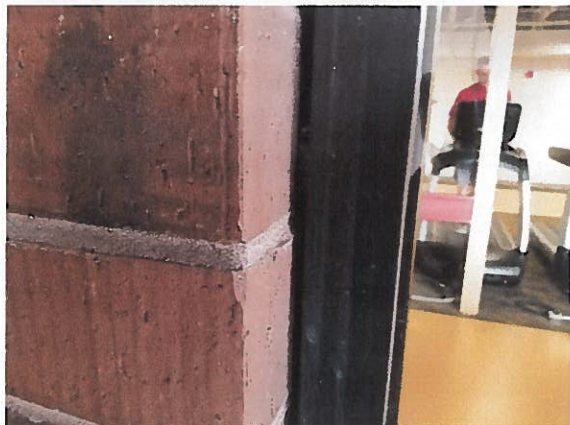
Photo #10: No caulking in windows in front of exercise room.

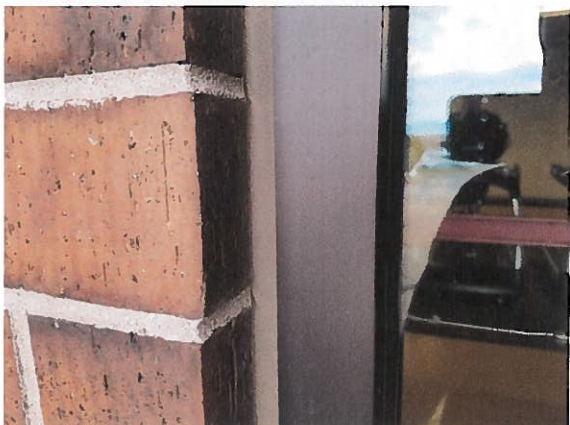
Photo #11: Properly sealed window to wall joint.

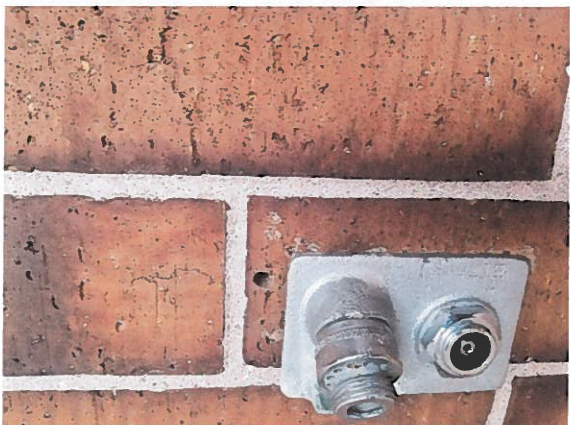
Photo #12: Drilled hole in brick should be sealed.

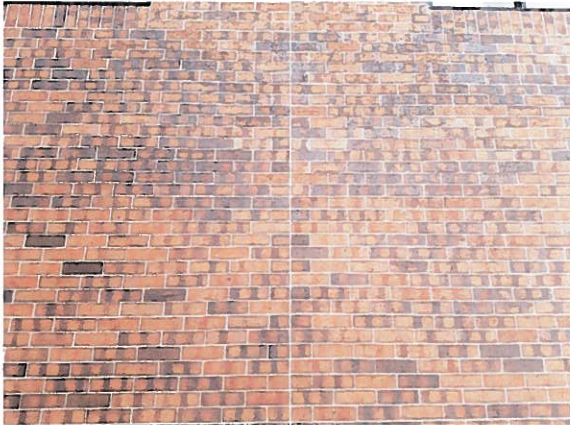
Photo #13:	Properly sealed joint.
---------------	------------------------

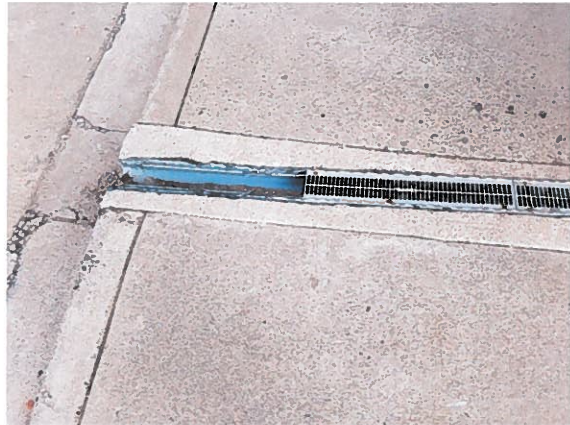
Photo #14:	Broken drainage grate at rear downspout. Trip hazard should be repaired immediately.
---------------	---

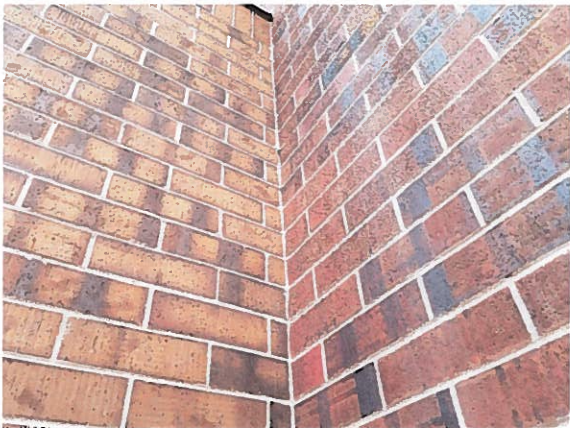
Photo #15:	Failed caulk joint.
---------------	---------------------

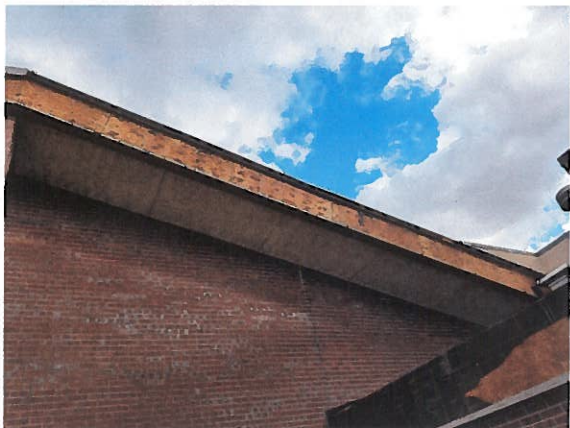
Photo #16:	Water damage in exposed tectum soffit.
---------------	--

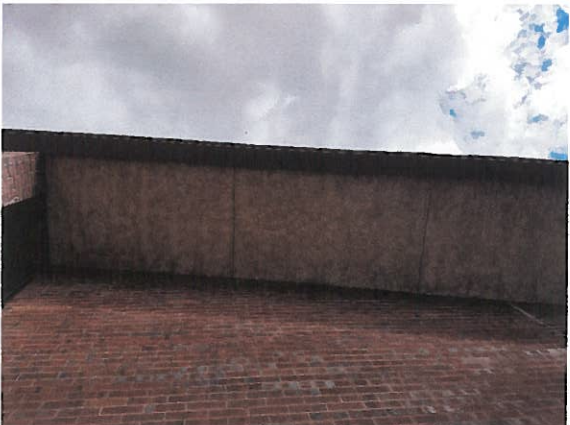
Photo #17:	Water damage.
---------------	---------------

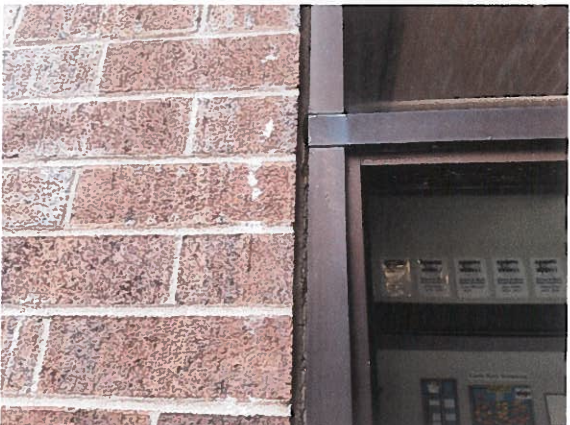
Photo #18:	Failed caulking.
---------------	------------------

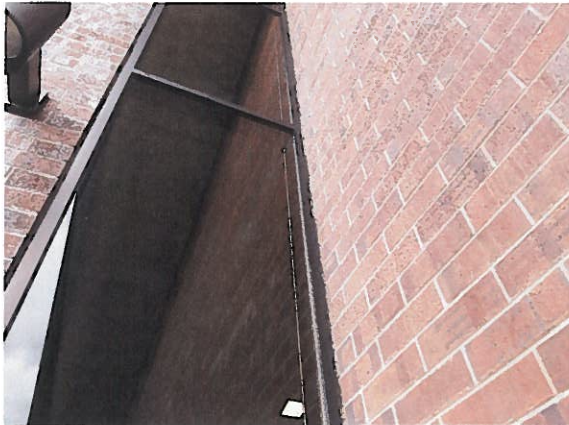
Photo #19: Failed caulking.

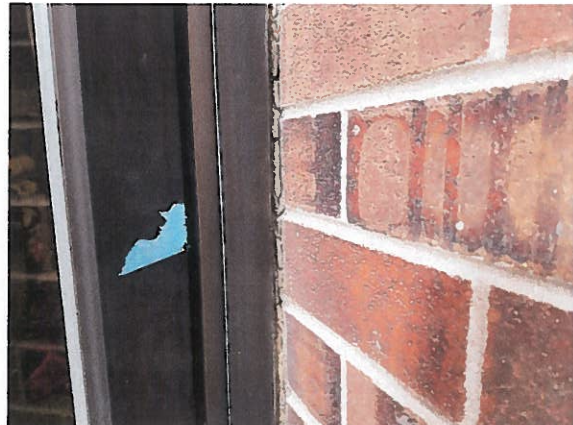
Photo #20: Failed caulking.

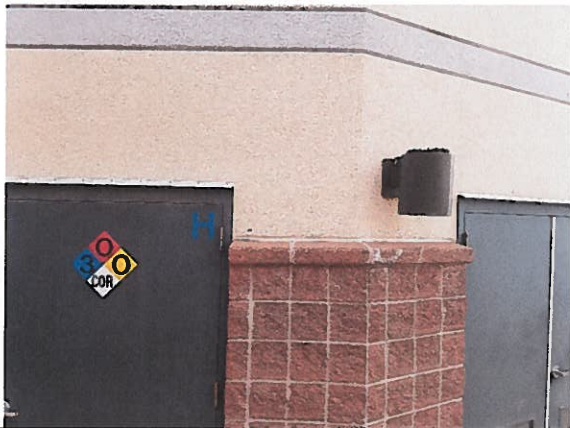
Photo #21: Efflorescence from water entry.

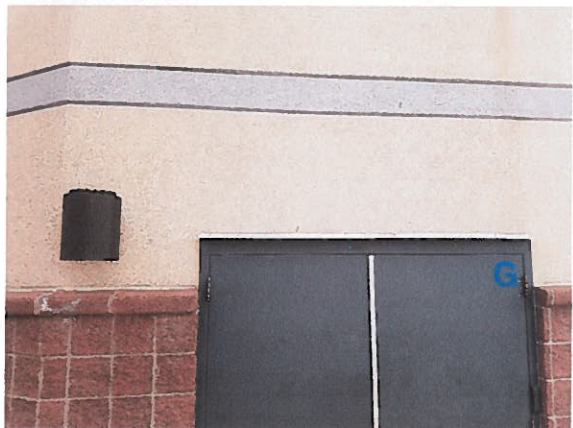
Photo #22: Efflorescence.

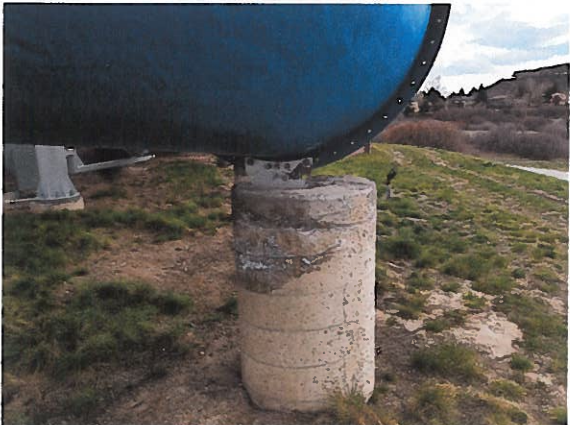
Photo #23: Posts should be waterproofed to avoid further damage.

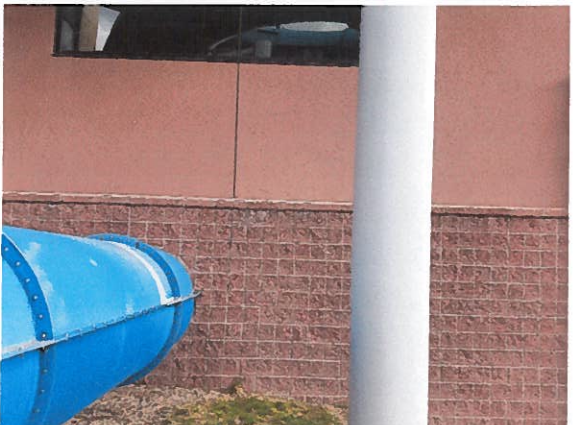
Photo #24: Water damage below caulk joint. Seal at slide entry to wall should be waterproofed.

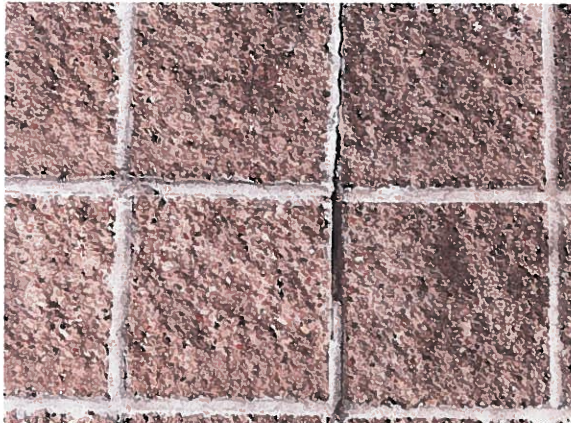
Photo #25: Damage to wall joints should be repaired.

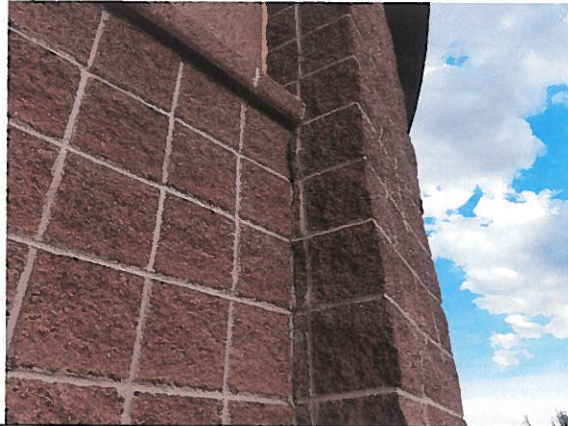
Photo #26: Damage at wall to wall joint.

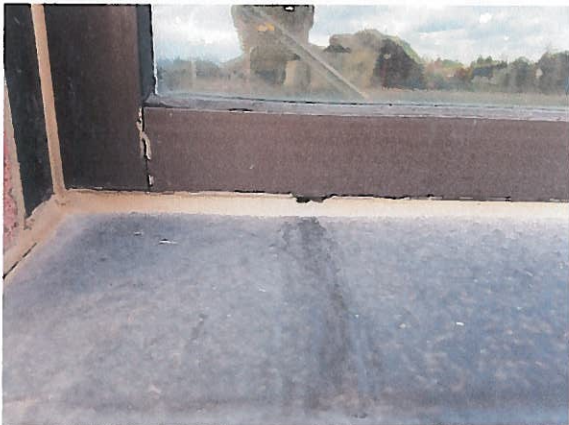
Photo #27: Newer sealant at window with properly exposed weep holes.

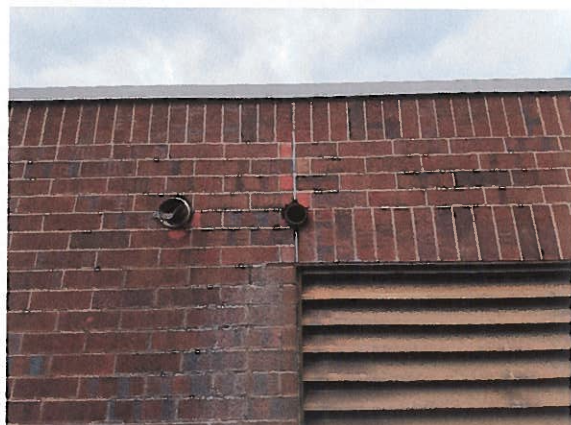
Photo #28: Water drain pipes from roof above are too short and water is damaging wall.

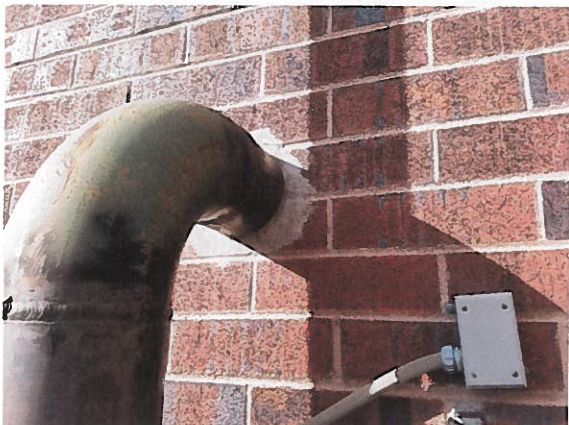
Photo #29: Some pipes through wall are properly sealed while others are not.

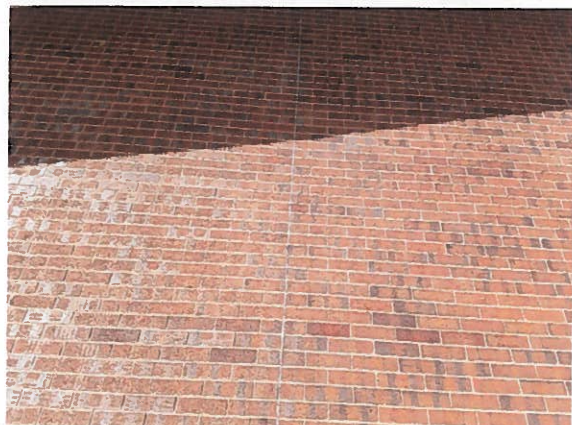
Photo #30: Joint starting to fail.

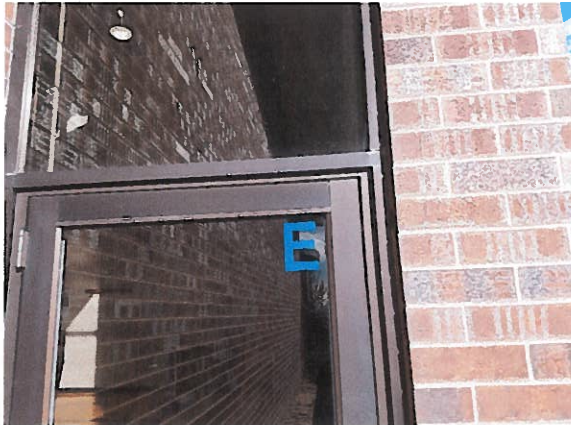
Photo #31: Failed sealant.

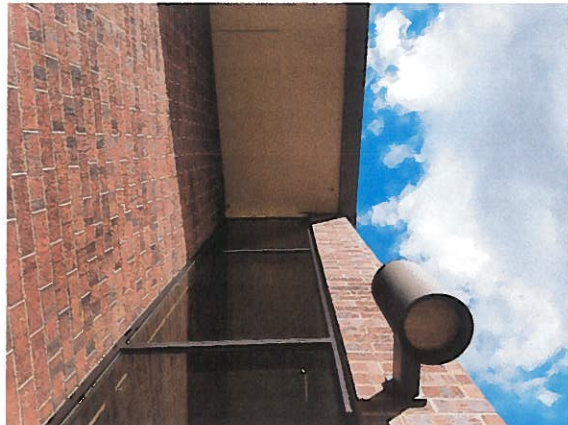
Photo #32: Failed sealant.

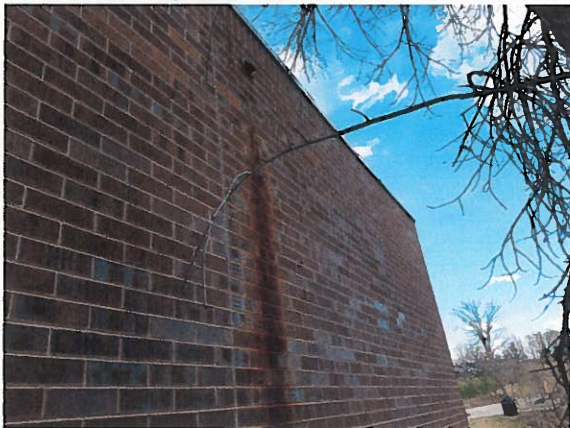
Photo #33: Another pipe too short, causing damage to wall.

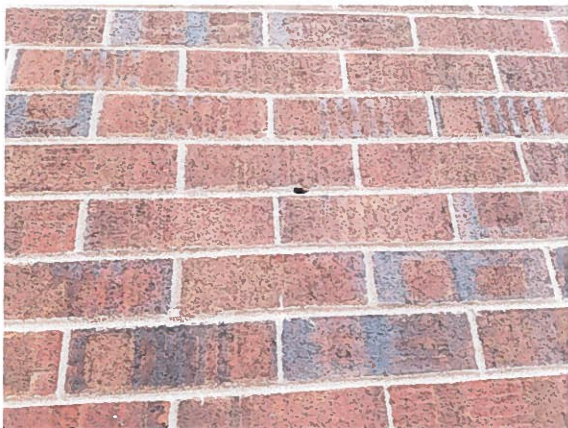
Photo #34: Hole in mortar should be repaired.

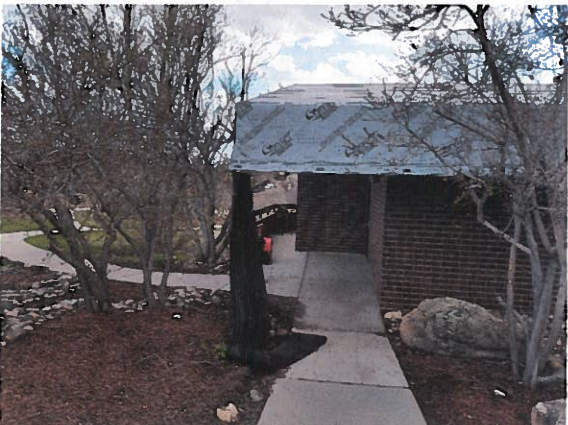
Photo #36: I asked roofing contractor on site to remove this.

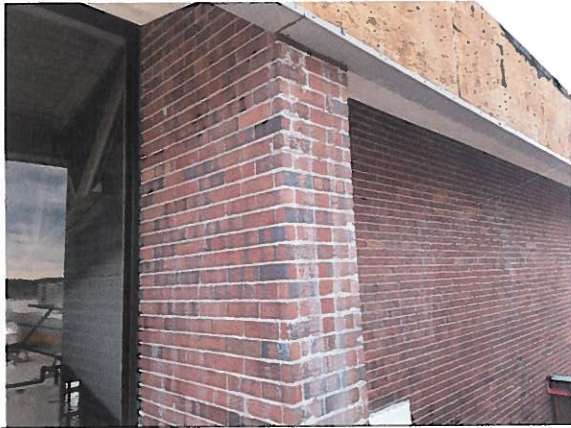
Photo #37: On roof at top of ladder, damage to wall from water entry from roof above.

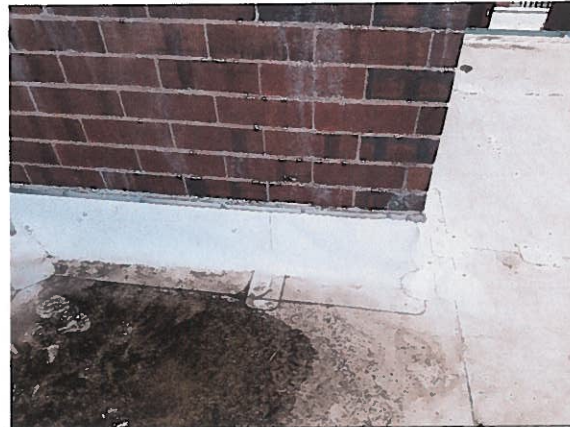
Photo #38: In discussion with roofing contractor, they acknowledge that they used the basic details as required to meet warranty. No counter flashing.

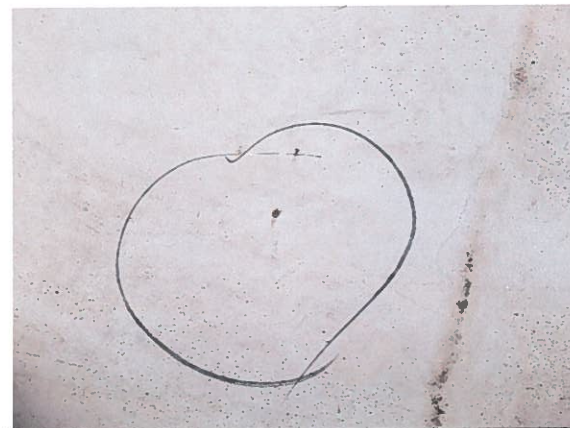
Photo #40: Hole in roof.

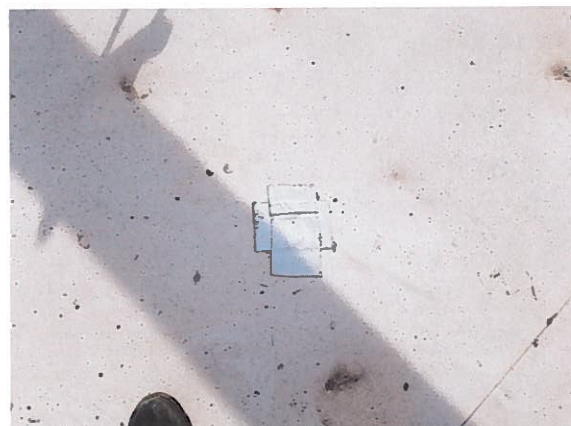
Photo #41: Previous repairs not appropriately completed.

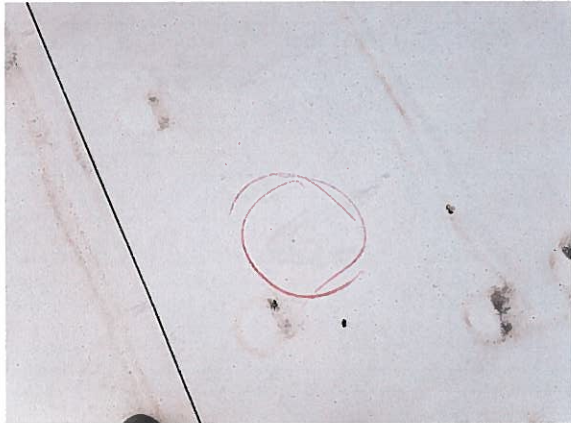
Photo #43: Higher circular roof. Hole in membrane.

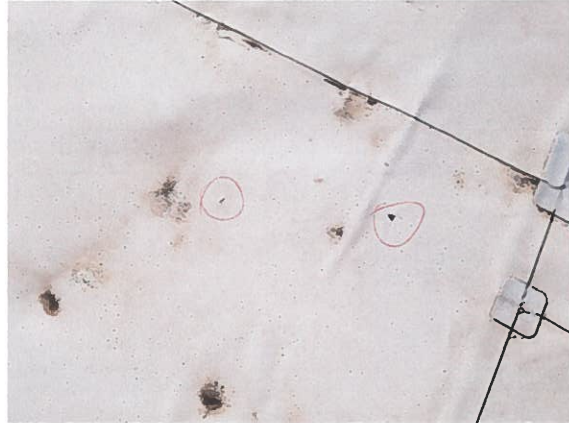
Photo #44: Holes in roof membrane. There are several on this roof level.

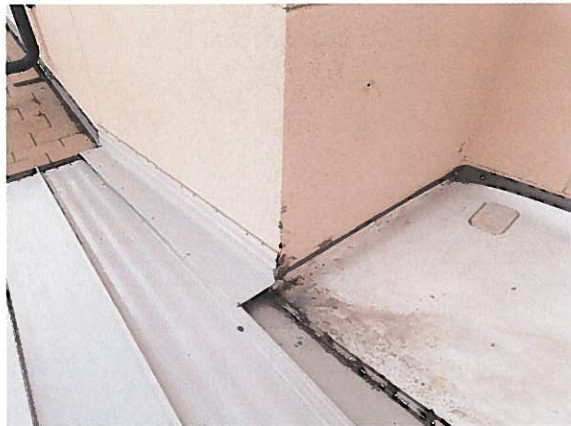
Photo #45: Damage to EIFS wall at lower roof tie in.

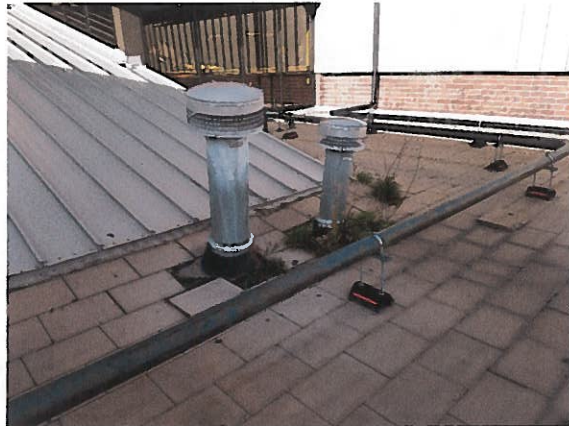
Photo #46: Grass and weeds growing throughout this roof area.

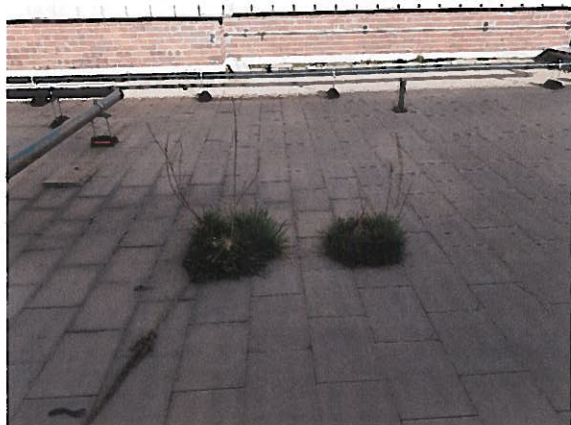
Photo #47: Drains blocked by growth.

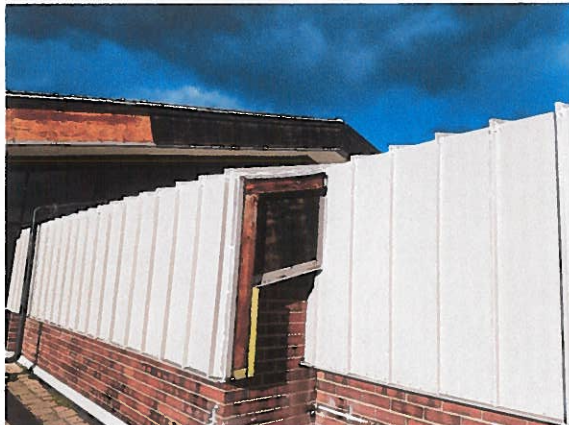
Photo #48: Panel missing at corner. Roofing contractor states that this is not in current scope of work.

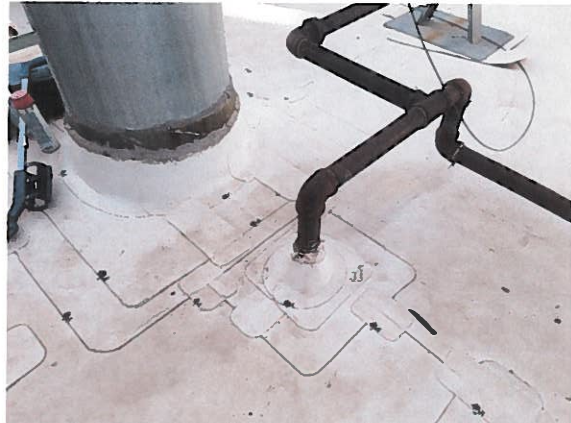
Photo #50: Poor detailing and flashing on new roof.

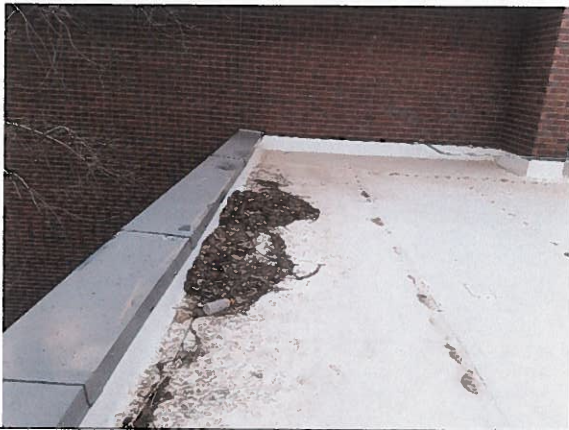
Photo #51: Debris should be cleaned up.

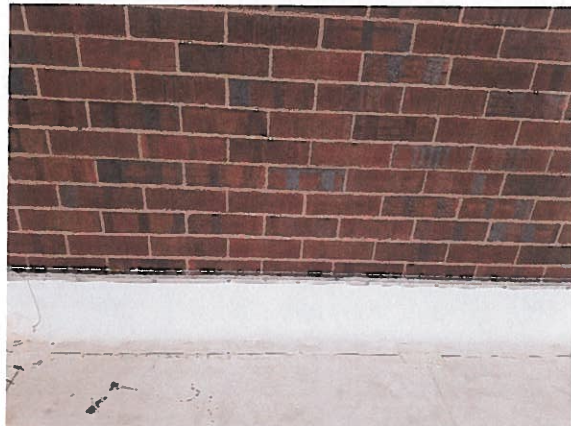
Photo #52: Term bar only, no counter flashing.

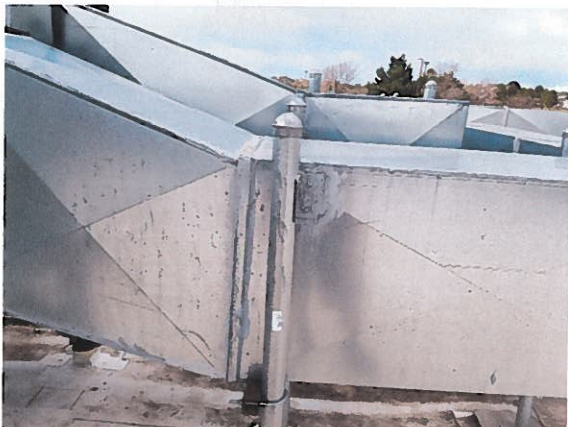
Photo #53: Metal duct work. Seams should be sealed.

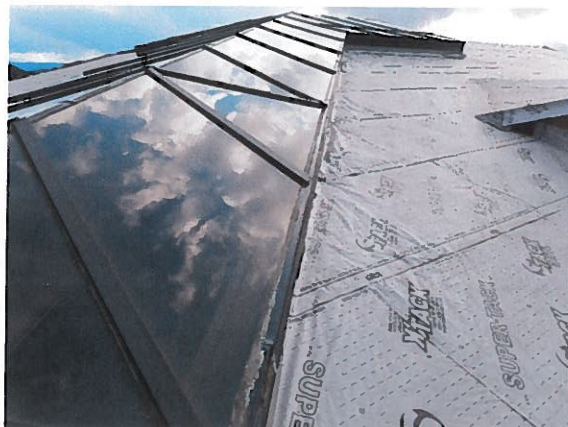
Photo #54: Large sky light above main entrance.

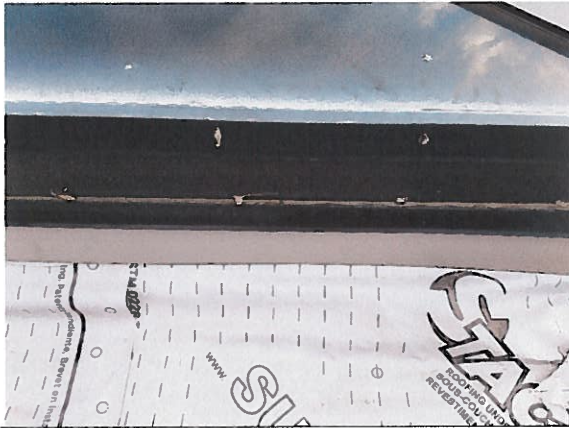
Photo #55:	Weep holes blocked n skylight.
---------------	--------------------------------

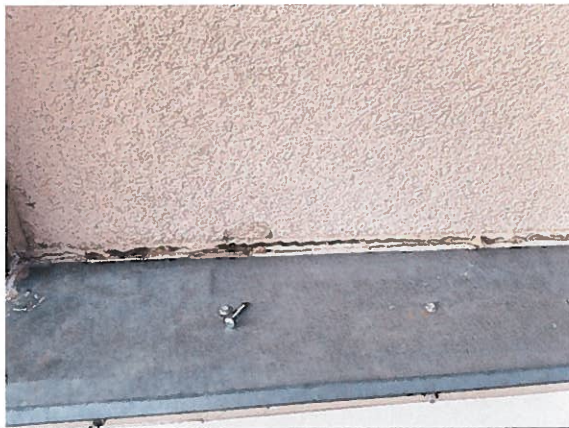
Photo #57:	Joint the length of counter flashing is failed.
---------------	---

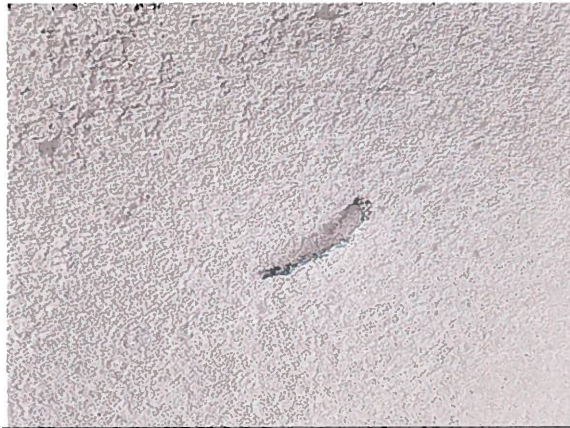
Photo #58:	Holes in stucco.
---------------	------------------

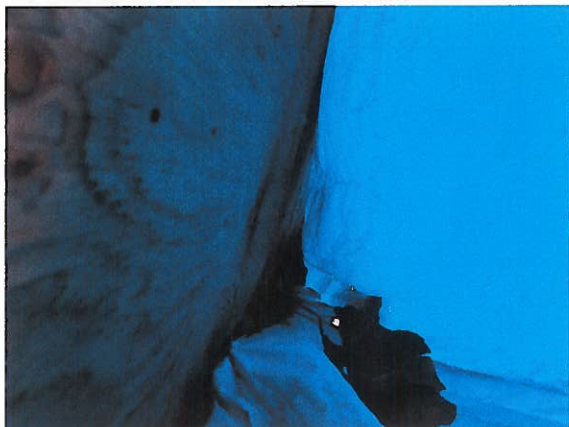
Photo #59:	Tarp holding water.
---------------	---------------------
