Attachment C

East Plum Creek Stream and South Well Field Improvements

Site Photos

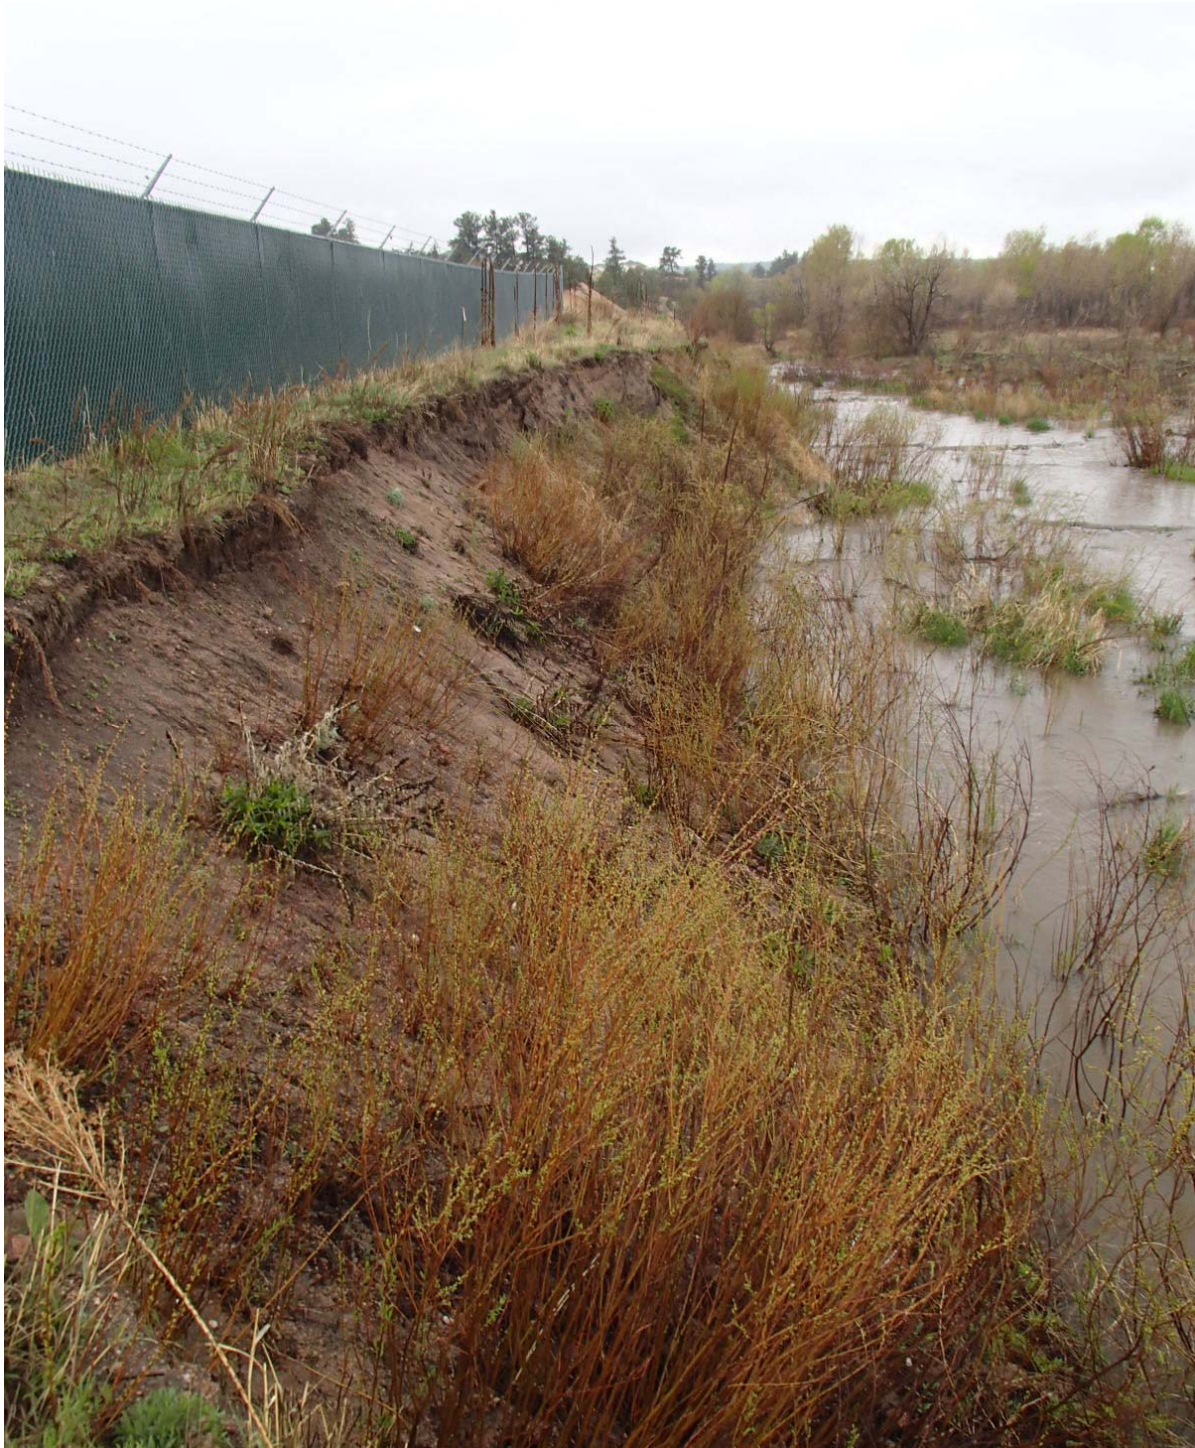
Looking south – bank erosion along well field fence.

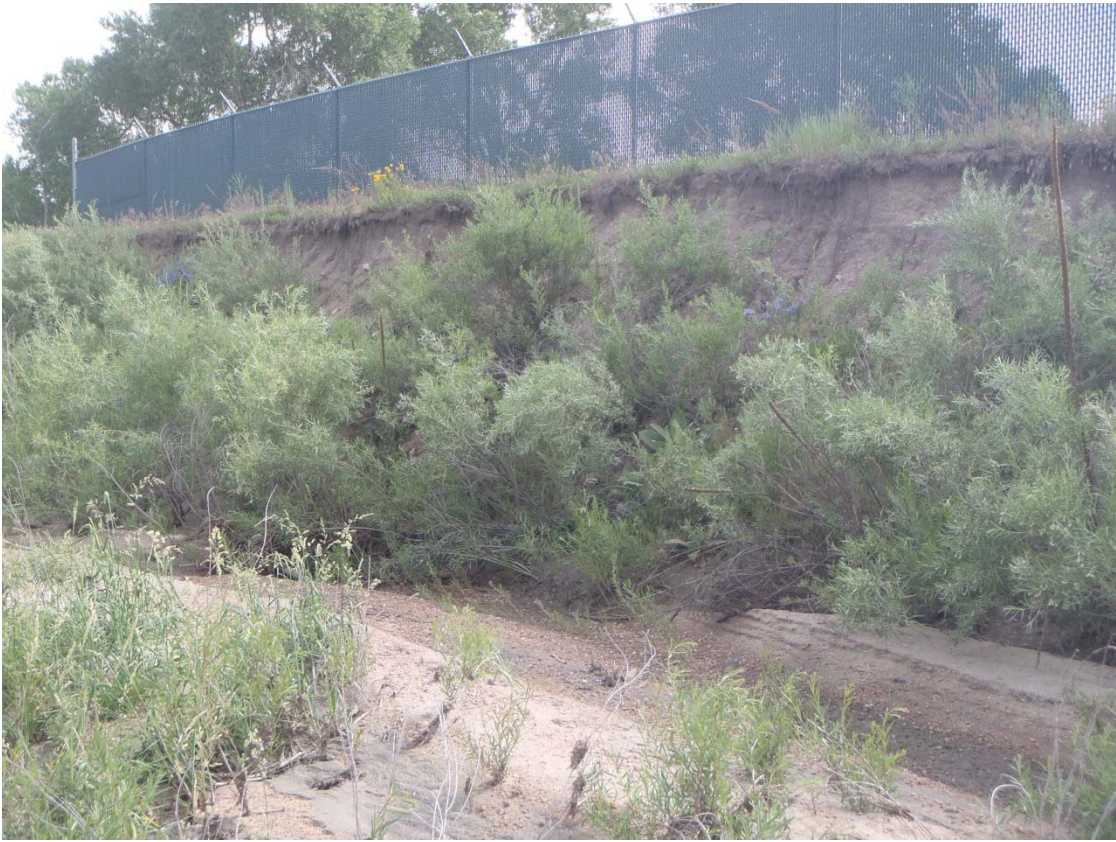
Looking northeast – bank erosion along well field fence.

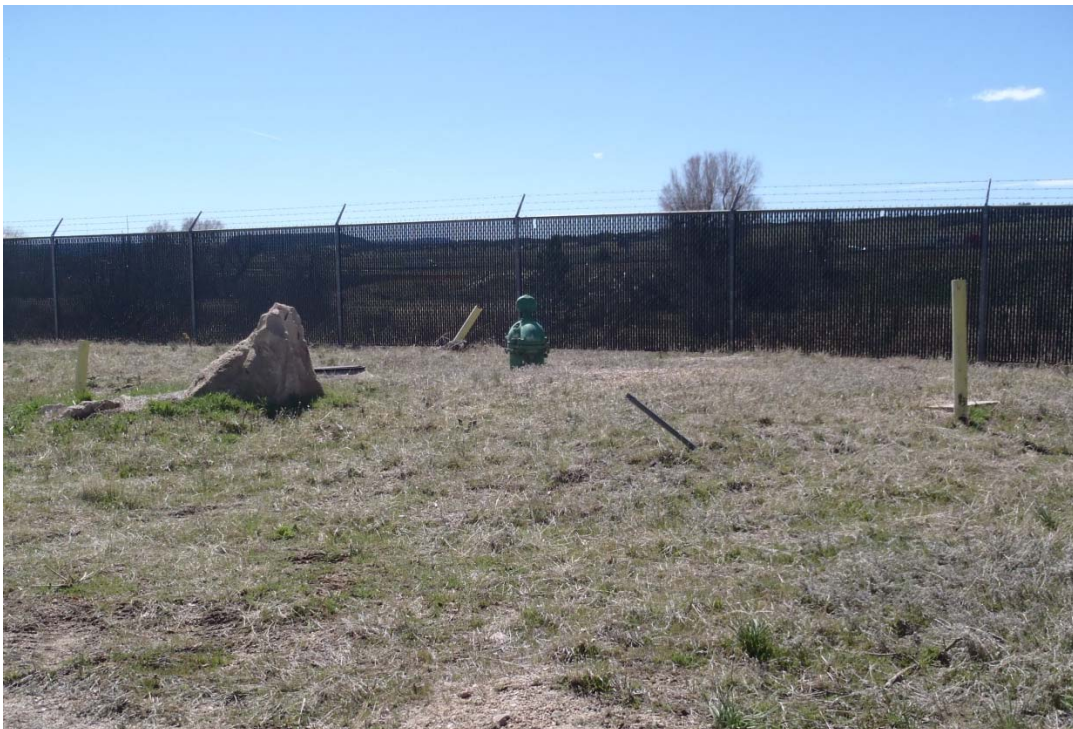
Looking west – Well 13AL just inside fence near eroded bank.

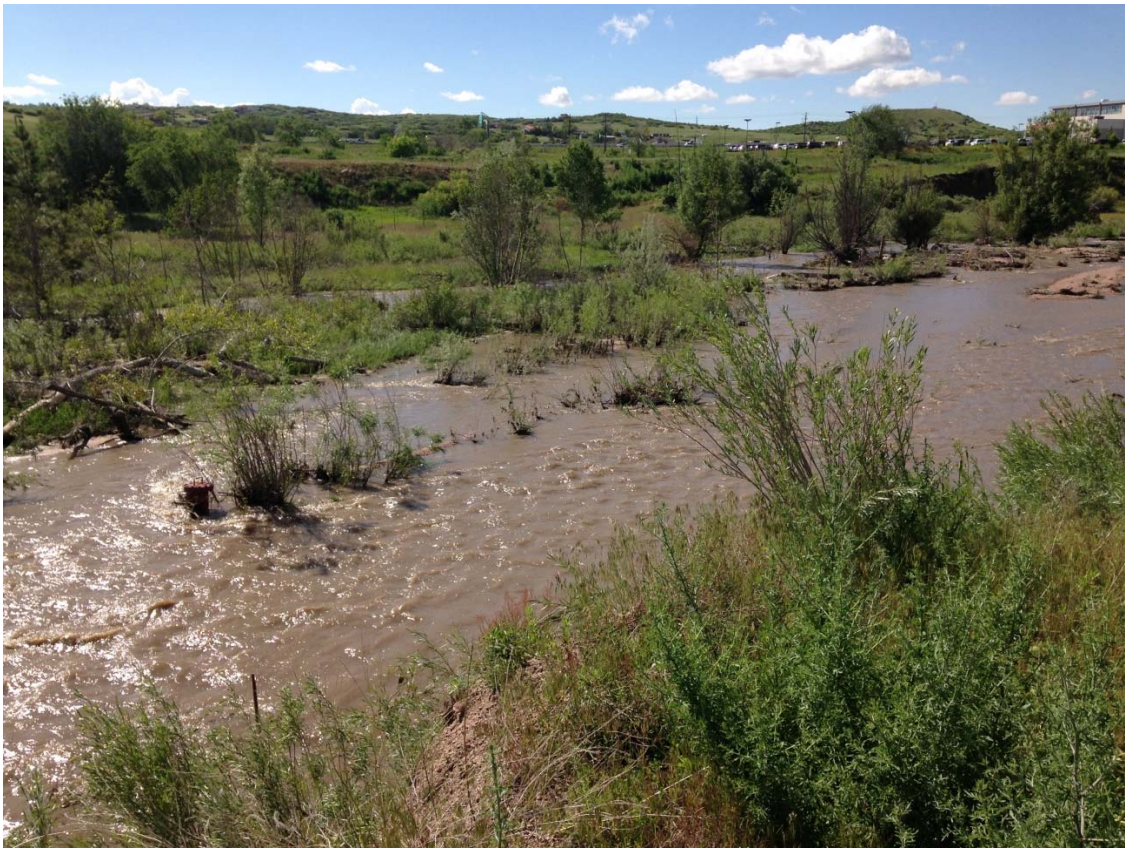
Looking northwest – Well 12R cleanout in creek.

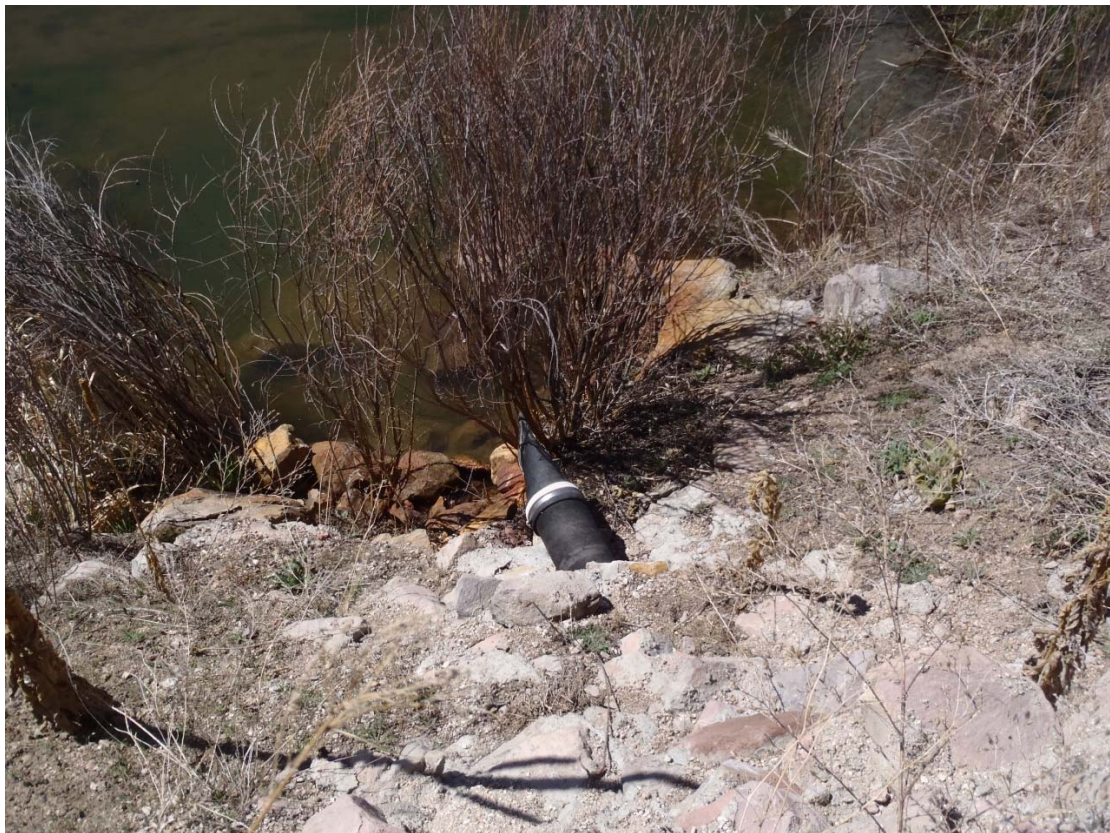
Looking west – Well 204 drain line at east bank.
