BODIS GROUP INC.
ROOF CONSULTING FIRM

REF: Destructive Analysis Results
Roof Assembly Replacement Specifications
Castle Rock Community Recreation Center
2301 Woodlands Blvd.
Castle Rock, Colorado

Roof Assembly Core Analysis Results

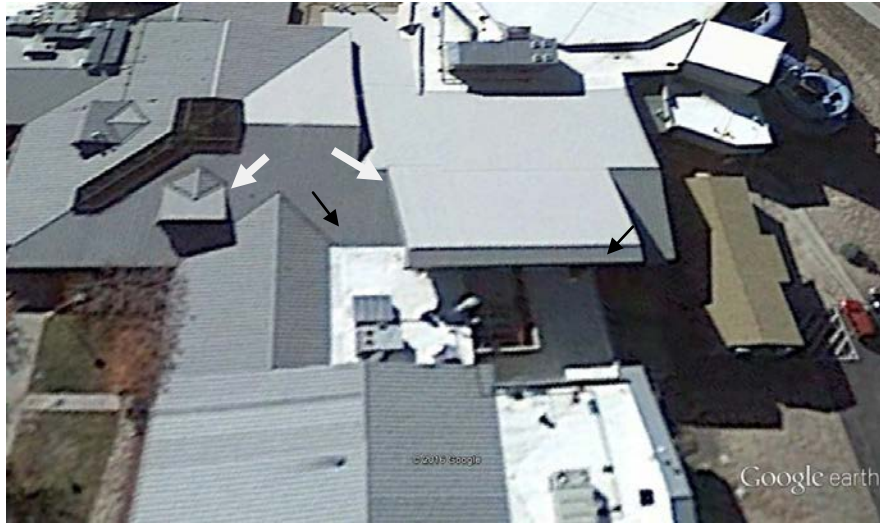
We observed the two cores cut through the roof assembly to the steel deck conducted by Colorado Commercial Roofing which indicated that the OSB, Oriented Strand Board/closed cell Polyisocyanate, foam core roof assembly was wet in an area over the east section of the swimming pool and next to the west upper section of the front entryway skylight. (white arrows roof photo) In other areas throughout the roof assembly areas over the swimming pool wet and deteriorated wood deck was observed.

We cut two cores through the roof assembly in the lower northeast and upper north areas over the swimming pool. (black arrows roof photo) The roof assembly we cut through consisted of 3.5" of fiber reinforced faced closed cell Polyisocyanate foam insulation board topped with a laminated 7/16" OSB, Oriented Strand Board. The roof assembly was installed over a black plastic vapor retarder installed over the steel deck.

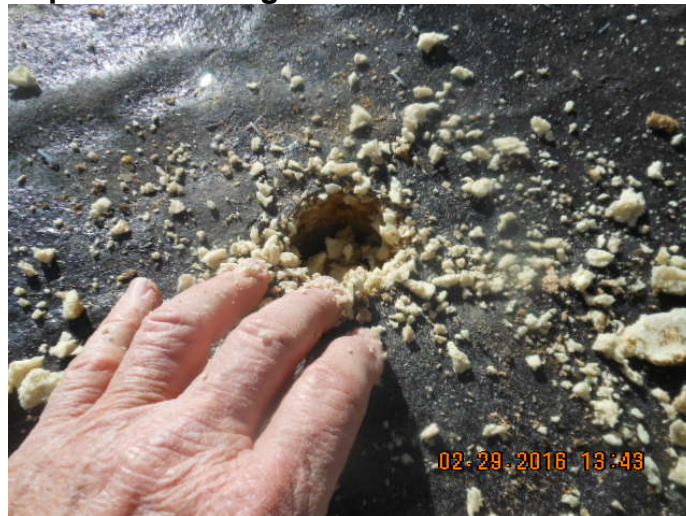
When we were installing the insulation pieces in the northeast core hole area, we noted air running through the steel deck flutes pushing the insulation pieces out of the hole. The core taken in the upper north roof area was taken out in one piece. We could feel the air flowing up through the core hole from the steel flutes. This probably indicates that air is coming from the wall areas inside the swimming pool and flowing into the steel deck flutes. This could be causing the moist pool area air to damage the roof assembly in areas that are not directly above the pool.

Insulation pieces blowing out of the northeast core hole area

It is our opinion that, if you do not stop the air flow in the metal deck flutes, moisture vapor will continue to build within the roof assembly and along the walls. This vapor build-up could cause future roof assembly damage and possible roof leaks. We recommend that you get a mechanical and/or a curtain wall consultant to inspect the situation and make positive recommendations.

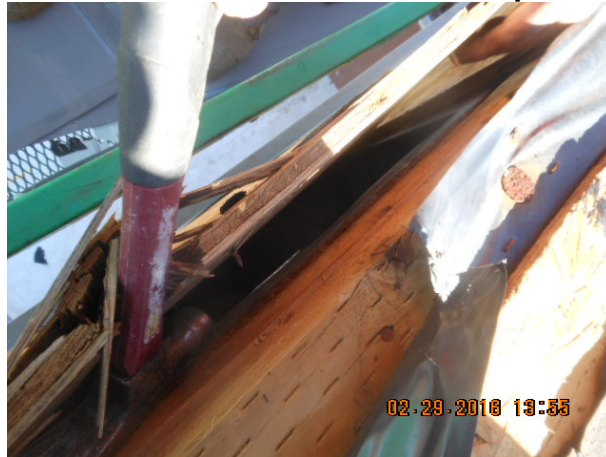
After the roofing contractor removed the standing seam metal panels off the gable and facing vertical walls we observed wet underlayment asphalt membrane and water stained and weathered wood panels. The roofing contractor removed part of the top north facing vertical wood panel. Under the panel we observed 2" x 6" wood framing and the side of the steel deck that was rusted. Based on the condition of the wood paneling in the north facing vertical wood panels and the rusted steel deck side that this area has been a source of water leaks or condensation for a number of years.

2" x 6" wood studs behind wood panels

Between the 2" x 6" wood studs install either Johns Manville or Owens Corning or equal R-19 Kraft paper faced fiberglass insulation 6.25" wide x 15" wide x 39.2" long roll.

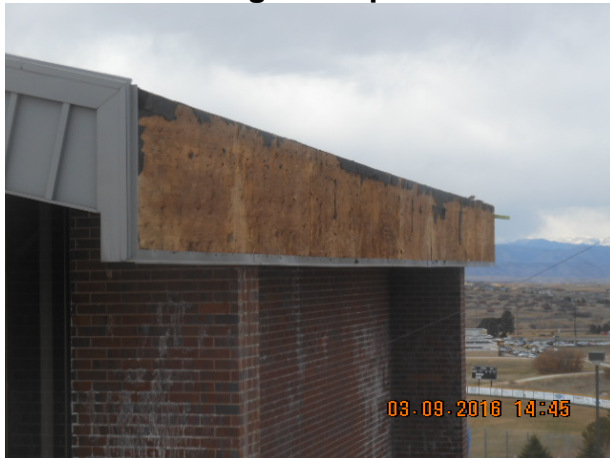
Front facing wood panels

We recommend that the gable and front facing wood panels will have to be torn off and replaced so the roofing contractor has a solid wood surface to properly secure the standing seam panels.

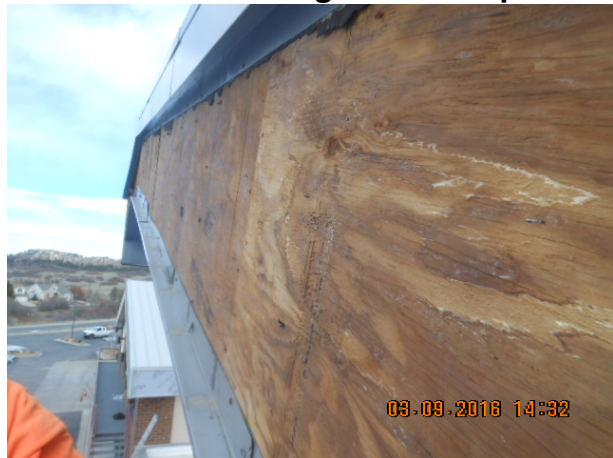
Weathered gable wood panels

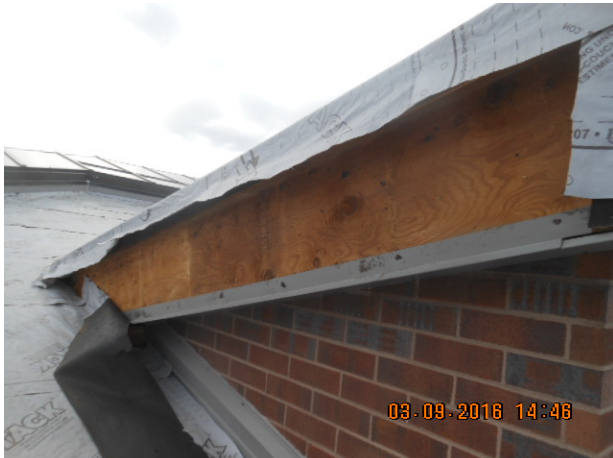
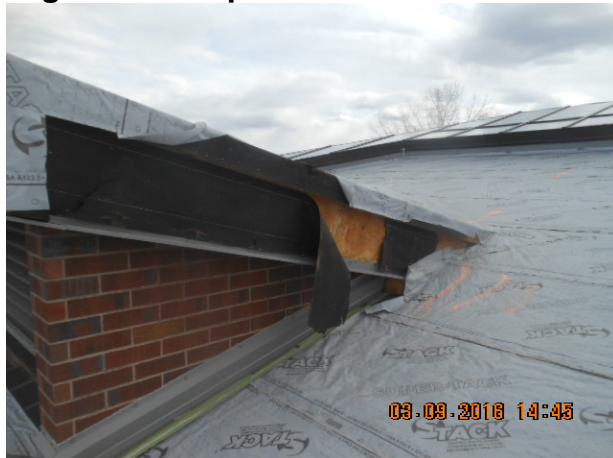
The same condition, wet and weather wood gable panels, was observed after the gable standing seam metal panels were removed.

Weather vertical dormer gable wood panels

Remove and replace the gable and front facing front panels on the sloping roofs and on the dormer gables.

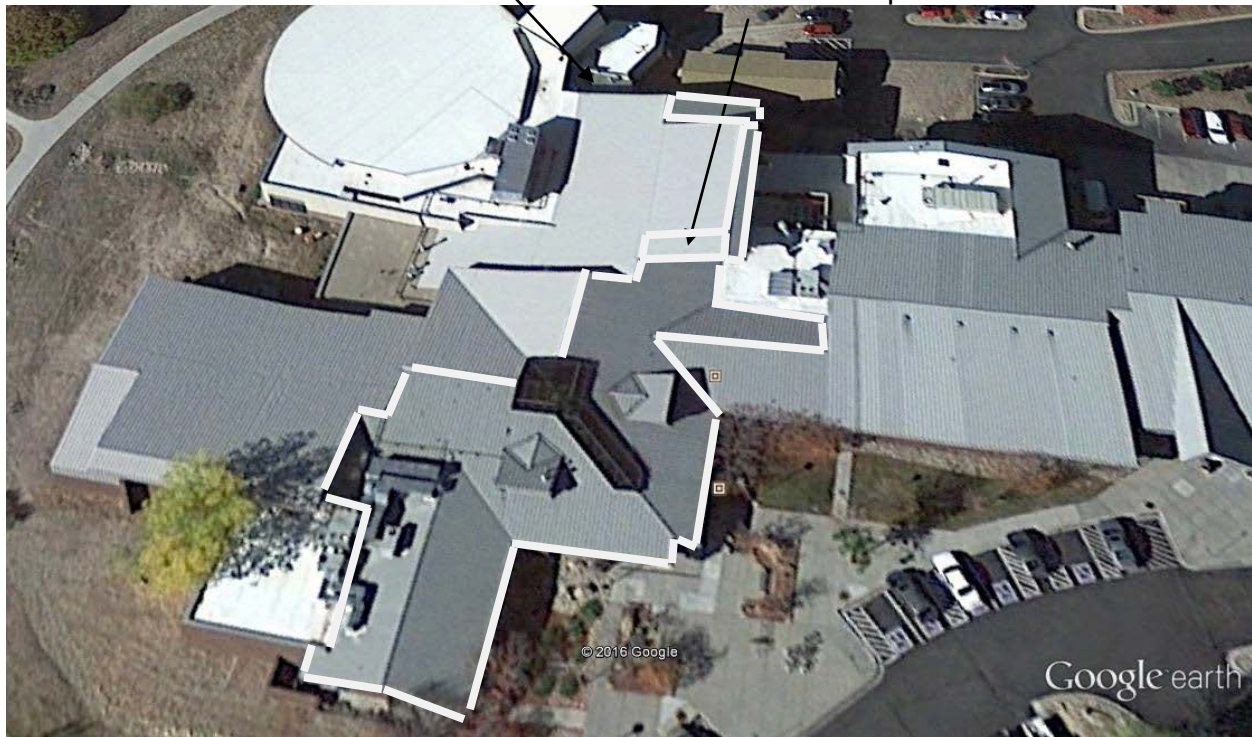
A non-destructive infra-red scan was conducted in the areas marked in the roof photo below. The Therographer indicated that because of the type of roof assembly the ThermoCam B-2 Camera and Thamex RWS Moisture Meter could only detect wet OSB wood, which is part of the roof assembly, not wet insulation. The scan report, attached, shows that a large sections of the roof area, delineated in yellowish areas on the scan photos, has water saturated OSB wood and the complete roof assembly has to be torn out and replaced. The roofing contractor cannot install his standing seam roof over wet water saturated OSB wood. The new roof assembly installation will provide the roofing contractor with a sound roof assembly to install his standing seam roof.

Some east section standing seam roofing panels, in the marked section of the existing newer south sloping standing seam metal roof over the pool, were removed for the scan and then reinstalled. The scan indicated wetness of the OSB wood at the roof assembly joints. Based on observations by the roofing contractor of water running from under the standing seam panels at the overlap and the scan results in the sampled area we have to assume there is additional wet OSB wood in the remainder of the south sloping standing seam roof. If we assume moisture follows air flow then we have to assume that the moist air from the pool is moving through the metal decking flutes then through the roof assembly joints.

White lines outline areas scanned

Small lower roof (not shown) was scanned

Panels removed on sloped roof area scanned

Based on the infrared scan results the roofing contractor knows where the wet roof deck areas are located. With that knowledge he should do the following:

All wet roof assembly areas should be cut out to the deck and removed. Any rusted metal decking will either need to be cleaned and painted or replaced if the rust has rendered an area non-structurally sound. This will need to be assessed as sections of the existing roof assembly are removed.

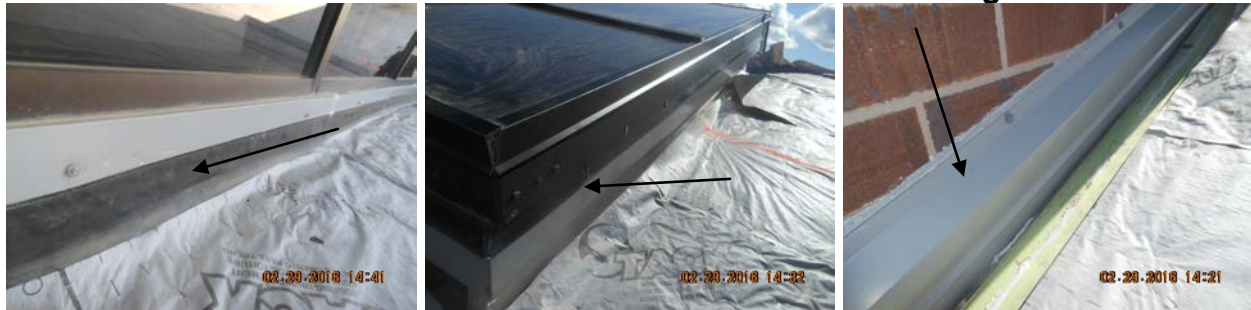
Curb and wall counter flashing to be removed, Ice& Water Shield applied to wall and roof surface then install new counter flashings

After the wall and curb counter flashings are removed in the swimming pool and curb leak areas install an Ice & Water Shield membrane up the wall overlapping the roof surface by 6". Install new sheet metal counter flashings.

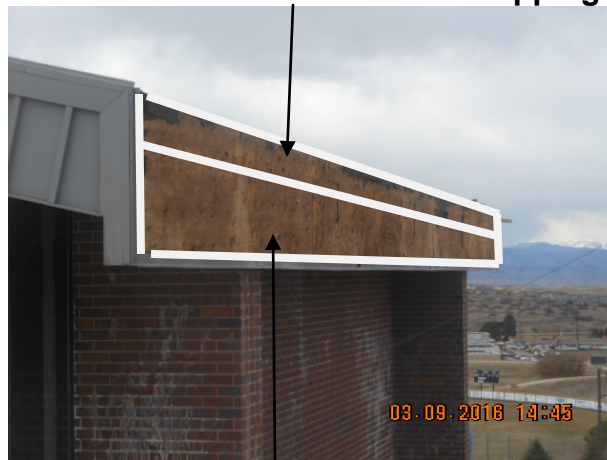
Horizontal Ice & Water Shield overlapping 12"

Install the new wood panels then over the vertical wood panels install the Ice & Water Shield membrane. Extend the horizontal Ice & Water Shield membrane that is installed to the new roof assembly down the vertical portion of the panels 12"

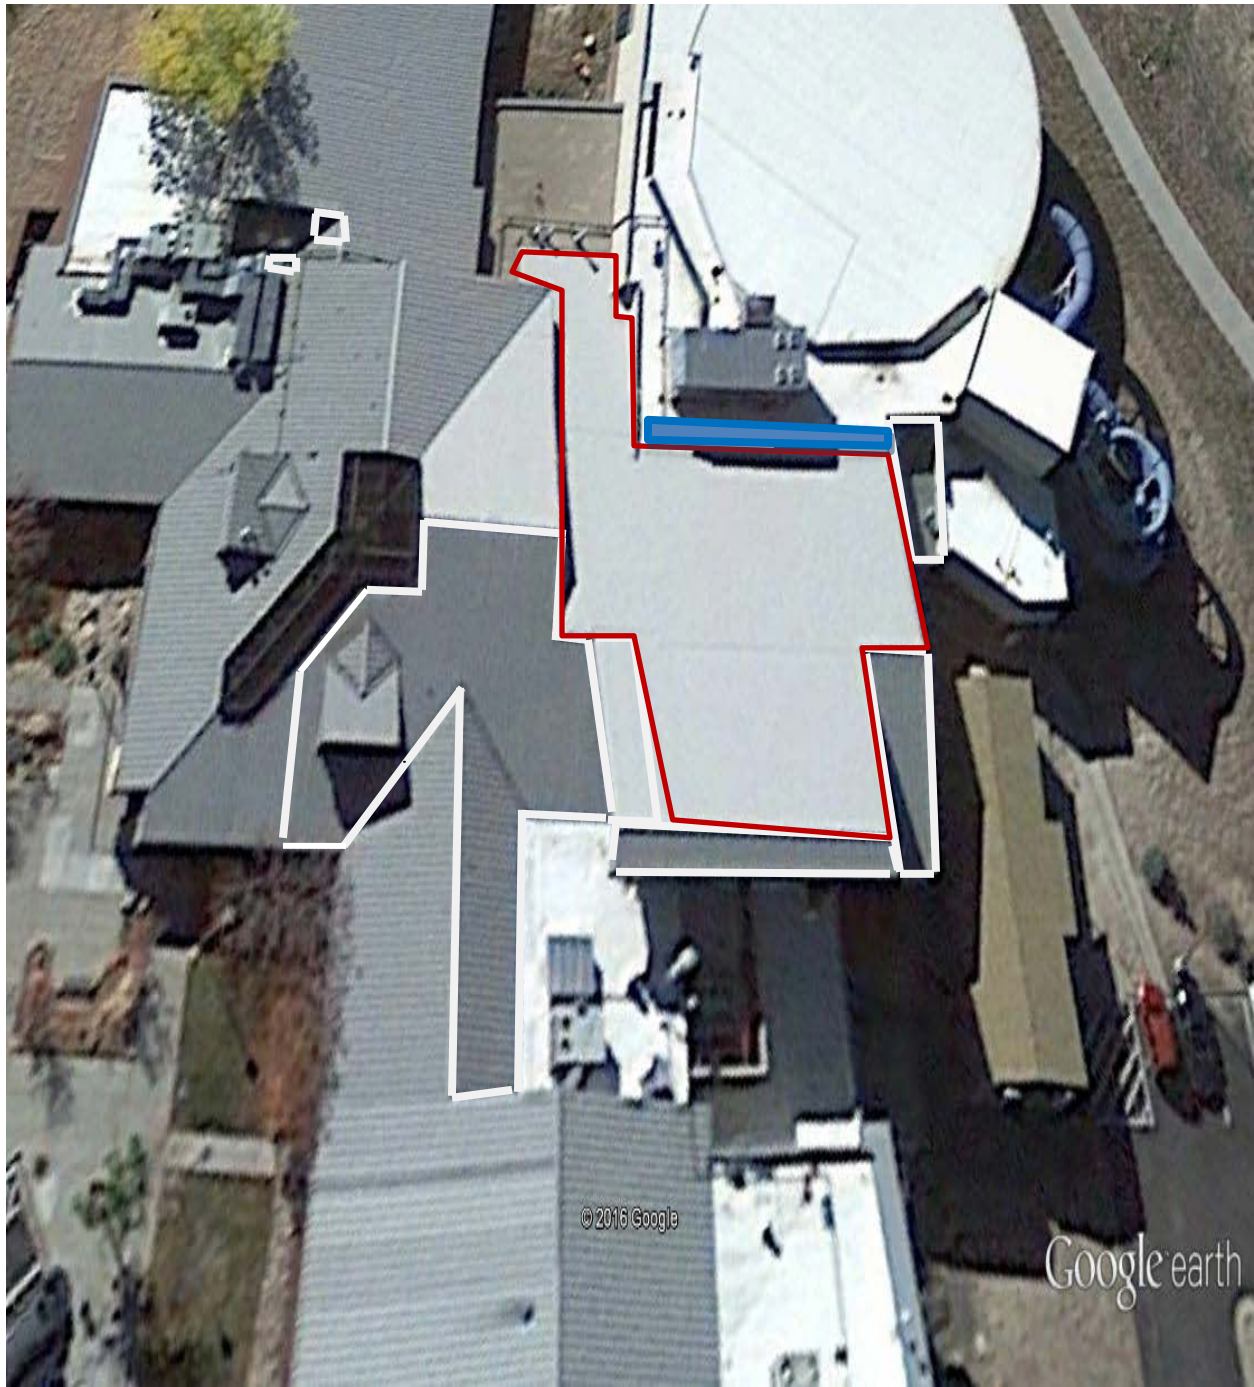
Water saturated and wet roof OSB wood areas outlined in white are areas that were infrared tested and showed as wet. The area outlined in red is expected to be wet because of the test area on this slope that tested as wet and other evidence (i.e: water seeping from the seams). The blue area is where the existing TPO tested wet, and is suggested that also be replaced.
