Waterman Regional Water Treatment Center Gets New Clearwell Access Hatch *By: Walt Schwarz, Project Manager*

The clearwell was built in 2005 along with the Ray Waterman Regional Water Treatment Center (RWRWTC) and has a capacity of approximately 546,000 gallons. Filtered water from RWRWTC flows into the clearwell and is then pumped out to the Town's potable water distribution system. A single three-foot square access hatch into the clearwell roof has proven inadequate for maintenance and operation activities. A new five-foot wide by nine-foot long access hatch on the existing clearwell was designed and bid for construction in 2015.

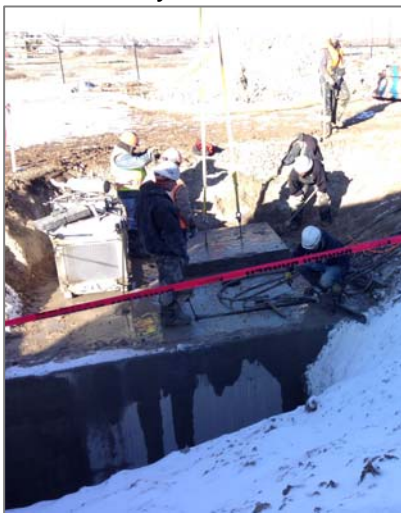
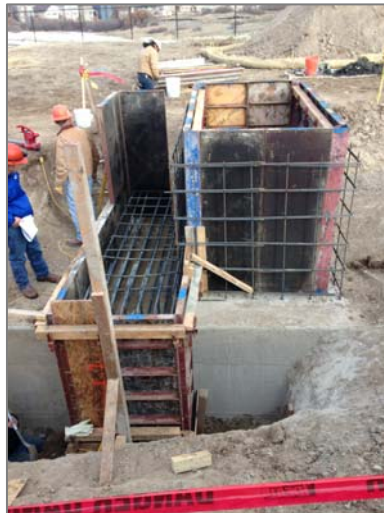
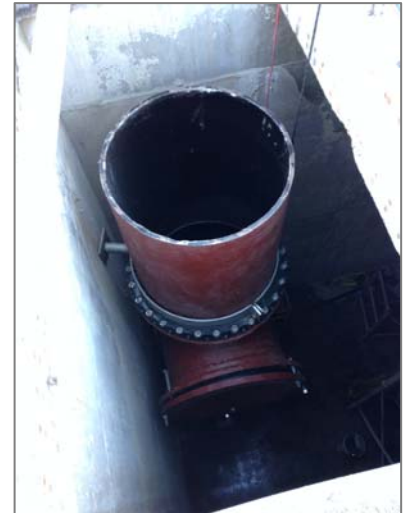
Left to right: Cutting and removing the 20,000 plus pounds of concrete, reinforcing and formwork for new concrete beam and hatch curb walls, and the new 42" diameter ductile iron pipe system.

Canterbury Construction was the low bidder and was awarded the construction contract in the amount of \$98,967. In addition to the new hatch, the project includes replacing a leaking metal weir box with 42-inch diameter ductile iron piping. The top of the new piping arrangement is approximately 15 feet above the clearwell floor. The elevation is important and is set to work hydraulically with the gravity flow filters.

Canterbury has installed a steel reinforced concrete beam that was needed to add support to the clearwell roof after removing the concrete section. The project is proceeding within budget and weather dependent. Canterbury plans to complete the hatch installation and other pieces of the project by end of February.

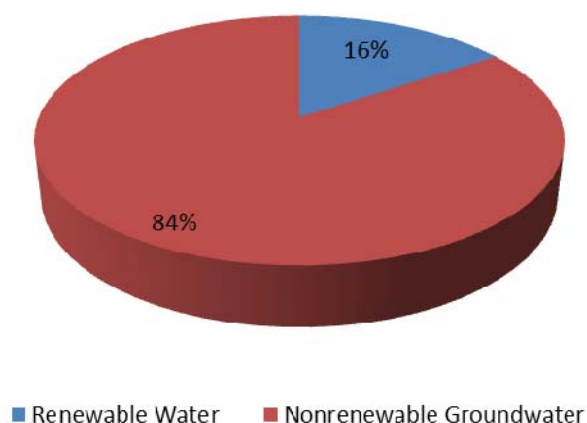
Water Supply Sources YTD

The Town's nine alluvial wells produced a total of 18 MG of renewable water during January, which represents 16% of the total water supply for the month and 16% (18 MG or 55 acre-feet) of the water supply year to date. The total renewable water produced since the opening of the PCWPF has surpassed 763 MG, which represents 11% of the Town's total water supply since the alluvial wells began pumping in May of 2013. Currently, the Town's renewable water rights surpass the capacity of the alluvial wells. The alluvial well project the Town is currently constructing will help close this gap.

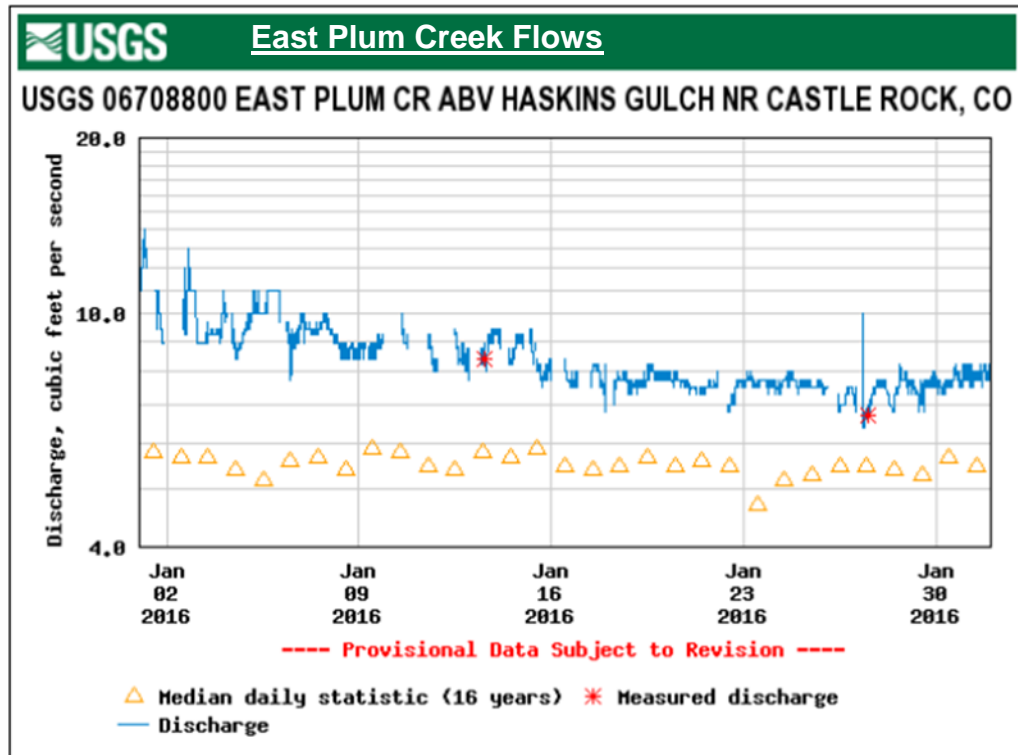
The flow hydrograph (see next page) represents stream flows in East Plum Creek taken from the stream gauge located at Haskins Gulch. The hydrograph shows that the East Plum Creek basin experienced stream flows between 7 to 14 cubic feet per second (cfs) with flows remaining around 7 to 8 cfs towards the end of the month. During the month there were no calls on the main stem of the South Platte, therefore a Free River condition and no out-of-priority depletions needed to be made up. The river call may change at any time as a result of downstream water diversion calls. We are currently about halfway through the snow accumulation season in the West. The NRCS Colorado SNOTEL report for February 1, 2016 shows the snow/precipitation for the South Platte River Basin is at 109% of average.

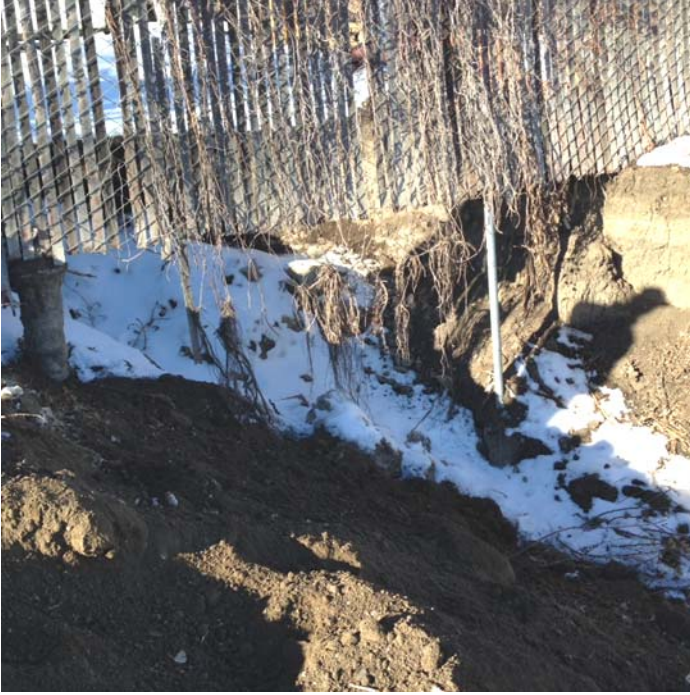
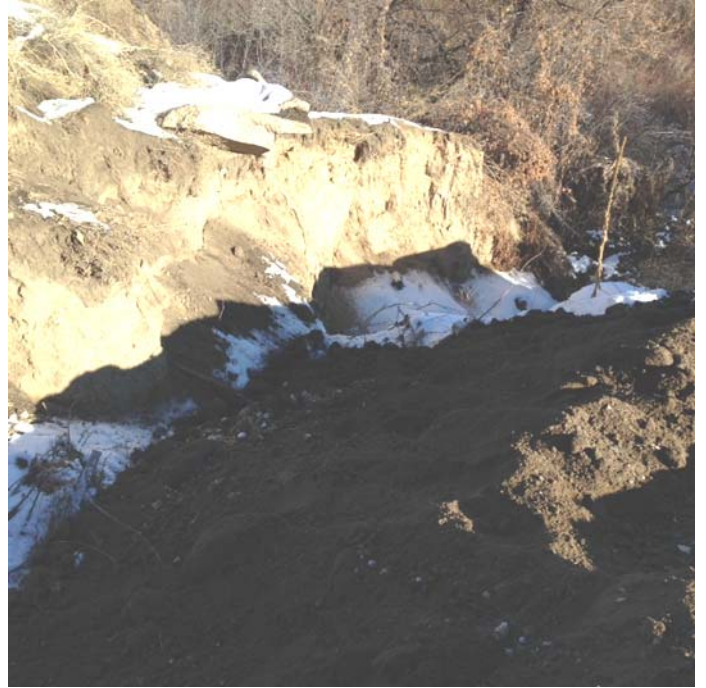
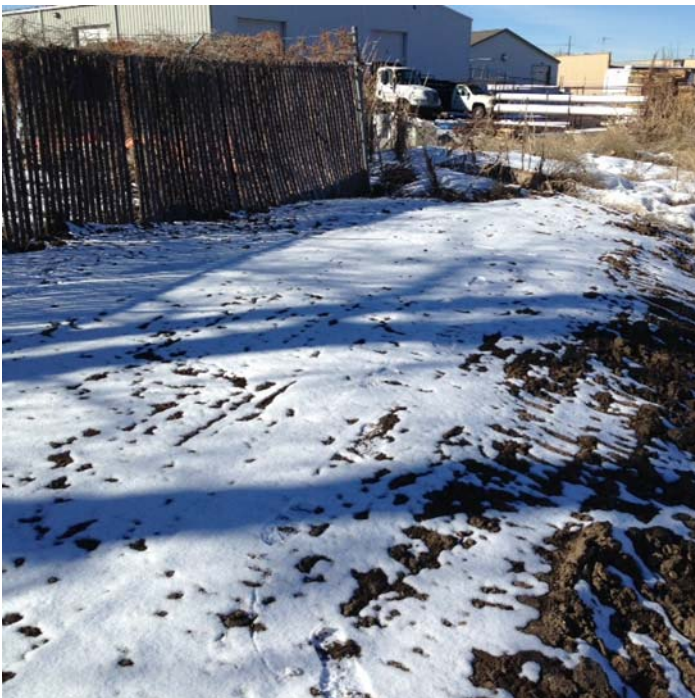
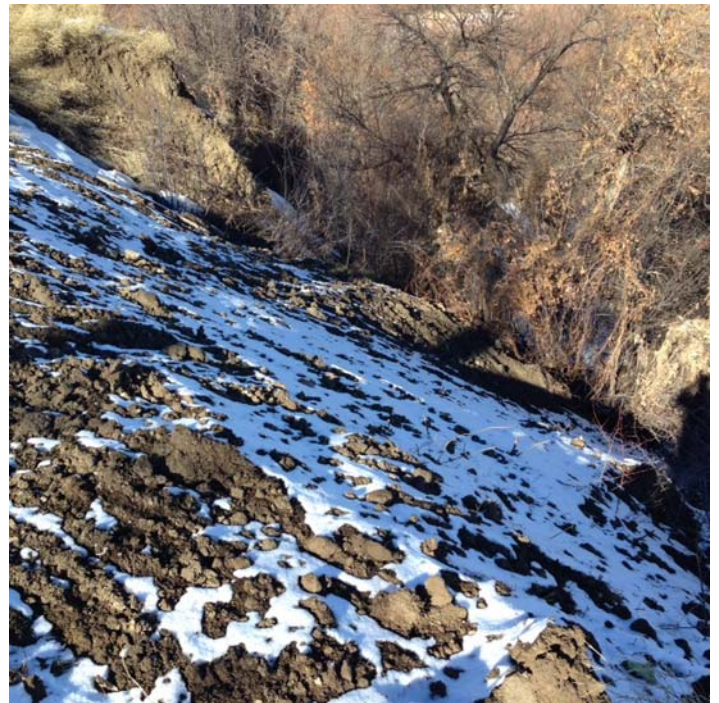
The eroded slope on Park Street was backfilled and repaired in partnership with the property owner.

Before

After
