Craig and Gould North Infrastructure Improvement Project

By: J. David Van Dellen, P.E., Project Manager

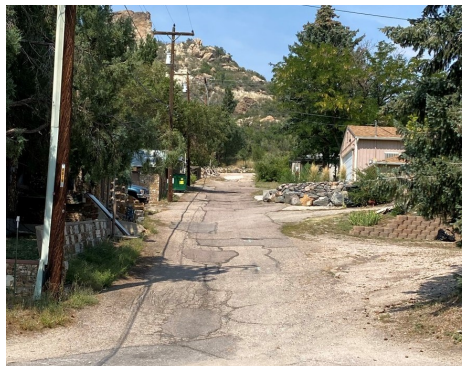
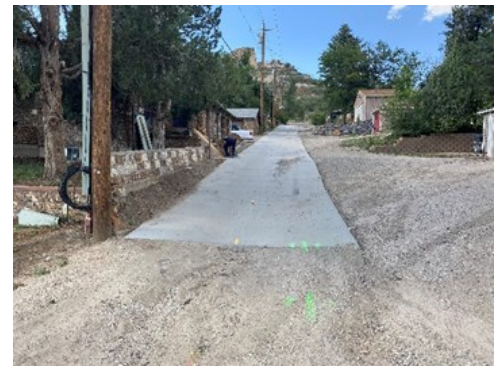
Alleyway before and with the first phase of stormwater and road infrastructure.

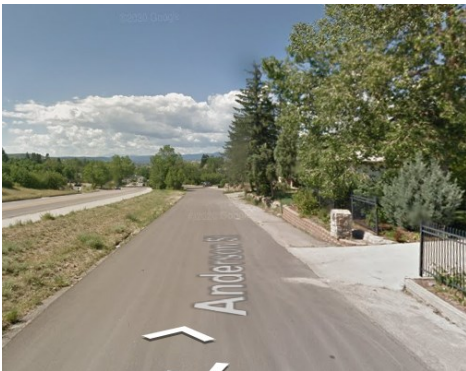
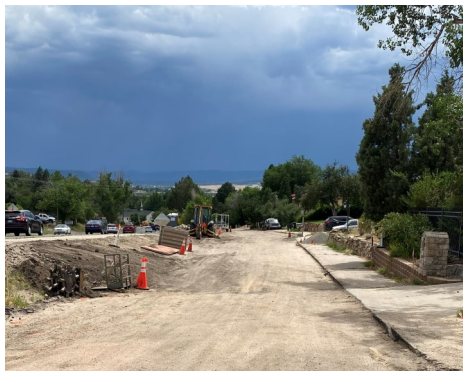
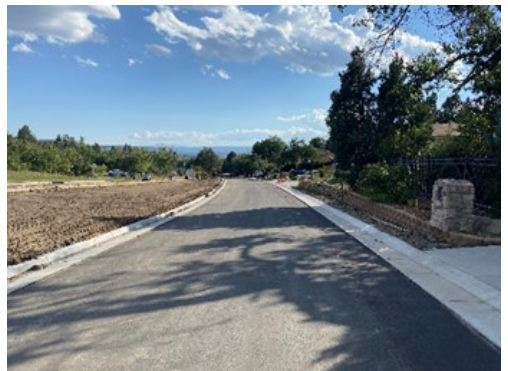
Anderson Street before, during and after improvements.

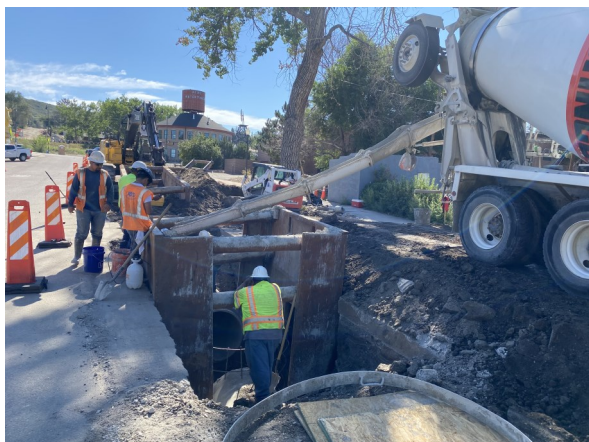
Storm sewer outfall, water main and sewer main in Sixth Street.

gutter and sidewalks throughout the majority of the project. Existing alleyways that remained dirt up to this point will be paved with concrete. In order to convey stormwater runoff, an outfall system is needed crossing the railroad. This outfall includes an underground water quality chamber to remove pollutants prior to discharging to East Plum Creek.

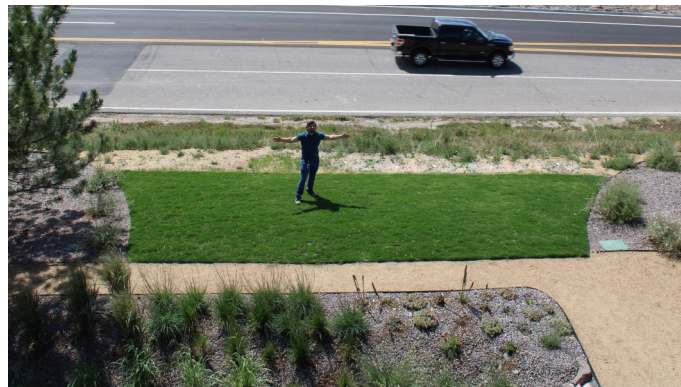
even in the August heat, with minimal watering only at night. After more than five weeks now it hasn't grown much, we haven't had to mow it, and the color is great. It has a horizontal growth pattern rather than a vertical one, so we think it will knit together and

form a "carpet" more than growing up into traditional blades. We've already cut the water back to three cycles every 5 days. We're going to continue stretching this watering interval in order to determine just how little water it really needs.

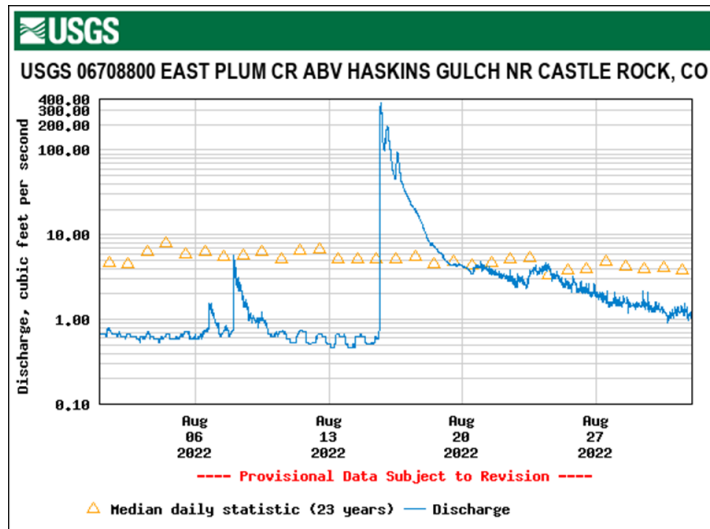
The hydrograph shows the estimated flows in the East Plum Creek basin.

- Flows ranged from 0.47 – 360 cubic feet per second (cfs).
- The monthly average streamflow was 6.69 cfs.
- The 22-year mean is 8.1 cfs.

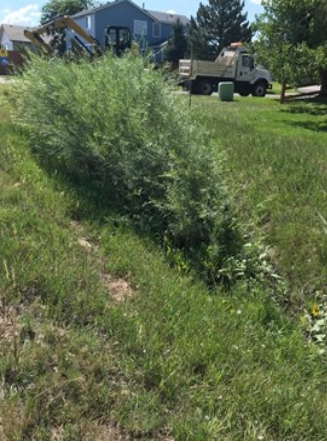
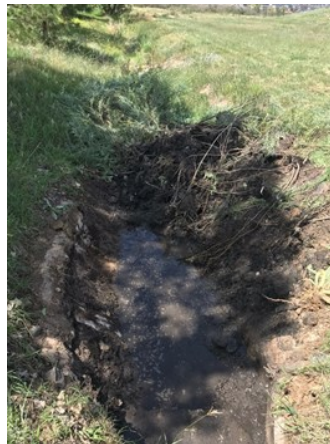
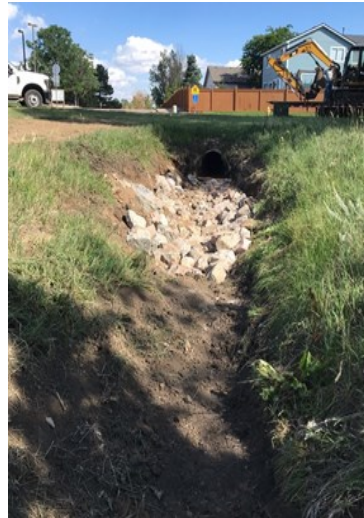
The Stormwater team renovated an outfall in the Founders area, which had filled with willows and sediment. The channel was regraded and rock laid at the outfall to assist with stormwater flows.

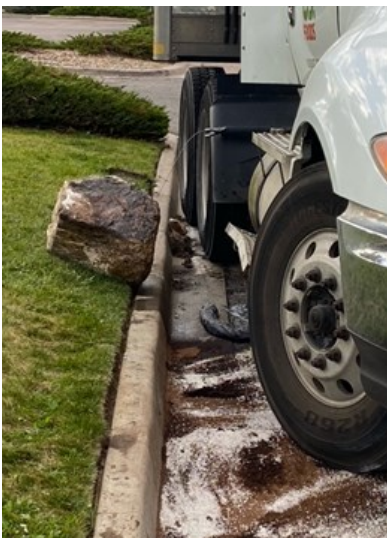
The Stormwater team assisted with a fuel spill at the Outlet Mall, when a truck's fuel tank encountered a decorative boulder. Drying materials were applied to help to stop the spread of diesel. Fuel did not enter the stormdrain system and only a small amount may have entered through the sewer manhole. Plum Creek Water Reclamation Authority was notified of the possible fuel contamination.

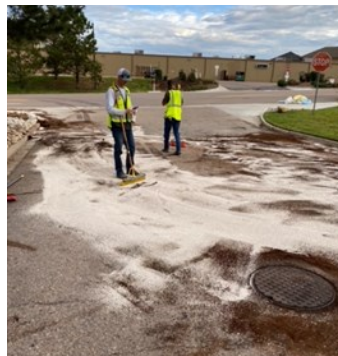
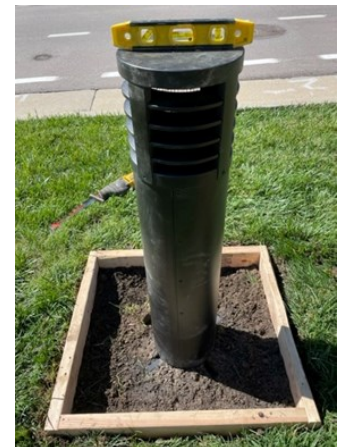
Various Town distribution line air vents were updated and expertly installed by the Distribution team.

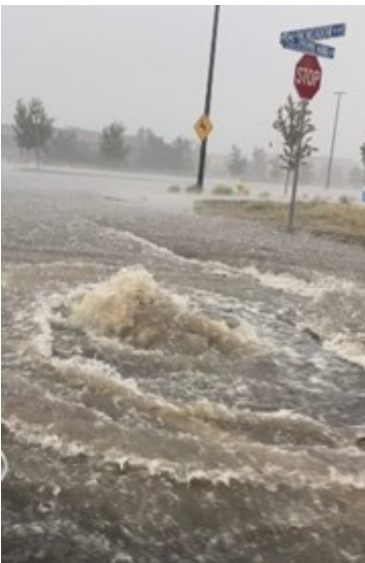
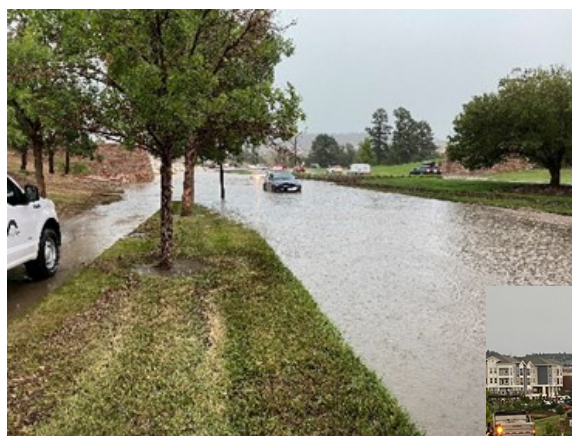
Extremely heavy afternoon rain caused stormwater systems to become overwhelmed. This resulted in several areas of significant flooding, with debris washing onto roads, creating traffic hazards. The Field Services Team assisted in relieving the flooding and in cleanup efforts. Infiltration and inflow from the heavy rain also caused multiple high level alarms at sanitary sewer lift stations, which the team also addressed.
