# CASTLE ROCK WATER

## SEPT 2024 MONTHLY REPORT

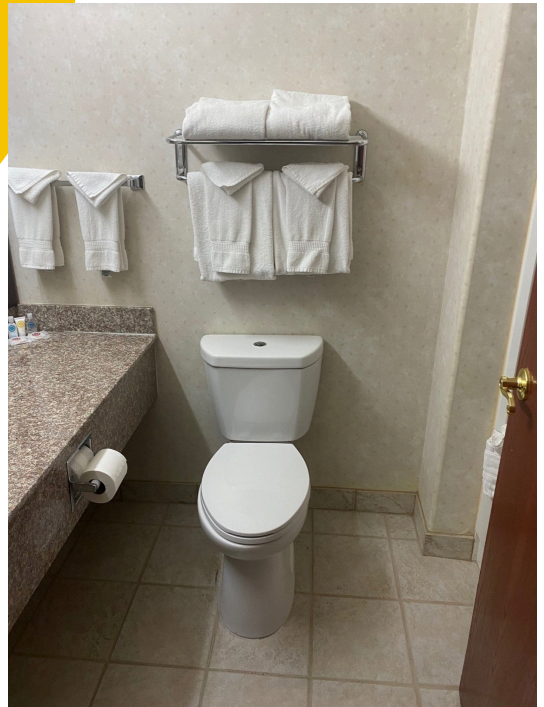
The Toilet Retrofit rebate supports customers to upgrade their existing 1.6 gpf or higher toilet to an ultra-high efficiency 0.8 gpf unit, using half of the water for every flush.

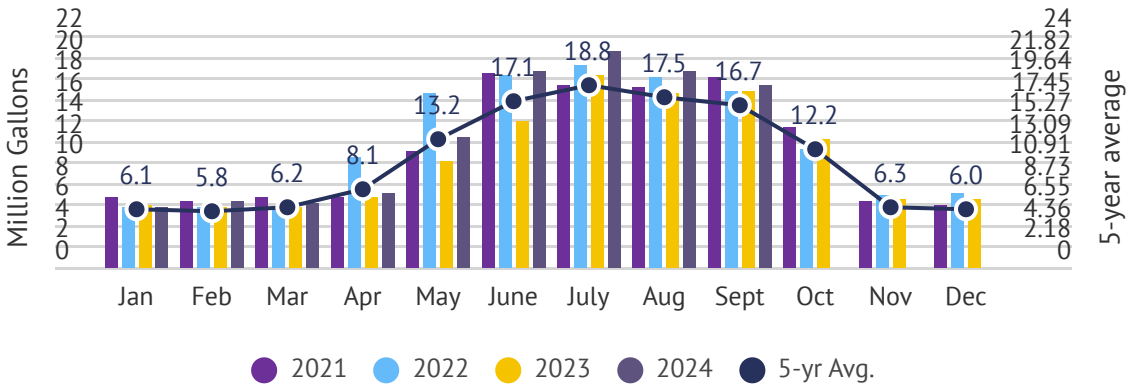
- The water demand total was 441.92 million gallons (MG) [1,356.2 acre-feet (AF)]
- 3% lower than the August 2024 total of 457.6 MG
- 25% increase from the previous year's September 2023 demand of 353.5 MG

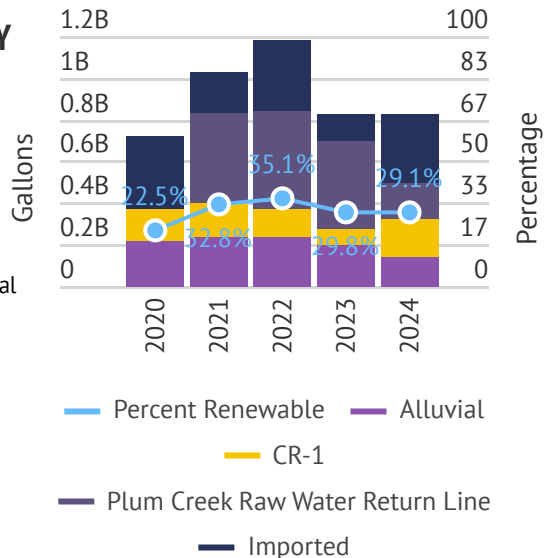
24.9%  
SEPT.

In total, renewable supplies accounted for 24.9% of the total water supply for the month (135.2 MG of 543.4 MG) and 29.1% of the annual water supply (828.3 MG of 2,842 MG)

- The CR-1 diversion produced an average of 0.94 MGD
- The PC diversion produced an average of 1.82 MGD
- The 14 alluvial wells produced an average of 0.49 MGD
- The renewable water production average was 4.51 MGD

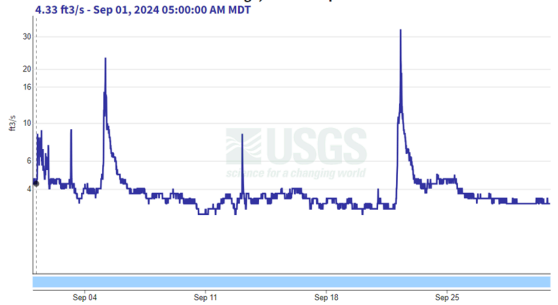
### East Plum CR Abv Haskins Gulch NR Castle Rock, CO - 06708800

The hydrograph indicates the estimated flow in East Plum Creek basin. (This text will indicate the peak and low points as the data is only an image.)

- Flows ranged from 2.7 to 32.8 cubic feet per second (cfs)
- Monthly average streamflow was 3.97 cfs
- 25-year mean is 4.7 cfs.

September 1, 2024 - September 30, 2024  
Discharge, cubic feet per second

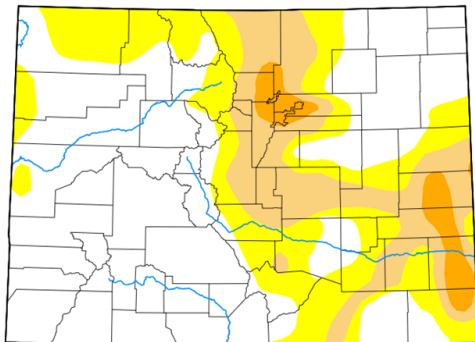
### Colorado

**DROUGHT** According to the most recent U.S. Drought Monitor maintained by the United States Department of Agriculture (USDA), Douglas County is experiencing abnormally dry conditions.

This map of Colorado shows Abnormally Dry to Moderate Drought for the top center of the state and the southeast border as Sept. 26, 2024.

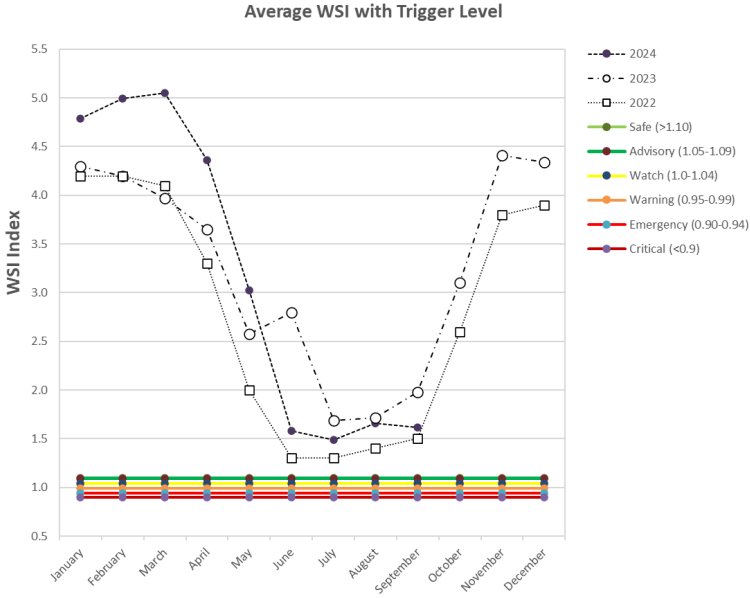
WATER SUPPLY INDEX  
1.62  
Sept. average

The Town of Castle Rock's Drought Management Plan uses a Water Supply Index (WSI) for the Town that accounts for local conditions relative to the Town's capability to address our water resources and daily water demands. Anything below 1.1 will trigger a drought stage relative to its severity.

This graph shows historical WSI data for 2022 to 2024 along with a peak WSI of 5 in March 2024, low of 1.5 WSI in July, and August's WSI of 1.66.

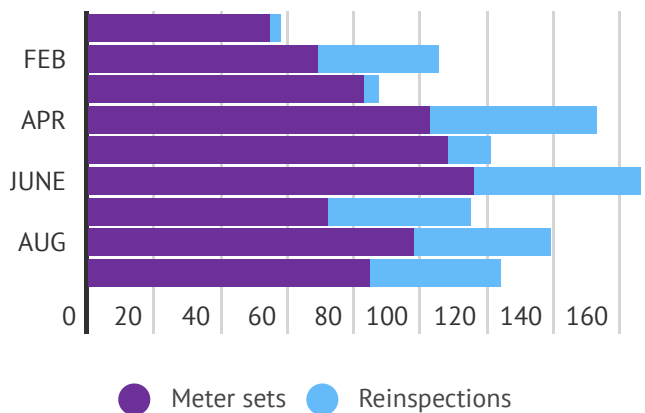
## METER SET INSPECTIONS

Meter set inspections are required on all new meters installed. This ensures that the meters are installed per specifications and according to Town code. At the time of the inspection, the curb stop is tested for operability and the MXU is installed which provides reading capability for our drive by technology. Re-inspections are needed to ensure installation meets code when original inspections are failed.

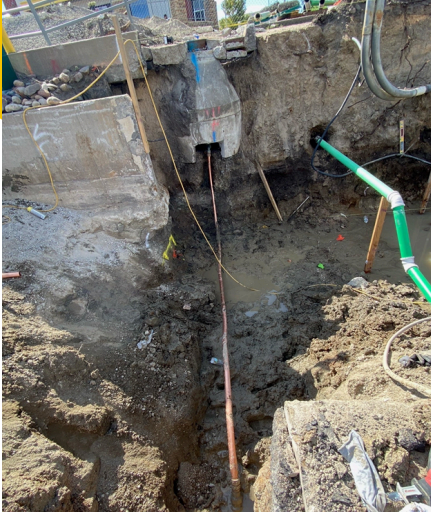
A contractor working on the intersection at Wolfensberger and Park St. damaged the service line to McDonalds. The contractor replaced the 2" copper service line from the curb stop to the corp stop. Water was off less than 30 minutes during the repair.

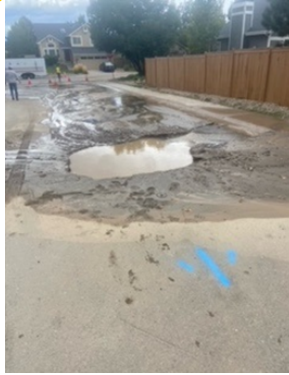
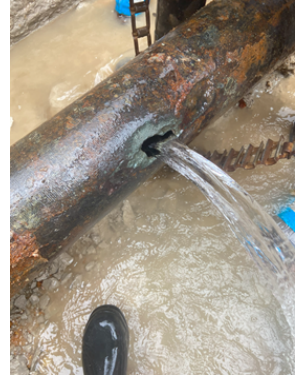
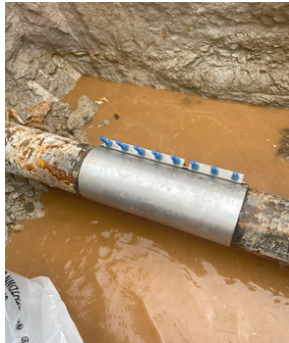
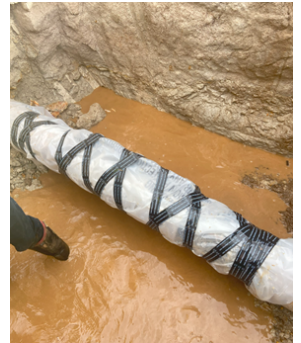
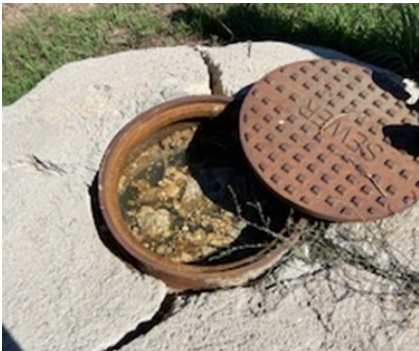
Staff was called out to an SSO caused by a grease and FOG blockage at a manhole in the Castle Highlands Area. The blockage took approximately two hours to clear and conduct cleanup operations.

There was another main line break on 8" CIP due to a 4" corrosion hole in the Meadows. Two residents were out of water for less than two hours during the repair.

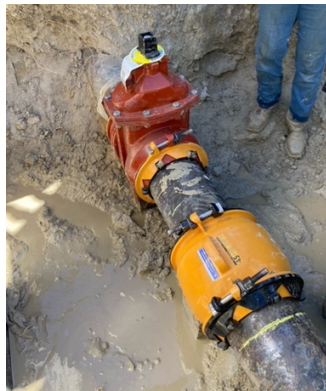
The next day a gate valve was also installed in the same area as the Meadows leak to assist with distribution system control. Two residents were out of water during the installation for less than two hours.
