CASTLE ROCK WATER

NOV 2025 MONTHLY REPORT

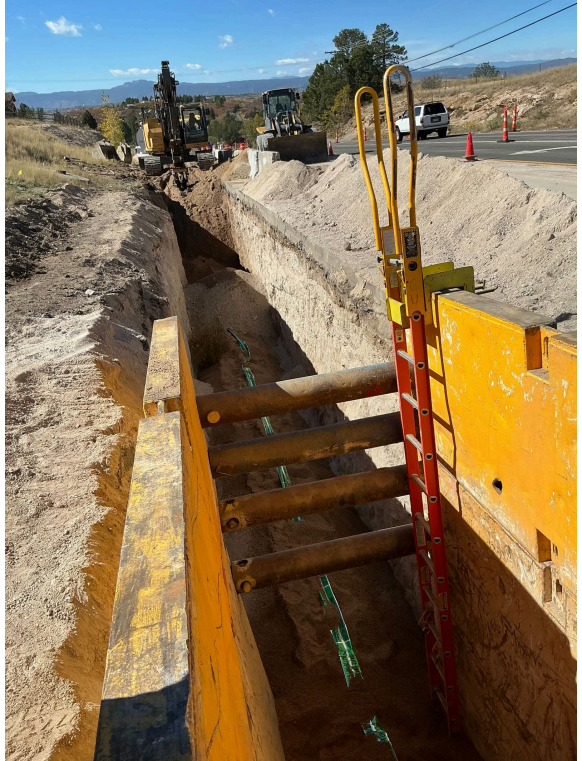
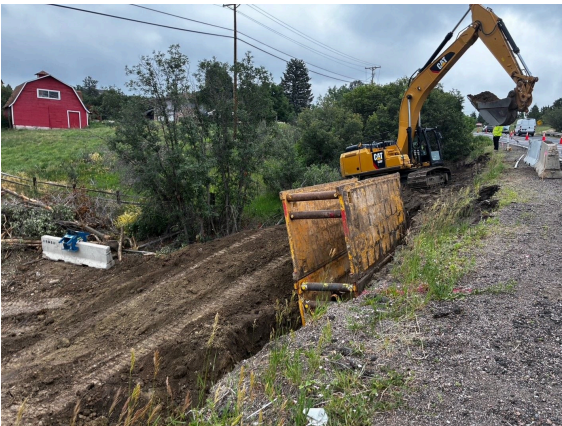
Fifth Street Sanitary Sewer Infrastructure

The Town has completed construction of a sanitary sewer system within the eastern reaches of Fifth Street that is needed to enable current and future service connections for properties in the area and protect the quality and resiliency of the \$12 million roadway expansion project. Approximately 1,500 linear feet of 8-inch PVC sanitary sewer, nine (9) manholes and two (2) sanitary service line stub-outs were installed. A length of approximately 100 linear feet of 10-inch sanitary sewer was also installed using Horizontal Directional Drilling under Fifth Street to connect the new system to existing sanitary sewer infrastructure on Valley Drive. The trenchless installation was used to minimize disruptions to Fifth Street. The project was able to accommodate keeping Fifth Street open throughout construction. The new sanitary infrastructure installed with this project will enable properties currently using private septic systems to connect to municipal wastewater services. This transition will improve watershed water quality, provide the

Town with reusable water supply and is a necessary step for any future expansion of the area's commercial or residential facilities.

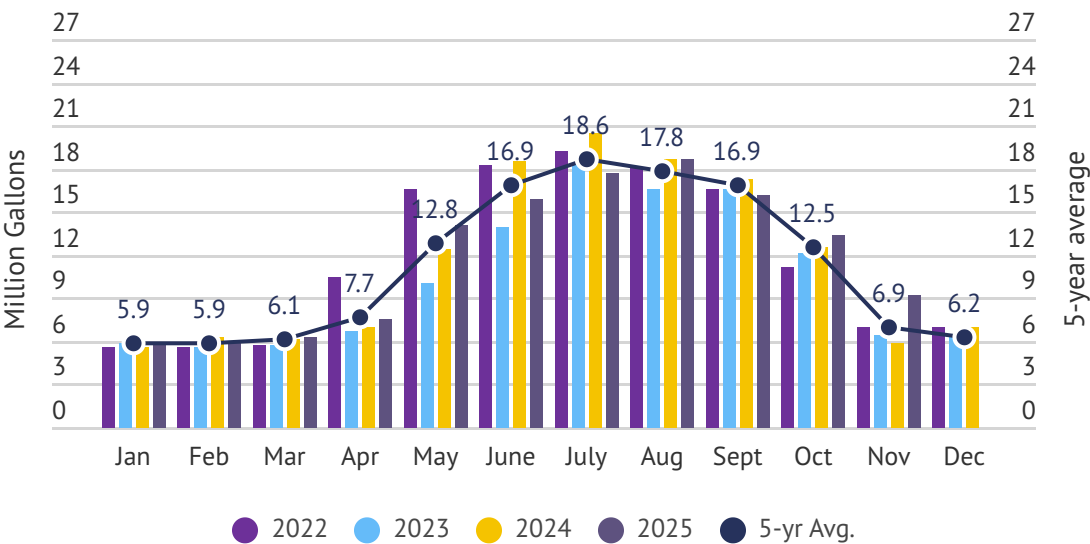
DAILY MAXIMUM DEMAND

Maximum demands inform us of the size of the infrastructure necessary to provide water service over short periods of time and help us to plan future water resources needs.

- 9.2 million gallons/day (MGD)
- 5-year average: 6.9 MGD
- 34% higher than the 5-year average

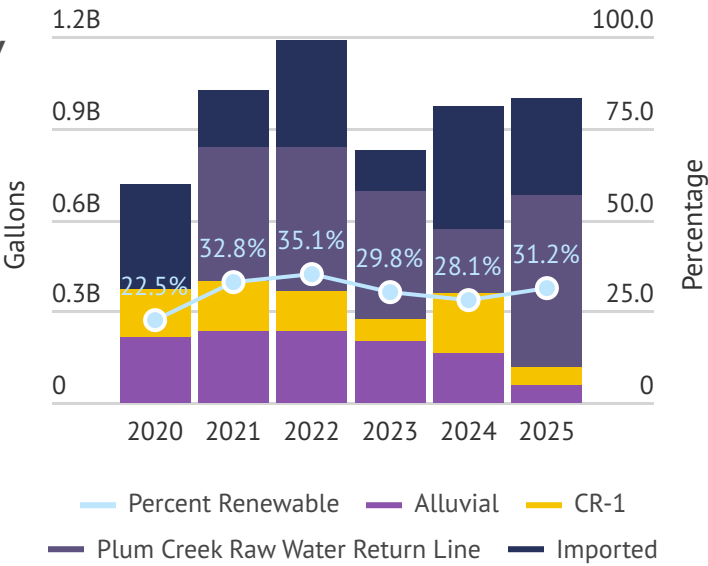
RENEWABLE WATER SUPPLY

In total, renewable supplies accounted for 1.2% of the total water supply for the month (2 MG of 171.3 MG) and 31.2% of the annual water supply (999.6 MG of 3,207 MG).

- The CR-1 diversion produced an average of 0.0 MGD
- The PC diversion produced an average of 2.81 MGD
- The 14 alluvial wells produced an average of 0.0 MGD
- The renewable water production average was 0.07 MGD

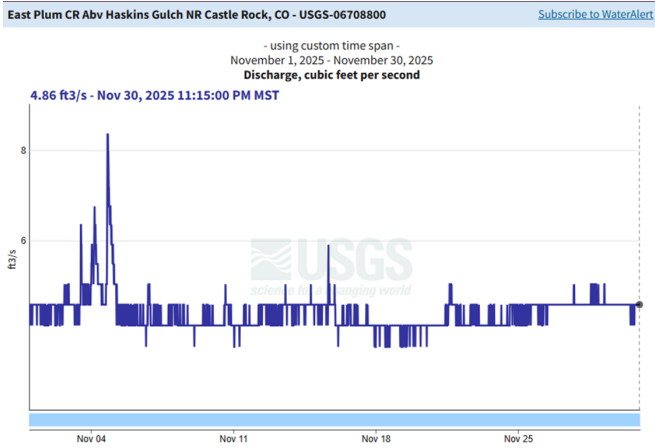
EAST PLUM CREEK FLOWS

The hydrograph indicates the estimated flow in East Plum Creek basin.

- Flows ranged from 4.2 to 8.4 cubic feet per second (cfs)
- The monthly average streamflow was 4.8 cfs
- The 25-year mean is 5.6 cfs

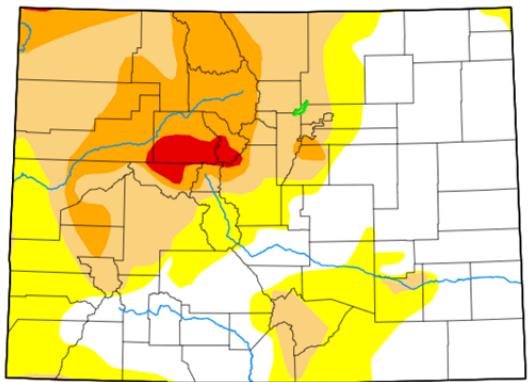
DROUGHT According to the most recent U.S. Drought Monitor maintained by the United States Department of Agriculture (USDA), northern Douglas County is experiencing abnormally dry, moderate drought, and severe drought conditions.

- None
- D0 (Abnormally Dry)
- D1 (Moderate Drought)
- D2 (Severe Drought)
- D3 (Extreme Drought)
- D4 (Exceptional Drought)
- No Data

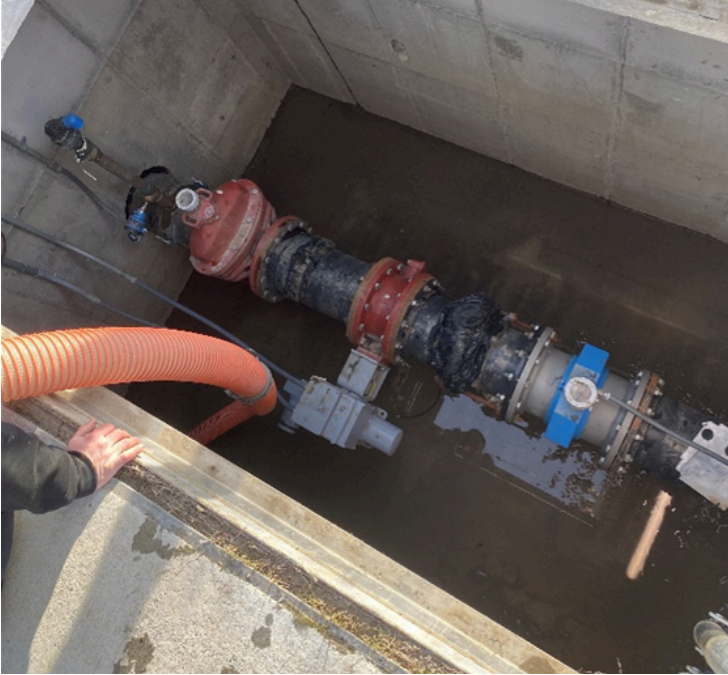
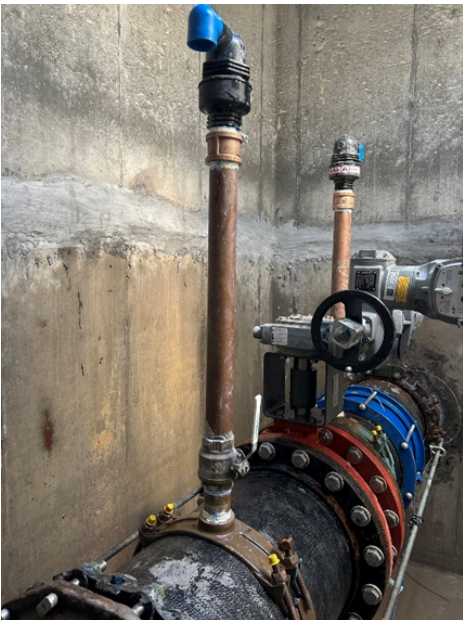
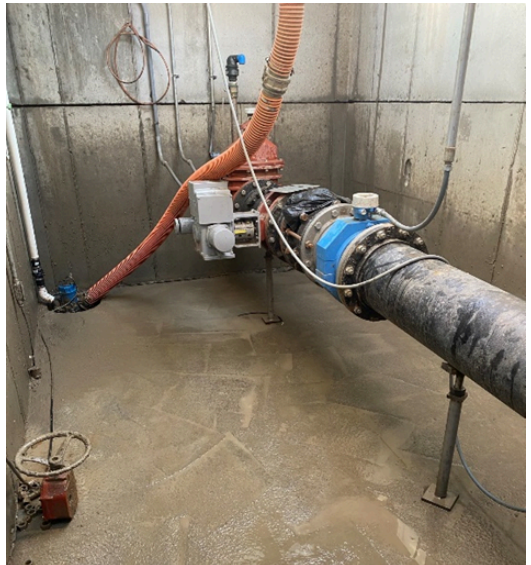
Tank 18 Altitude Valve Vault

Distribution spent a day at Tank 18 working on the Altitude Valve and the Isolation Valve vaults. Mud and dirt were cleaned out of the vaults, as well as around the sump pump, and then the pipe and valves were sprayed down. After the cleanup, the team isolated the vaults to remove the 2-inch pipes with a pressure transmitter and an air vac, so they could move the ball valve below the transmitter to make future maintenance easier. Both the Altitude Valve vault and the Isolation Valve vault are in the process of being upgraded.

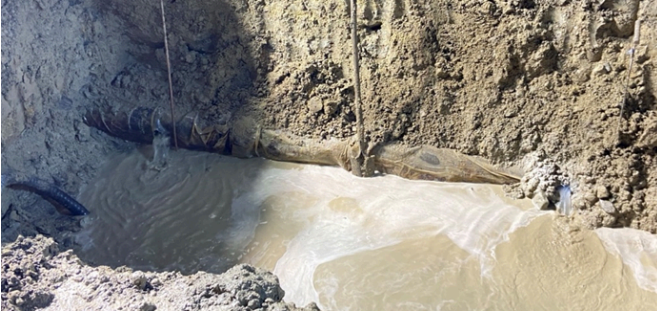
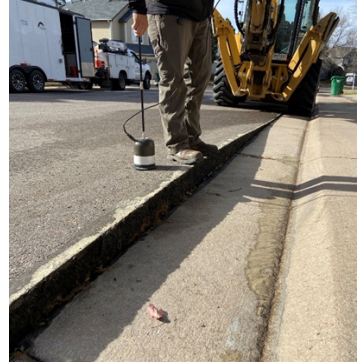
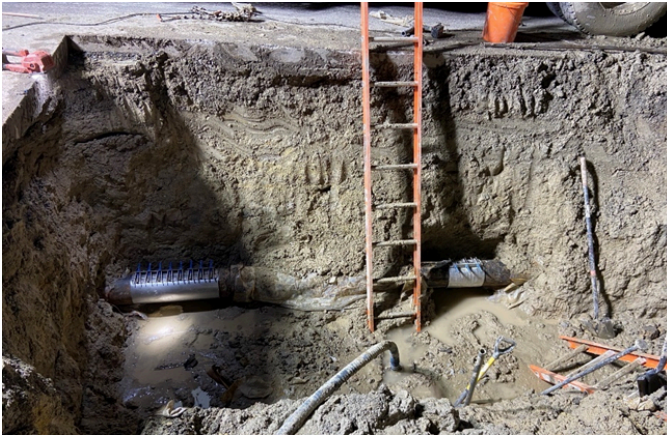
The Distribution team responded to a water main break on Wildflowers Way. The break was on 8" DIP and was caused by corrosion holes. Once the water main was exposed, two holes were present, after backfilling, another hole started leaking. The three repairs took a total of 14 hours; during this time, 19 residents were without water.

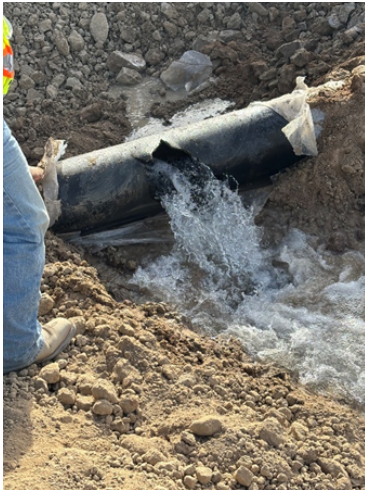
A contractor hit a water main in the area east of the Vistas at Plum Creek Apartments. The 180-unit complex and 50 resident homes experienced reduced water pressure for 8 hours while the contractor made the repairs.

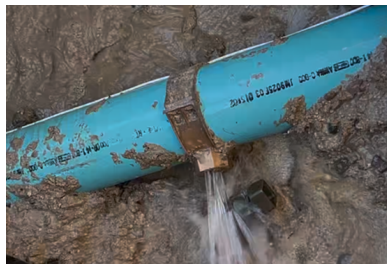
A broken corp stop caused a leak on Ridge Trail Lane stop on a fire suppression line. Water was off to six homes for 20 minutes while the repair was made.
