Over the next few pages, Castle Rock Water provides highlights of the accomplishments and projects in 2016. Please join us as we take a look back at 2016.

2016 Castle Rock Water Asset Management Year In Review

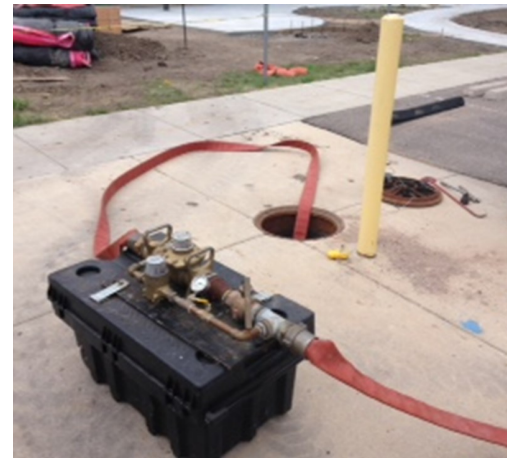
Six-inch meter bench test being conducted at the Justice Center inside the vault

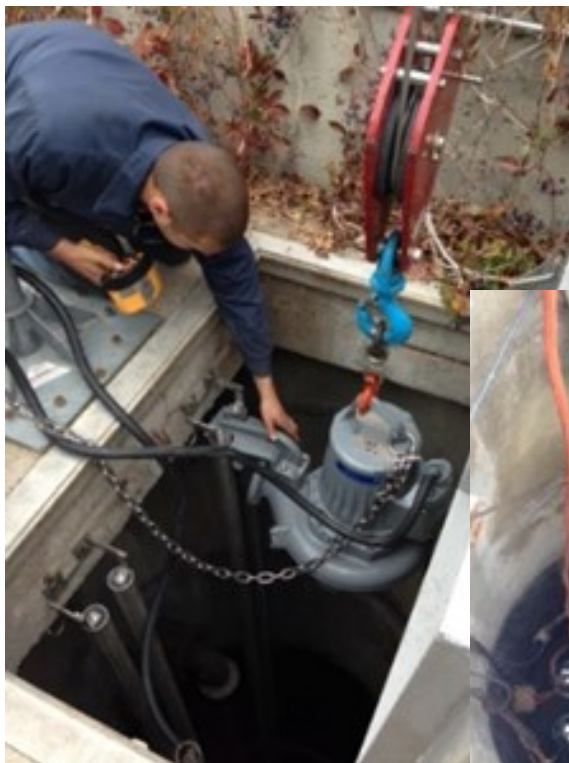
New pumps, guide rails and piping were installed at the Meadows 5 Lift Station as part of the wastewater system upgrades.

The Meadows 5 Lift Station is approximately 27 years old and was originally constructed with a Gorman Rupp pumping system. The original pumps were replaced long ago with Wemco pumps. In 2015, staff replaced the WEMCO sanitary lift pump #1, which was failing, with a Flygt submersible chopper pump, which has been operating exceptionally well since. The lift pump #2 and mounting hardware was also worn out and failing. The existing Wemco pump would not seal against the mounting base due to wear and this reduced the pump's ability to efficiently move wastewater. The existing Wemco pump #2 was installed in 2006 and due to a lack of available parts, had exceeded its useful life. Additionally, the Wemco pump has had a history of plugging and failing seals. Staff chose to replace the aging Wemco pump #2 with a second matching Flygt pump, to have uniformity of systems and reduce disparate spare parts.

The Town selected Water Technology Group, the Flygt vendor, for the pump replacement. The project team developed a plan to keep residents in service by using contract vector truck services overnight, which required Town Council concurrence. The total cost for this project was \$39,134. The work was completed on time and under budget.

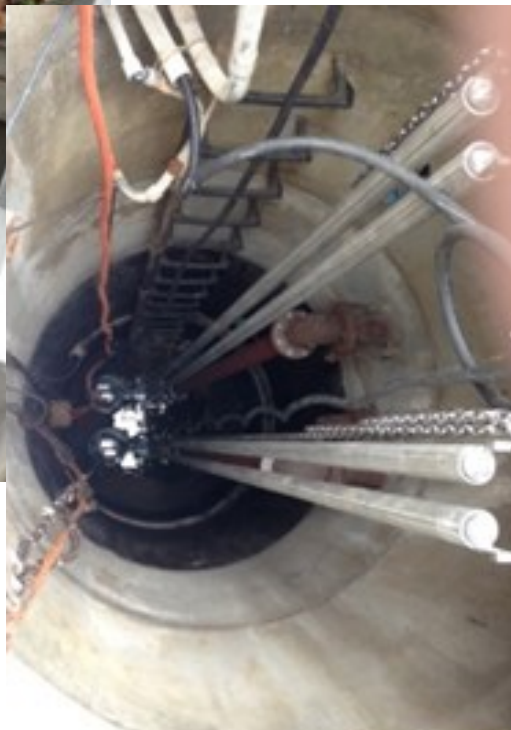
Wastewater's new easement machine allows the team to easily work on uneven terrain and allows access to facilities located in easements.

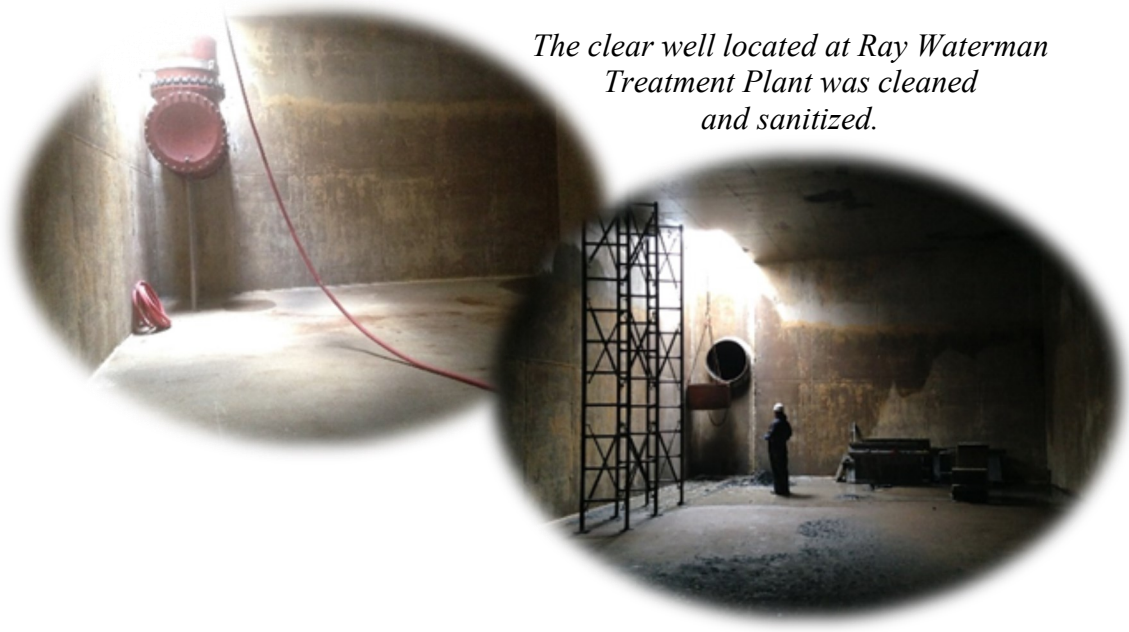
The clear well located at Ray Waterman Treatment Plant was cleaned and sanitized.

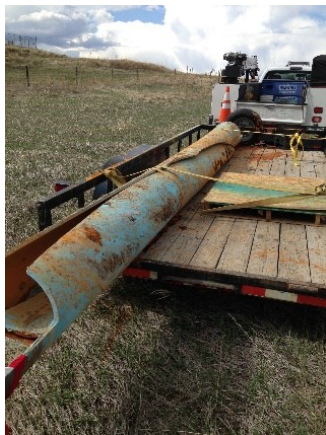
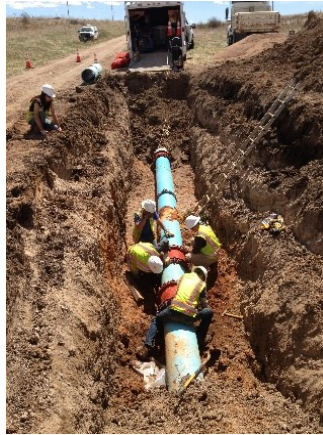
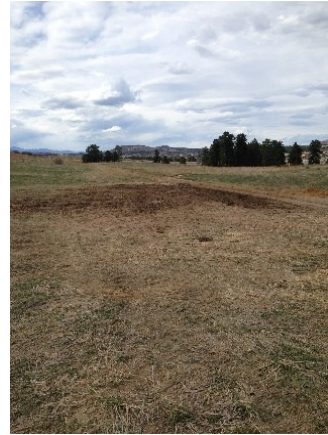
A repair was made to a broken 16" raw water line which feeds water from the North Central Well Field to the water treatment plant. A total of 26 feet of pipe was replaced.

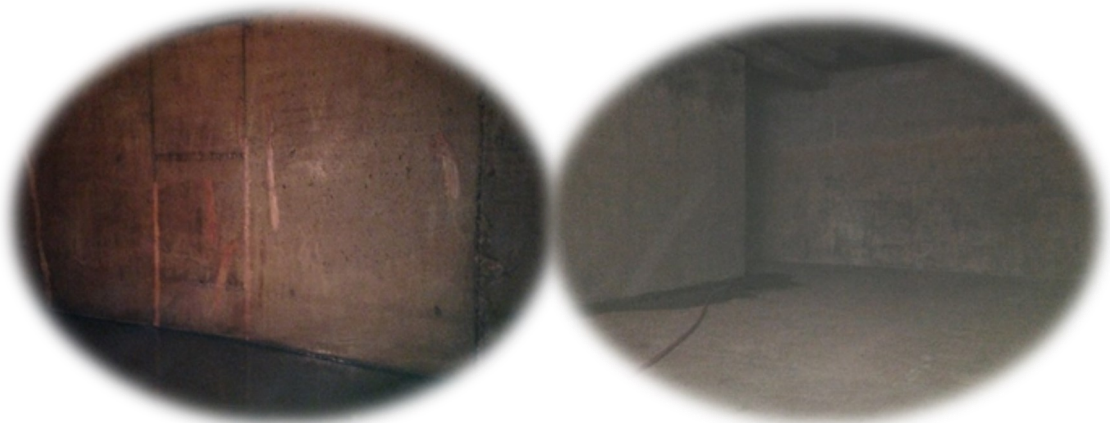
The clear well at Plum Creek Water Purification Facility was cleaned and sanitized.

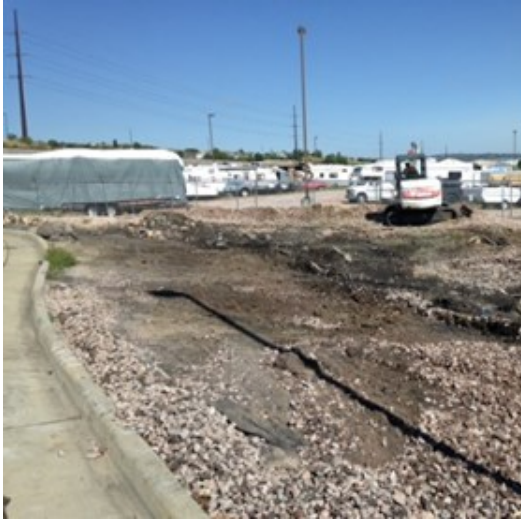
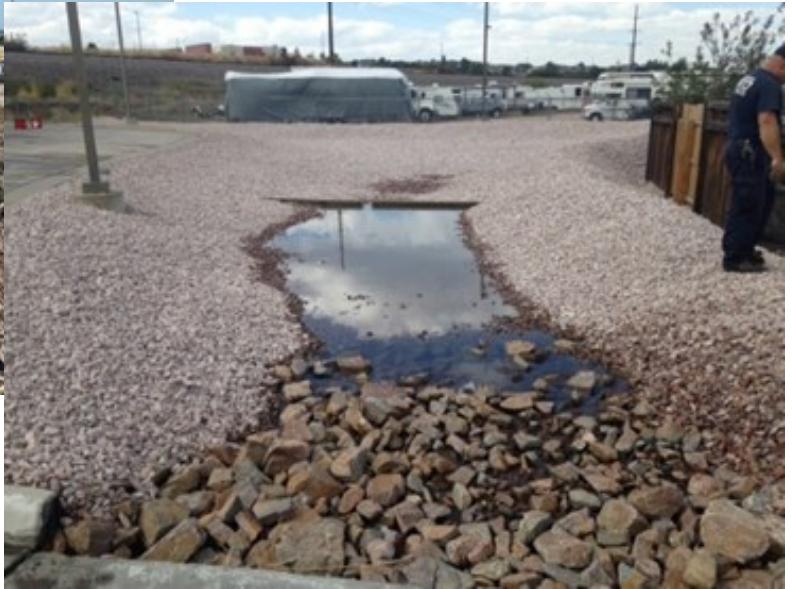
The Stormwater team refurbished the Fire Department Training Center detention pond.

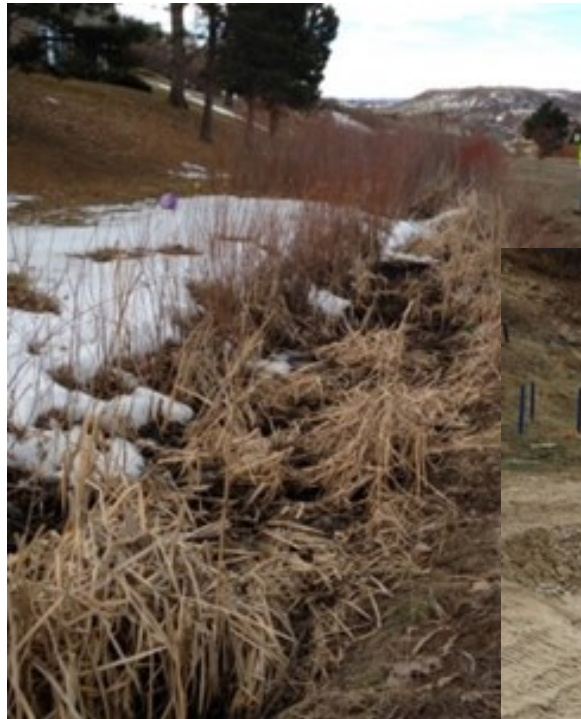
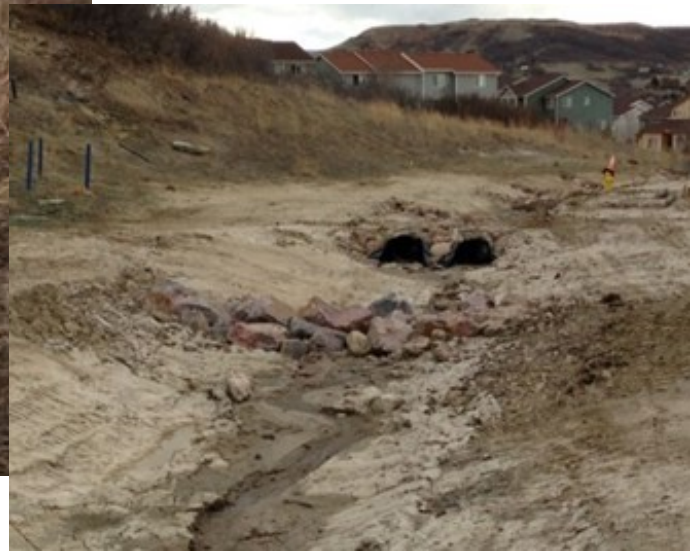
Repairs made to the Plum Creek Ditch after it had become clogged with sediment, plants and debris, causing it to spill onto Plum Creek Parkway during severe storms. This overflow created road icing, which was a safety hazard for drivers on this main arterial.

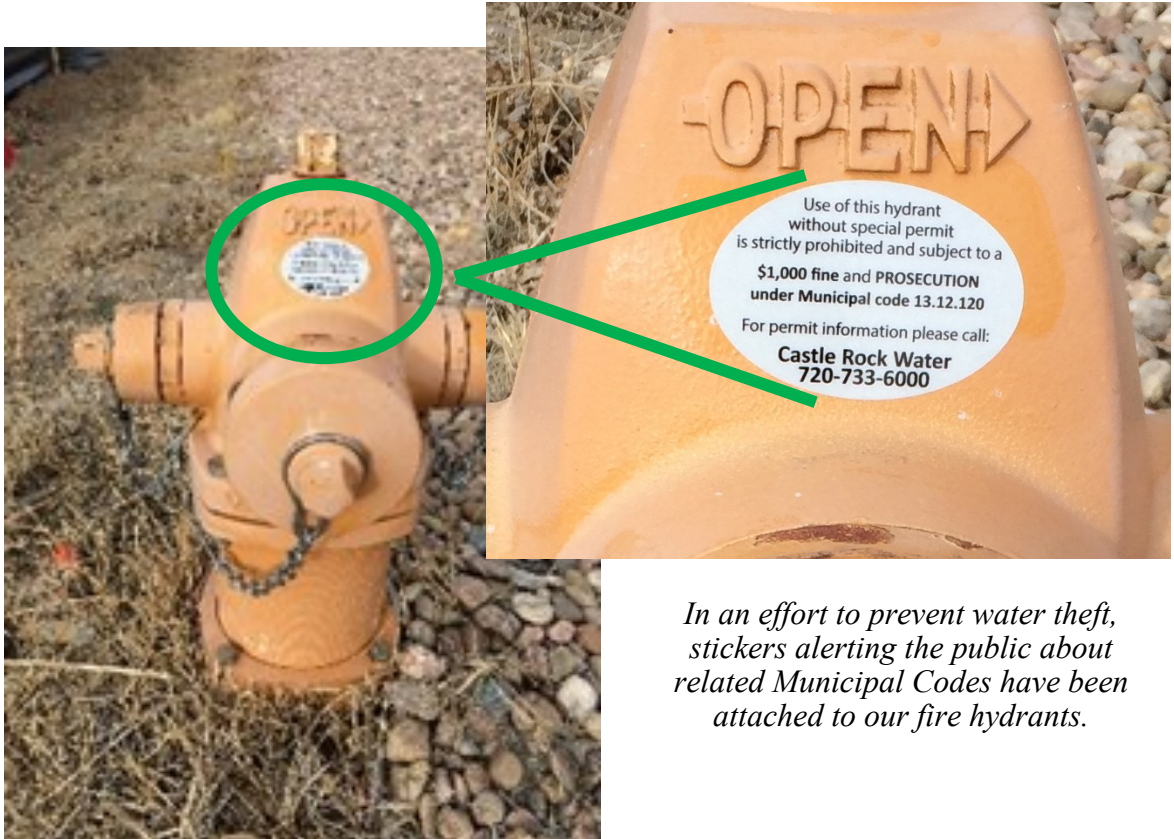
In an effort to prevent water theft, stickers alerting the public about related Municipal Codes have been attached to our fire hydrants.

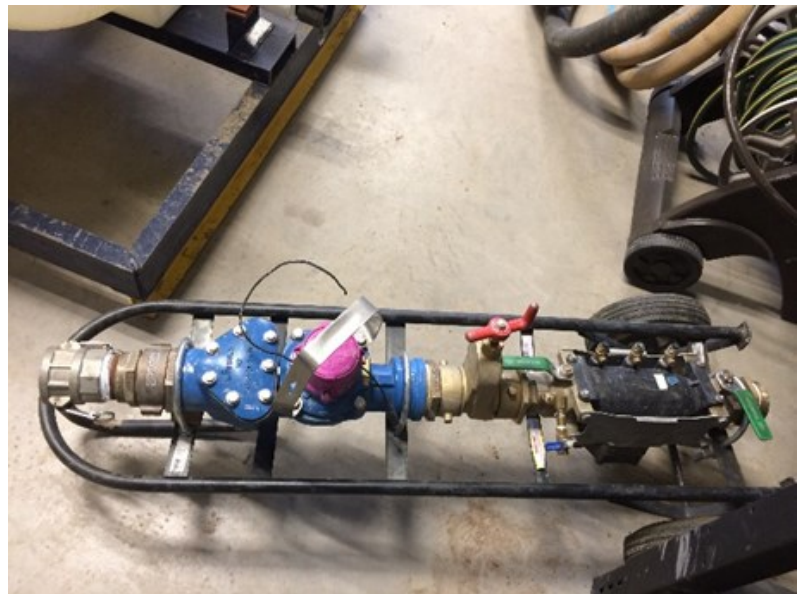
The hydrant meter bulk water program is now offering dolly mounted hydrant meters complete with backflow device, to make it easier and less expensive for short term hydrant users to access our water.

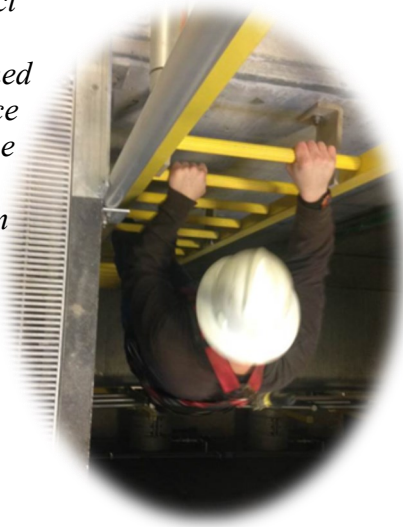
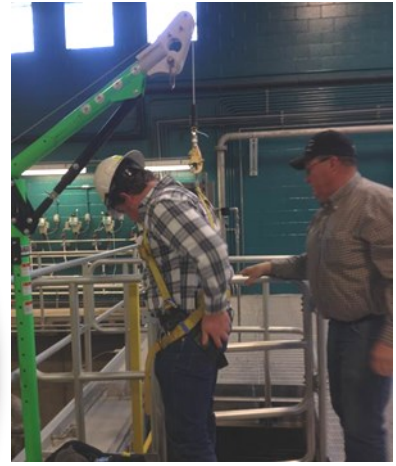
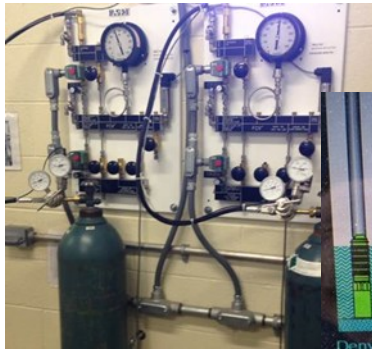
Field and Treatment Services work together to clean and inspect machinery, basins, and performed annual maintenance on equipment at the Plum Creek Water Purification Facility.

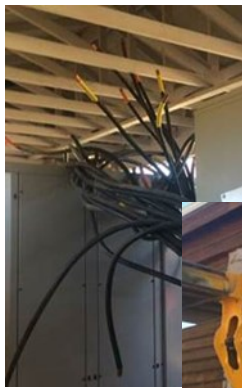
The variable frequency drive was replaced at Well 14R. This equipment is essential to supplying water to Plum Creek Water Purification Facility.

The variable frequency drive (VFD) at Well 14R was replaced and is used to drive the well motor at different speeds, giving the operators the ability to speed up or slow down wells to maintain aquifer levels. The new VFD will improve energy efficiency, the reliability of the well, as well as guarantee the availability of parts in the event of a problem. The contractor on this project was Applied Ingenuity, and the project was completed on budget (\$90,803.89) and schedule.

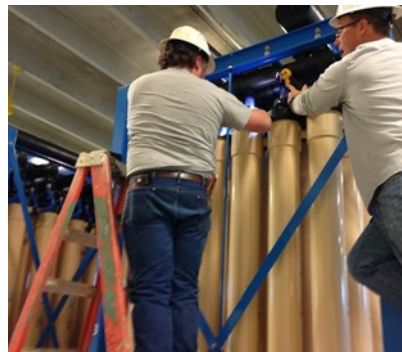
Plant Mechanics repaired a broken membrane strand that failed integrity testing during Pall membrane rack maintenance

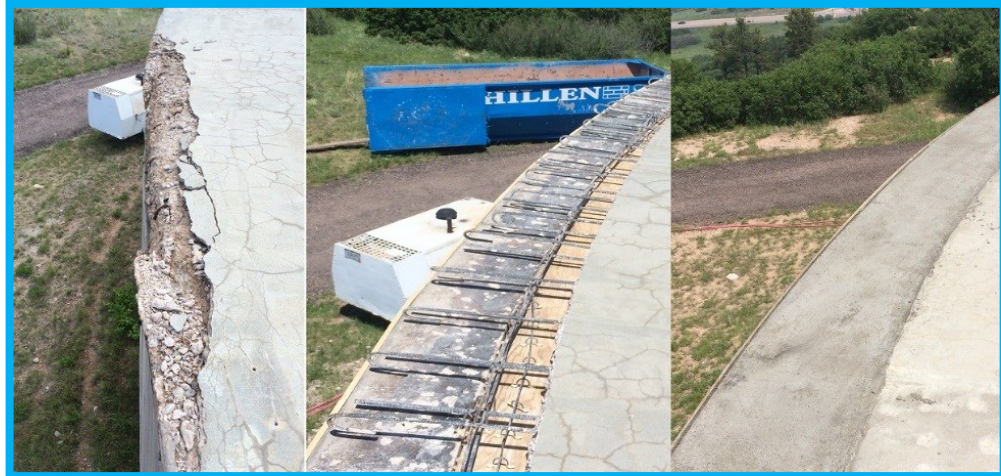
Tank 3 Concrete Roof Repair Sequence

Tank 3 is the Town’s oldest water storage tank currently in service. The water tank has a capacity of one million gallons, was built in 1969 and is rapidly approaching the half century mark. In today’s dollars, replacement of the tank could exceed \$2 million. During the Town’s routine tank inspections, several areas for improvements were identified at Tank 3 – the most important of these being repairs needed to address degradation of the concrete roof and walls. Canterbury Construction was the low bidder on the project and was awarded a contract in the amount of \$111,166.

Construction of the improvements began in May and was completed in July 2016. Temporary shoring support had to be installed inside of the tank before the damaged concrete could be removed from the roof. Additional improvements included installation of a new interior tank ladder and overflow pipe to replace corroded existing equipment and installation of a new raised tank roof hatch, raised air vents, and a silt stop on the tank outlet. Construction of the improvements was completed within budget, and the tank is back in service. The completed improvements will help improve staff safety at the tank, make sure we continue to meet the latest state regulatory standards, and significantly extend the lifespan of Tank 3.

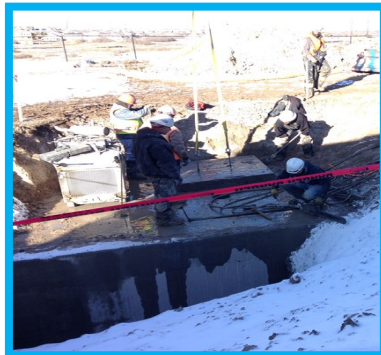
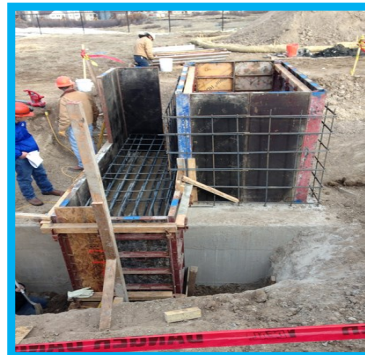
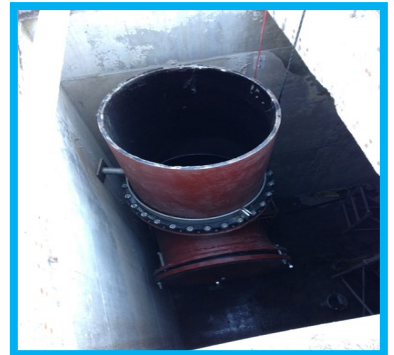
Canterbury Construction was the low bidder and was awarded the construction contract in the amount of \$98,967. In addition to the new hatch, the project included replacing a leaking metal wier box with 42-inch diameter ductile iron piping. The top of the new piping arrangement is approximately 15 feet above the clearwell floor. The elevation is important and is set to work hydraulically with the gravity flow filters.

Canterbury installed a steel reinforced concrete beam that was needed to add support to the clearwell roof after removing the concrete section. The project stayed within budget. Canterbury completed the hatch installation and other components of the project in February of 2016.

Left to right: Cutting and removing the 20,000 plus pounds of concrete; reinforcing and formwork for new concrete beam and hatch curb walls; and the new 42" diameter ductile iron pipe system.

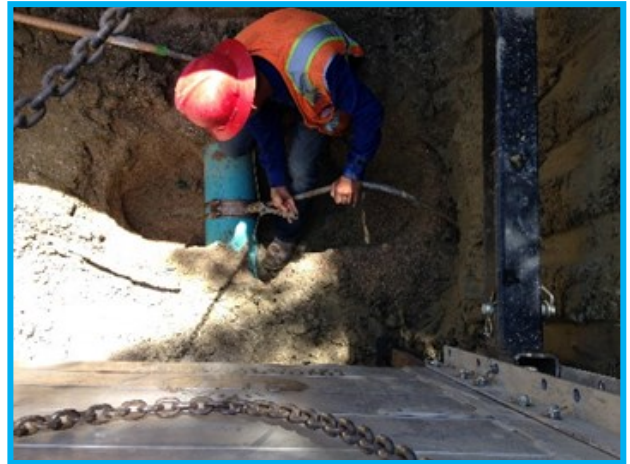
Eaglestone Tap Relocation

Castle Rock Water completed water service line improvements in two areas during the summer of 2016. Ten homes along Eaglestone Drive had been experiencing low pressure for a number of years. Castle Rock Water investigated these complaints and determined that service lines had been connected to the wrong water main when the homes were constructed in 2004. The Service Line Improvement Project relocated the residential service tap from the Red Zone main (lower pressure) to the Green Zone main (higher pressure). This project boosted the service pressure by approximately 60 pounds per square inch (psi). In addition to the service tap relocation, the project added two additional water quality sample stations to the Town's water distribution system.

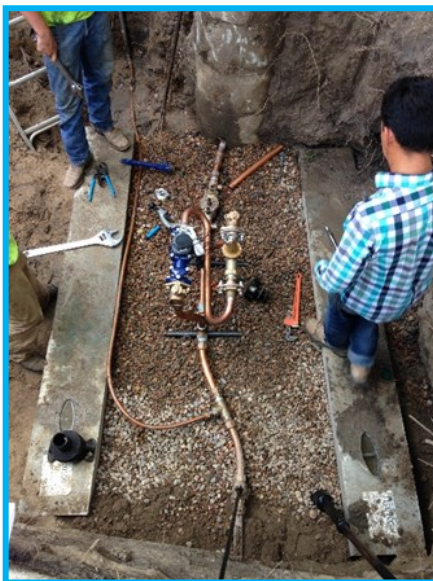
New Meter Assembly

The second part of the Service Line Improvement Project replaced four meter pits at the Castle Creek Commons apartment complex. The Meter Services Division identified these four meter pits for replacement. The water mains and services for the apartments were constructed in 1984. These meter pits were at the end of their useful life and did not meet the Town's current standards. The most critical issue that this project needed to address was that these services were installed without a curb stop. The curb stop allows for the service to be shut down for maintenance and emergencies. Without the curb stop, a section of the distribution main would need to be shut down, affecting numerous customers.

The service relocations for Eaglestone Drive were completed in July followed by the Castle Creek Commons meter pits in August. The total project cost was \$99,475. 53 Corporations was able to complete the project for approximately \$6,000 less than their original bid.

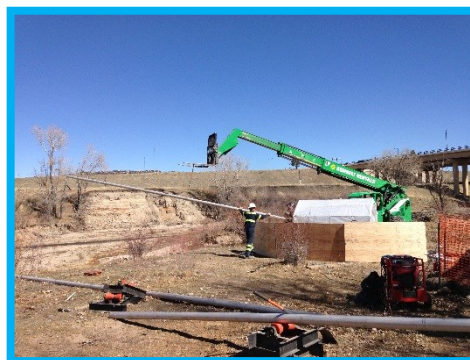
AL-16 Lateral Arm Installation

Velocity Constructors, along with Layne Christensen Company and Directed Technology Drilling, constructed the project. The project consisted of drilling three new vertical wells that are approximately 50-feet deep, with approximately 450 feet of horizontal directionally drilled screen. The contractor also installed approximately 4,000 feet of 4-inch and 12-inch raw water pipe and the required electrical connections to operate the well. A new metering vault and control panels were also installed at the site. The construction of the project was completed in June, and the facility was approved by the Colorado Department of Public Health the beginning of August 2016. The new alluvial wells are anticipated to produce approximately 300,000 gallons per day.

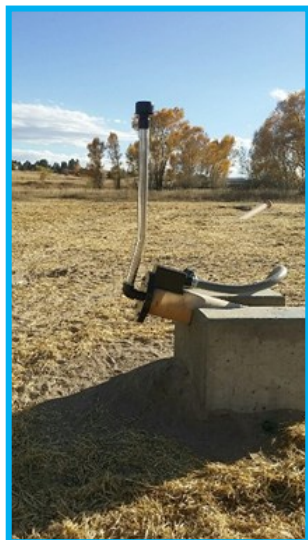
CR-12R Pit less Installation

Directed Technology Drilling, along with Velocity Constructors, constructed the project. The project consisted of drilling two new lateral arms for CR-11R and CR-13R, approximately 700 feet of horizontal directionally drilled screen. The contractor also re-drilled well CR-12R using horizontal directionally drilling technology with approximately 500 feet of screen. The project included new piping between CR-12R and the existing flow metering vault. Construction of the project was completed in October 2016. The new alluvial wells are anticipated to produce approximately 280,000 gallons per day.

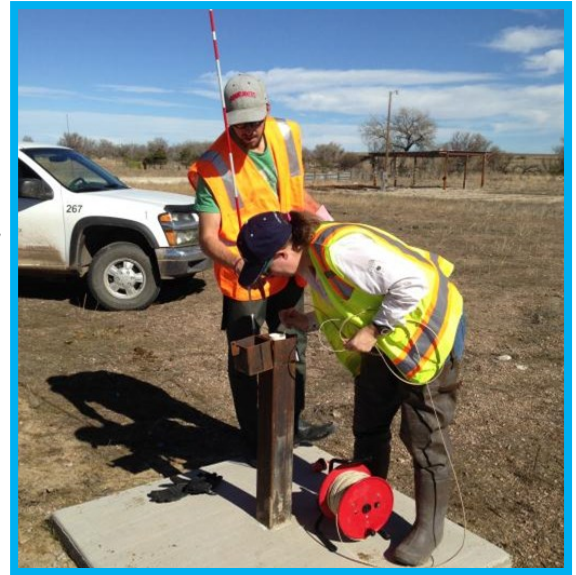
Staff Checking Monitoring Well Levels at Box Elder Well Field

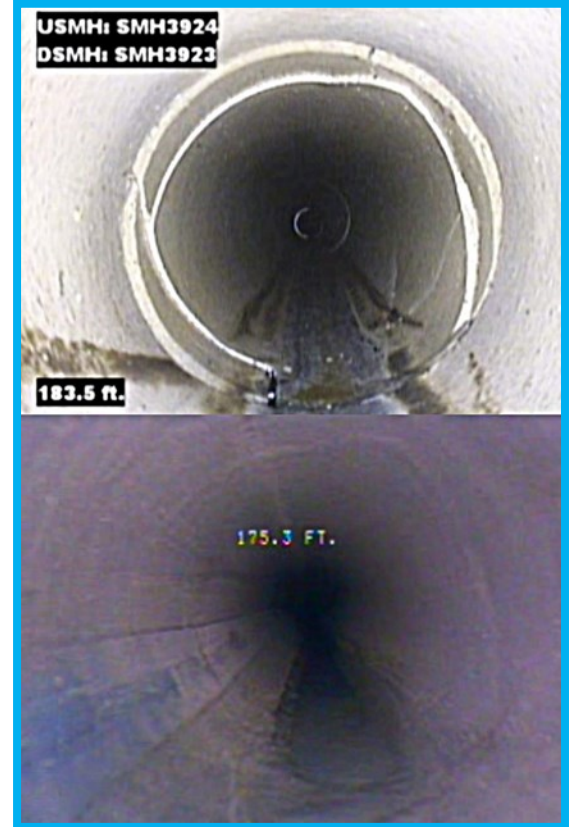
As a result of Castle Rock Water's annual sewer cleaning and video inspection program, nearly two miles of old clay sewer pipe in the Castle North neighborhood of Town was identified for rehabilitation in 2016. Sewer pipe in this area was constructed in the 1970's and had a history of root intrusion, increased annual maintenance, and pipe defects. Sewer pipeline point repairs involving street cuts and excavation of short sections of pipe were completed in 2014 on some of the most critical defects in this neighborhood. Subsequent Cured in Place Pipe (CIPP) lining of the sewer system throughout the neighborhood was planned as part of the rehabilitation process. CIPP is constructed through a process in which a resin-saturated felt tube is pulled into the existing pipe, pressurized to fit tight against it, and then cured to form a new pipe within a pipe. No digging is involved in the construction process and the new CIPP is joint-less, corrosion-resistant, and has a minimum expected life of 50-75 years.

Cracked Clay Sewer Pipe (Top Photo) and Post-Construction CIPP Lined Pipe (Bottom Photo)

A Request for Proposals (RFP) for this 2016 CIPP Project was publicly advertised in August 2016 on the Rocky Mountain E-Purchasing System. Proposals were received from three qualified contractors, and Insituform Technologies was awarded the contract in the amount of \$215,590. Construction was completed under budget and ahead of schedule in November of 2016. The newly installed CIPP liners will extend the lifespan of the existing sewer pipes, reduce the frequency of street cut sewer repairs, reduce frequency of sewer cleaning and root cutting maintenance, and reduce groundwater infiltration of the sanitary sewer system.

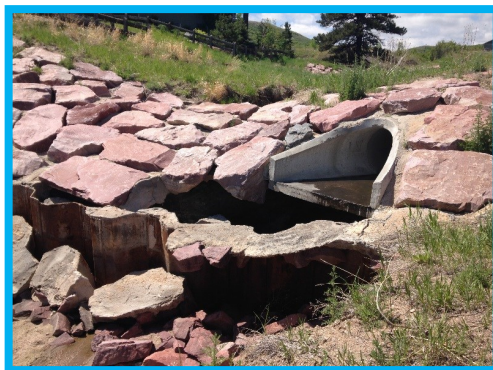
Before

In late April of 2016, the Parks Department referred a stormwater maintenance issue to Castle Rock Water from a nearby homeowner. The resident was concerned about erosion at a storm sewer discharging into the drainage channel behind their home. Upon investigation it was determined that a much more serious condition existed with a grouted boulder drop structure at this location. Not only was the whole structure in danger of collapse, but it also protected a twelve inch water main and soft surface trail fifty-feet upstream. Failure to act quickly would result in much more expensive repairs in the future, and could interrupt the public water supply.

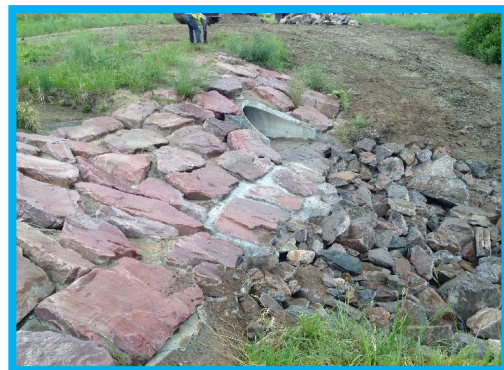
After

The Stormwater Team contracted with 53 Corporation for \$23,340 to complete emergency repairs to the structure, working closely with the contractor to determine a scope of work necessary to repair the facility and prevent more damage from subsequent rainfall events. Work began the last week in June 2016, and was completed in less than two weeks.

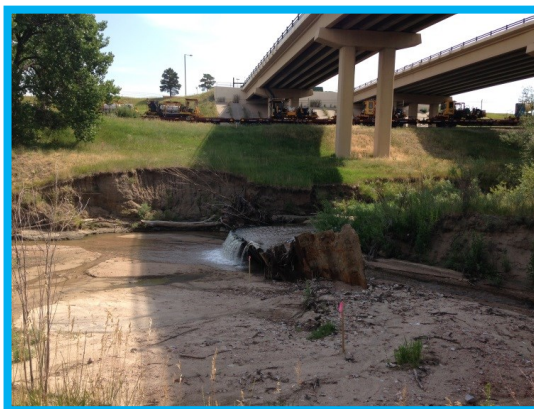
Before

Sheet pile protection across the low flow channel of East Plum Creek (EPC) was installed in 1992 as part of the 16-inch water main construction project to provide water service to The Meadows. In May 2015, Castle Rock Water became aware of a potential failure of the sheet pile. High flows along EPC in June 2015 accelerated erosion around the west end of the sheet pile causing failure of the system, which resulted in flow around the end of the sheet pile instead of over the top. The design life of the existing sheet pile was compromised due to the insufficient depth and width installed in relation to the EPC flow conditions at this location.

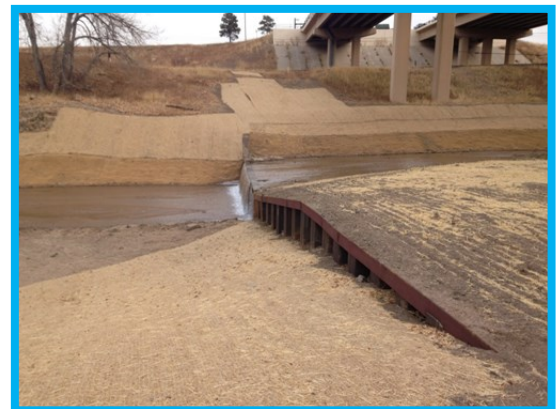
After

The total construction cost for the project was approximately \$600,000. The project was completed on budget and schedule. The Stormwater and Water Capital Reserve Funds were utilized to cover engineering and construction costs. Phase II, to be completed at a later time, includes a grouted sloping boulder grade control structure immediately downstream of the cut-off wall and is estimated to cost approximately \$300,000.

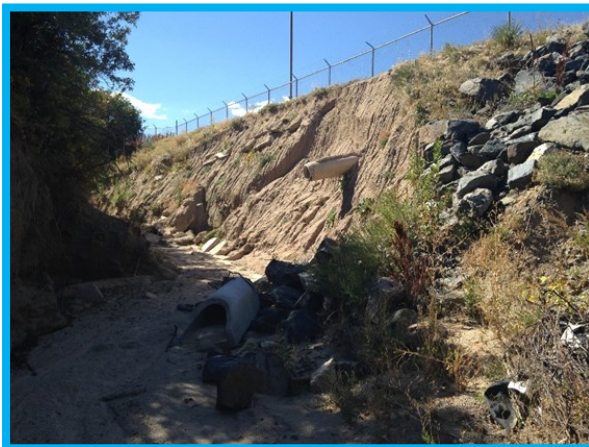
Before

Following a strong storm event that produced some localized flooding in this area, the property owner at 840 Topeka Way alerted the Town to a serious bank erosion condition within the channel behind the business. The channel bottom had dropped several feet over the years at this location, and a section of the site detention pond discharge pipe had separated and dropped into the drainageway, with a second section close to falling also. With our recent experience constructing a similar project on Omni Tributary several months earlier, repair plans were made.

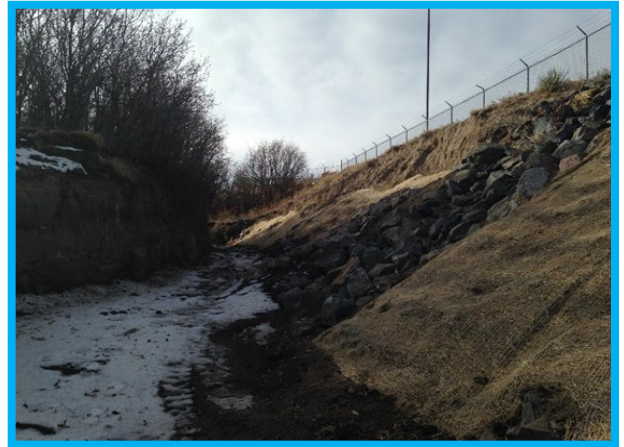
After

Due to limited access to the work area, a right of entry agreement was reached between the Town and the owner of the property on the south side of Industrial Tributary, which is currently vacant land proposed for commercial development as Millers Landing. Notifications were sent out to Traffic Control West (complainant) and neighboring property owners in late October 2016, and repairs were completed by the Stormwater Field Services Team over the following two weeks. Repairs included reclamation of the site following construction.

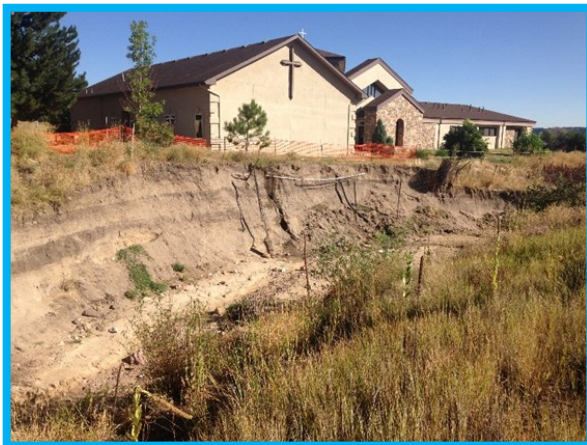
Before

The project is located adjacent to Epiphany Lutheran Church, at 550 Wolfensberger Road, with a near vertical stream bank encroaching to within 25 feet of the church's main building. After being alerted by the church to the dangerous condition that had developed as a result of heavy early spring rain events, the Stormwater Engineering Team responded by designing emergency repairs to stabilize the slope and prevent any further damage from occurring.

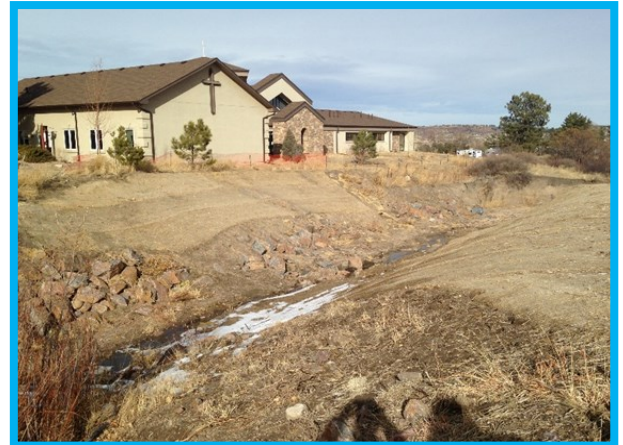
After

Notifications were sent out to the church and neighboring property owners in late April 2016, and repairs were completed by the Stormwater Field Services Team over the following two weeks. Subsequent reclamation of the site was accomplished under contract by Apex Companies as part of the 2016 Reclamation Project.

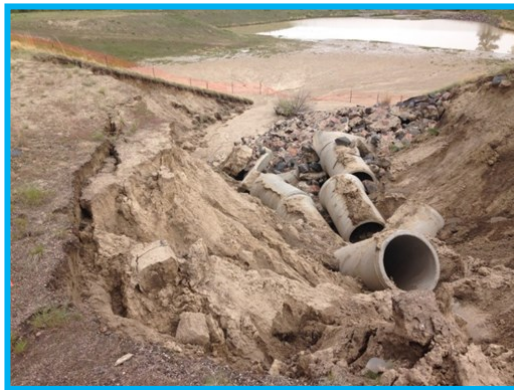
Before

In July 2014, the Town became aware of a failure at a grouted rundown at the south-east corner of the regional detention pond in Heckendorf Ranch, Filing 1. Subsequent storm events caused a complete failure of the rundown, leading to the unraveling of approximately seventy feet of dual 42-inch reinforced concrete pipe (RCP) storm sewer outfalling to the rundown. Although the specific cause of failure is unknown, it appears that surface water intrusion on the underside of the rundown structure created a void that eventually collapsed the system over time.

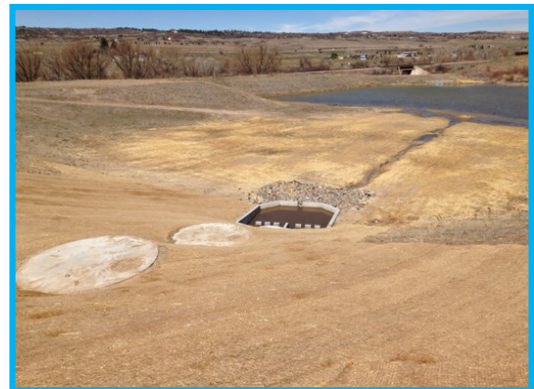
After

The Town consulted with EMK Consultants, Inc. to provide design support, and underwent a thorough review of alternatives to ensure that the replacement system is sustainable for the life cycle of the utility installation. Three alternatives were analyzed for reconstructing the outfall and rundown. A fully piped option that included a single 54-inch RCP storm sewer constructed to the bottom of the pond was selected as the most suitable and cost effective alternative. Also constructed were storm inlets at the top of the pond to capture and convey overland sheet flow to minimize future erosion on the pond embankment, and a concrete forebay at the pipe outfall to improve water quality within the pond.

Sabell's Enterprises, LLLP was awarded the contract to construct these improvements, which were completed in April 2016. The total construction cost for the project was \$247,000. These improvements were closely coordinated with the Fire Department and were designed to support the future fire station on the site above the failure area.

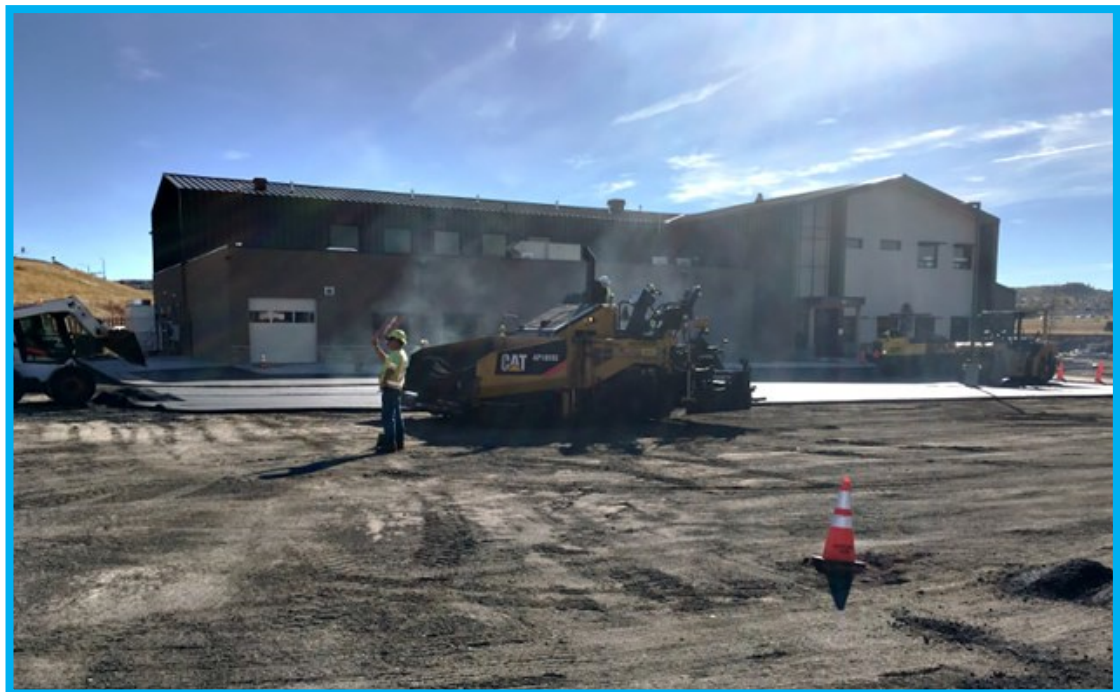
Castle Rock Water Operations staff moved into the newly constructed Operations and Maintenance (O & M) Facility in February 2016. Recycled asphalt millings were temporarily installed around the building near the end of construction. Money was budgeted in 2016 for upgrading the pavement to asphalt around the building. Public Works and Castle Rock Water staff teamed up in August to solicit bids from paving contractors that have completed previous work for the Town. PLM Asphalt and Concrete was awarded a contract in the amount of \$230,000 for paving more than 5,000 square yards of 6-inch asphalt on the north, west, and south sides of the facility. The contract also included installation of new concrete pads, sidewalk, and curb and gutter around the O & M Facility and elsewhere on the site. Pavement construction was completed on time and under budget in early October. After paving was finished, Public Works completed striping the parking lot. The new pavement improved staff and public safety access to the building, and also reduced tracking of mud into Castle Rock Water facilities. It also helps keep Town and personal vehicles cleaner. The area east of the O & M Building may be paved in the future.

Asphalt Work at the O & M Building
