2016 Water Demands

CASTLE ROCK water 2015 - A LOOK BACK

Securing our future drop by drop

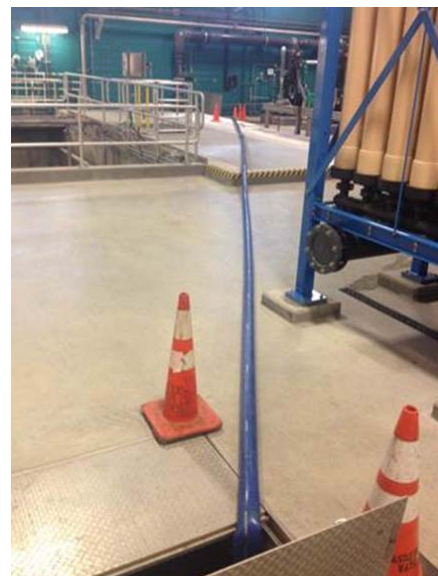
Pumping down the membrane feed well

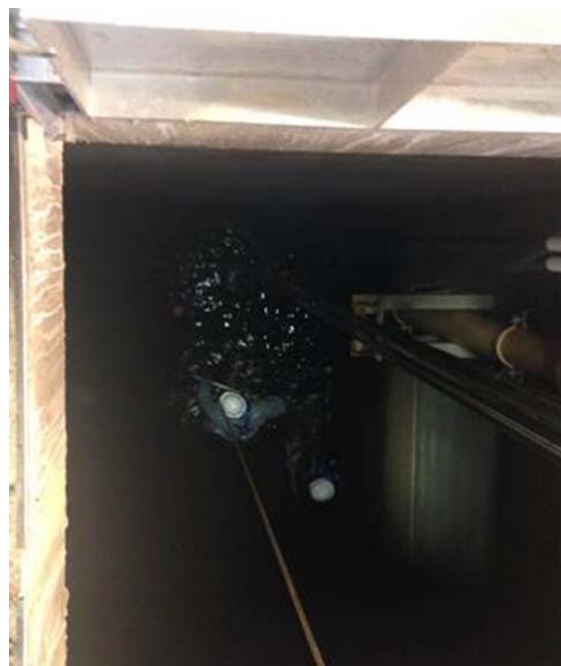
Removing sediment from the recycle basin

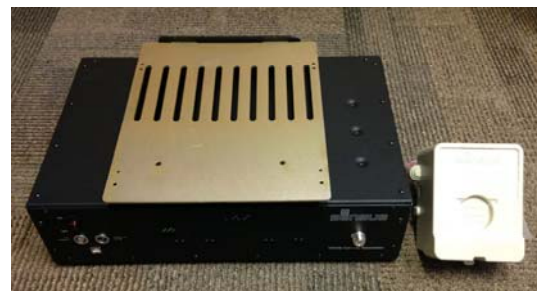
This picture depicts the new equipment being used for meter reading. The equipment on the left is a vehicle gateway base (VGB) station and is mounted in the trucks and used to collect monthly meter reads. The small white box on the right is mounted on the side of the house and sends radio signals to the VGB.

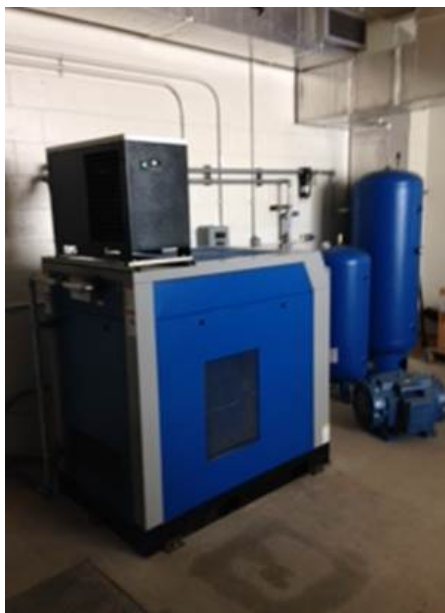
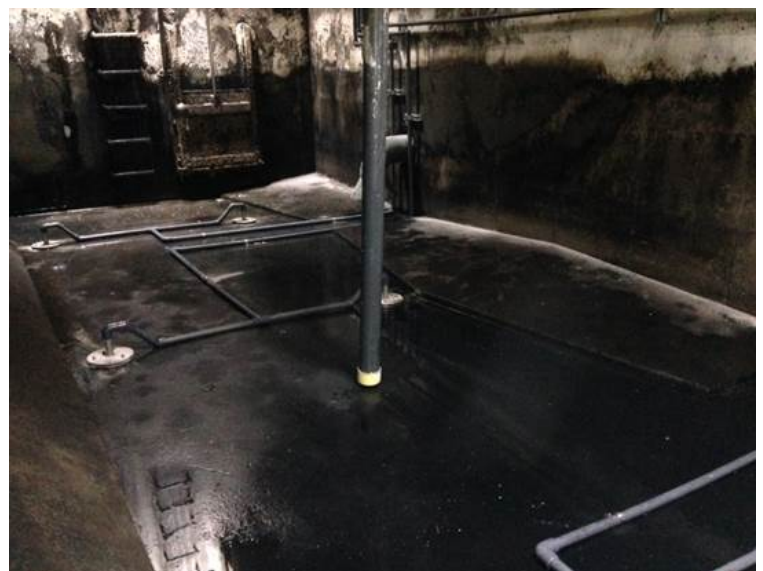
Plant mechanics, working with collections staff, installed a new mixer to prevent grease balls from building up inside the wet well. At the Mitchell Creek lift station. The pictures below shows the compressor and wet well diffusers.

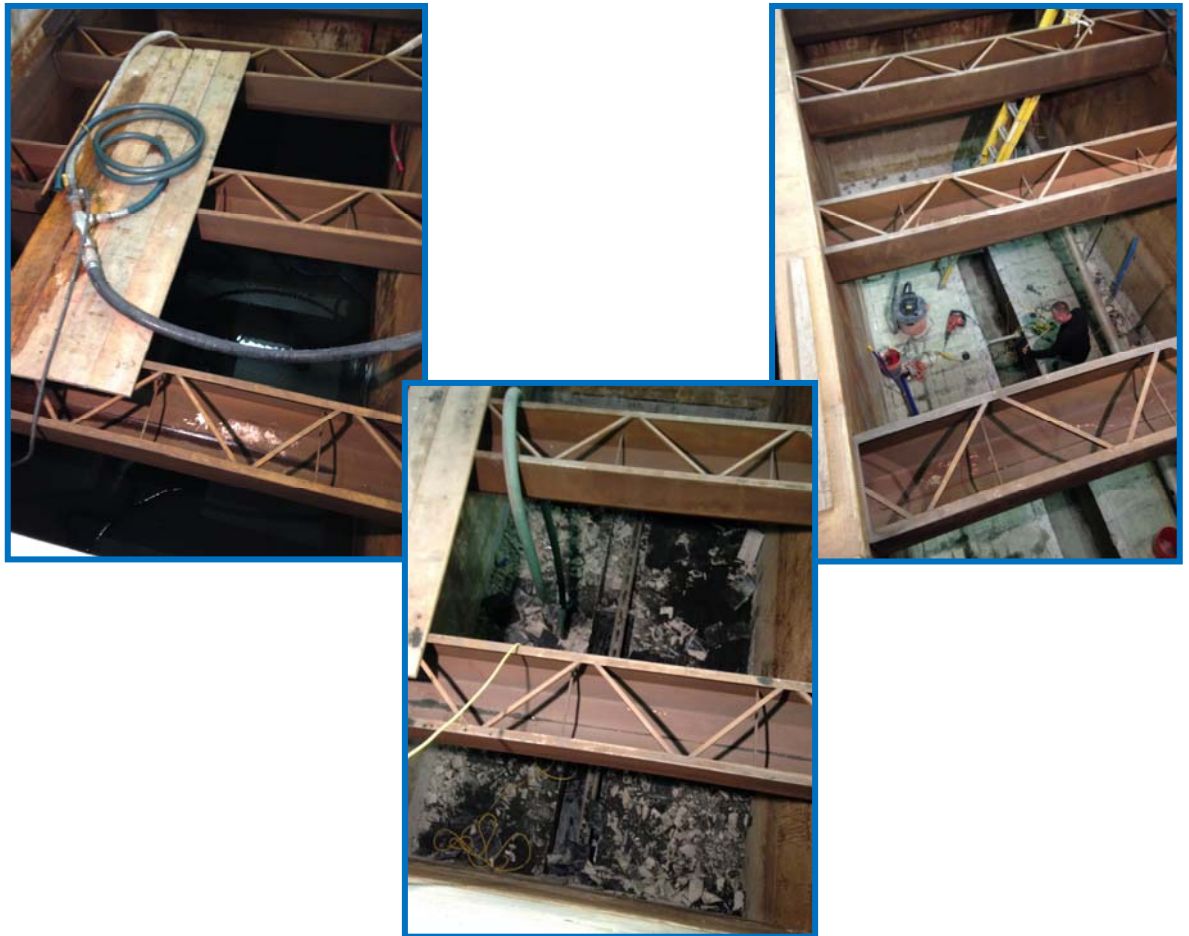
Showing three stages – vacuum media out, demo underdrain & remove, and prepare base, filter gullet and air scour piping for new underdrains.

The filter underdrains installed during construction of the Ray Waterman Regional Water Treatment Center (RWRWTC) in 2005 were a plastic material with slotted openings on top. During normal operations filtered water collects in the underdrain, is then conveyed through piping to the clearwell, and is ultimately pumped into the water distribution system.

Installed directly onto the plastic underdrain assemblies were seven layers of varying sizes of graded gravel. The gravel base layers were to support the overlaying filter media (greensand and anthracite) and prevent smaller filter media from passing through the slots of the plastic underdrain. In years 2010 & 2013 the Operations Team (with significant effort) cleaned a total of about 21,500 pounds of filter media out of the clearwell. The media and underdrain systems were not functioning in an optimum manner.

Utilities contracted with AWI-Anthrtec to remove the existing media and all the plastic underdrain systems, then install new stainless steel underdrains for all eight filter beds. The steel underdrains are fabricated with laser cut slits that allow filtered water to flow through but will retain all media (no gravel base layer needed). Construction started in November 2015 and will be complete by May 2016. The AWI contract was for \$553,000.

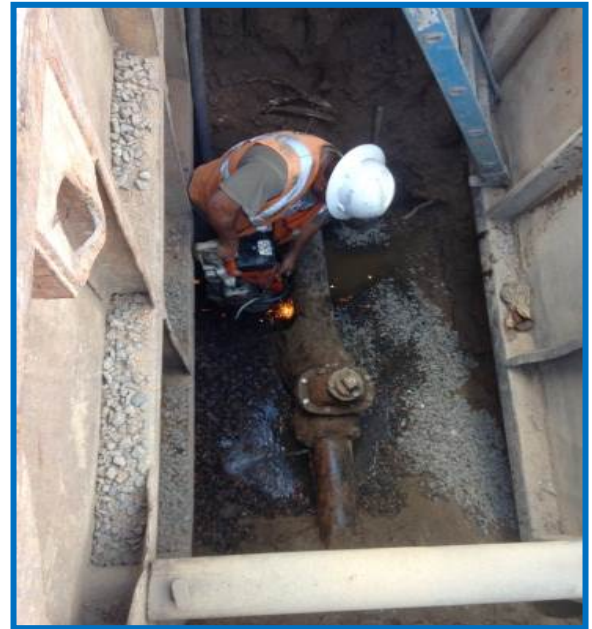
Cutting valve out to install new valve

The Castle North Valve Repair Project was initiated in 2013 to repair valve components that were failing due to corrosion, reducing operational readiness and with the potential to cause significant property damage. The water main valves in the Castle North Area had shown a high rate of failure upon operation. In 2013, the first phase of the Castle North Valve Project repaired 29 critical main line valves in the neighborhood. Another 36 main line system valves in the area were repaired during Phase 2 in 2014. The previous repair projects proved to be timely - a water main break on Oakwood Drive in early 2015 was more easily managed due to the repairs completed over the previous two summers. Phase 3 of the valve repair project involved the repair of the remaining fire hydrant guard valves in the area and the replacement of six valves that had failed recently due to their age. The total cost for this Phase 3 of the project was \$172,000. The total cost for all three phases was \$392,000. All work was completed within budget and on schedule.

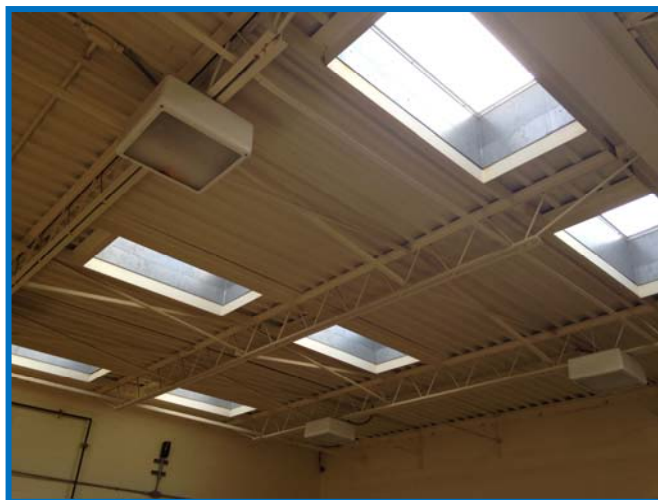
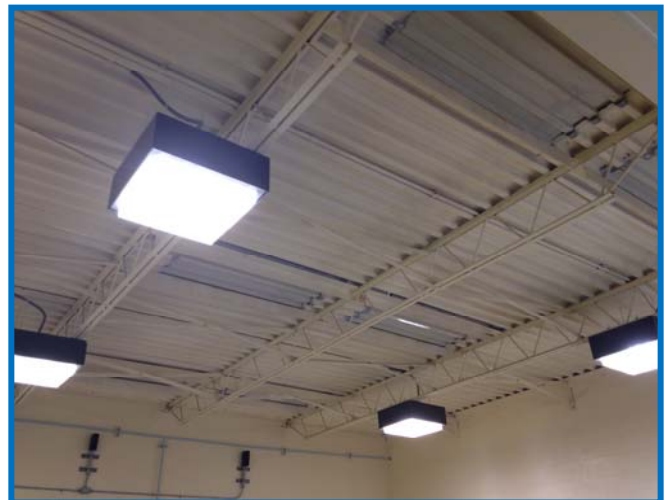
Pictures showing the many skylights in the filter bay at Meadows WTP before the new roof – most were leaking

Meadows Water Treatment Plant (MWTP), placed into service in 1987, is one of the Town's older treatment facilities. The facility, expanded in 2003, has a treatment capacity of approximately 8.0 million gallons per day (MGD). The roof over the original building had skylights that were leaking. Staff contracted with Douglas Colony Roofing to remove the skylights, an unused roof access hatch, replace roofing membrane, and install sufficient new ballast to meet current building roof requirements. This important project was completed for \$47,263.

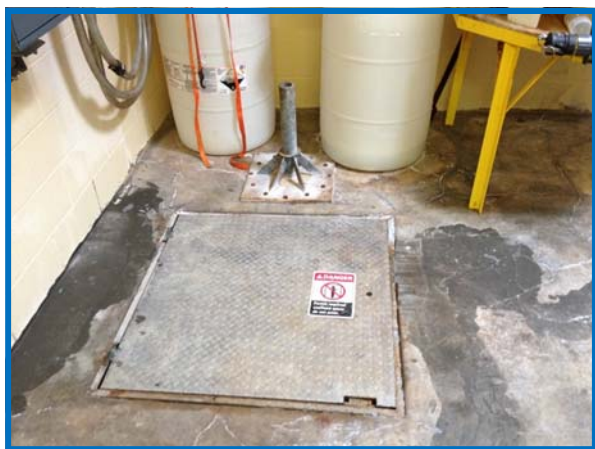
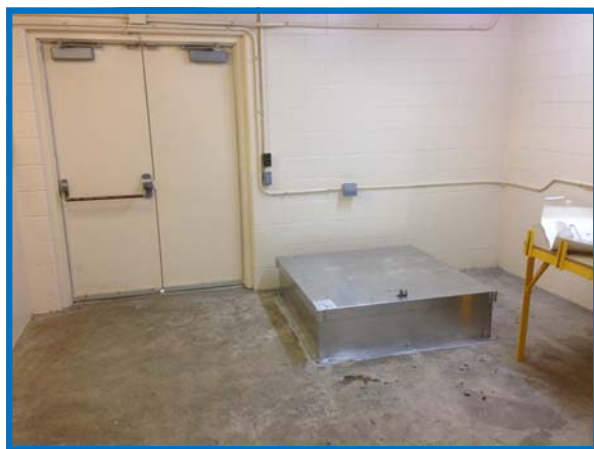
Before and after photos of the hatch and freshly painted walls

The Founders Water Treatment Plant was built in the mid-1980's and was in need of some repairs and rehabilitation. Engineering and Operations staff worked on various improvement projects. Door hardware was replaced on doors that were no longer closing well. Painting was done to freshen up the walls. Old, inoperable basin hatches were replaced. Staff contracted with Coblaco Services to line the equalization basin - the basin leaked and the leaks damaged the exterior stucco of the building. Staff also contracted with Stonhard Services to recoat the chemical room floor that was stained and pitted from years of normal operations. The equalization basin lining, chemical room floor coating and new hatch were completed in 2015 for \$46,985.

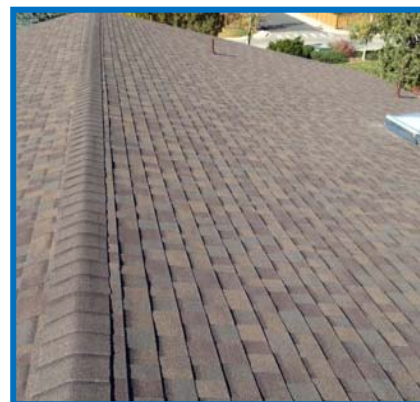
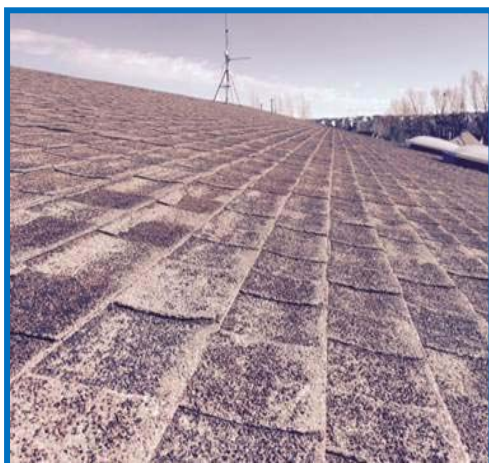
Before and after photos of the new roof at Founders Water Treatment Plant

The Founders Water Treatment Plant was constructed in about 1987. This plant was designed to treat Denver Basin groundwater and has a capacity of 3.45 million gallons a day. It is a critical part of the Town's water system. Roof replacement was completed in 2015 on budget for \$12,962.

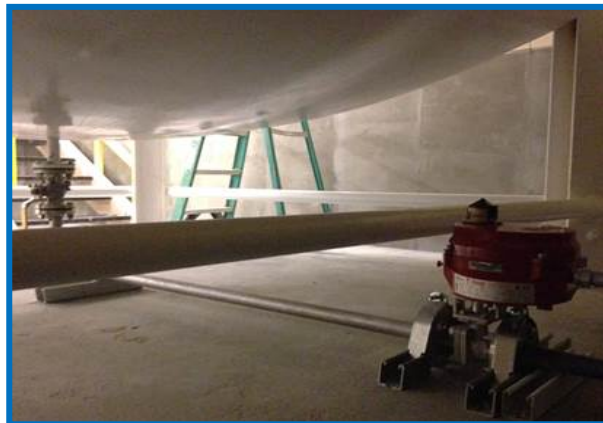
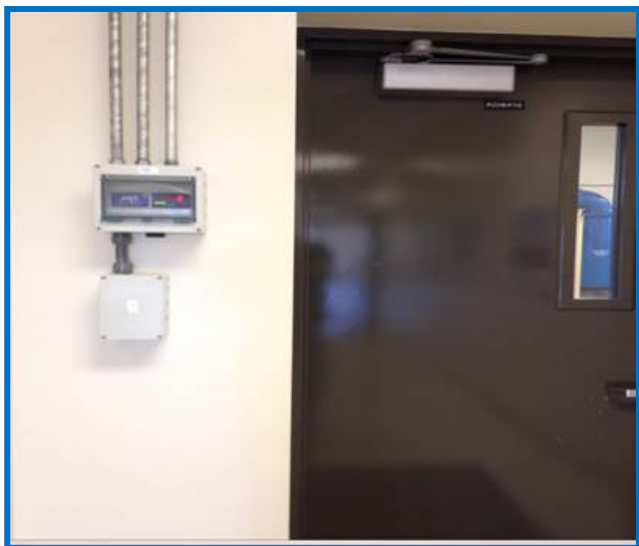
Operations and Supervisory Control and Data Acquisition (SCADA) staff installed stainless steel piping and automatic isolation valves, that shut the chemical feed off in the event of an ammonia leak on the 10,000 gallon ammonia storage tanks. Stainless steel piping provides stronger piping to contain the aqueous ammonia. The automatic isolation valves are tied to the permanently mounted gas detectors that monitor the atmosphere for an ammonia leak. Two new gas detectors were installed in the hallway outside the chemical storage room and in the main bay above the ammonia injection point. This provides plant operators improved warning of an ammonia gas leak. SCADA personnel installed the new gas detectors.

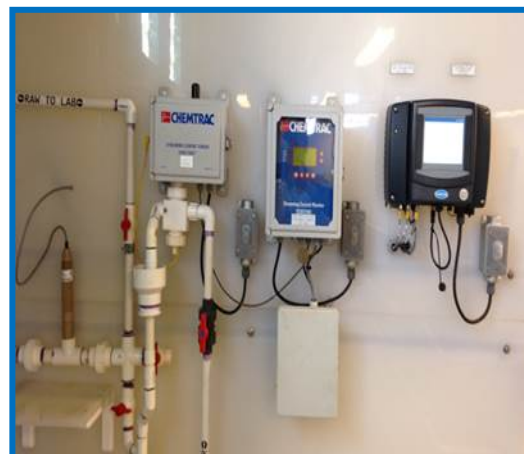
Interface Module and pH Probe

New Hach turbidity analyzers used for state water quality reporting provide the treatment operators with more precise nephelometric turbidity unit (NTU)¹ resolution for improved process control. A new Hach ORP sensor, four pH sensors and the interface modules used to connect the sensors to SCADA were also installed for improved process control. This work was completed at a cost of \$21,809.

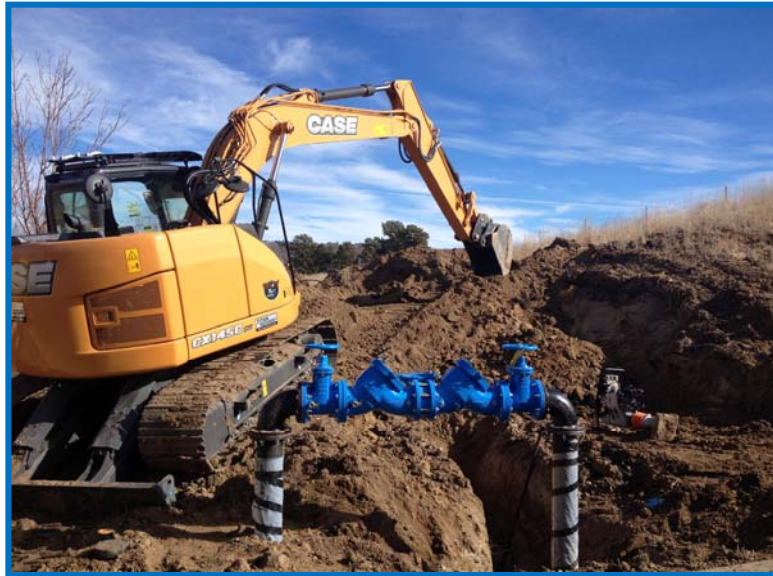
Contractor making the connection between the potable water line and the raw water line back to the injection wells. The potable water is protected from cross-contamination by the blue backflow preventer shown in the photo.

Aquifer Storage and Recovery (ASR) is the process where treated renewable water is injected via wells into subsurface aquifers, and stored to be recovered in the future through well pumping. A well field in The Meadows development was selected for the pilot testing of this technology. Inspection of the wells demonstrated that a thorough cleaning and rehabilitation was needed, which was completed in May of 2014. That phase was followed by the equipping phase, completed over the summer of 2014, which involved the installation of special flow control valve (FCV) systems that allow operators to either inject potable water down into the aquifers or pump water from the wells to meet water system demands. Concurrent with the fieldwork, staff worked with the Federal and State regulators on the permitting process. Final permits were received in December 2014.

The construction project was awarded to 53 Corporation to connect buried raw well water piping to the treated potable water distribution piping, and to install a backflow preventer to protect the potable water system from any untreated water. Construction began in January of 2015 and took about a month to complete. Once completed, staff implemented pilot testing of the ASR process in both wells. The pilot testing involved conducting repeated cycles of injection / storage / and recovery in the aquifer over increasing time periods to measure effects on the aquifer water level and water quality.

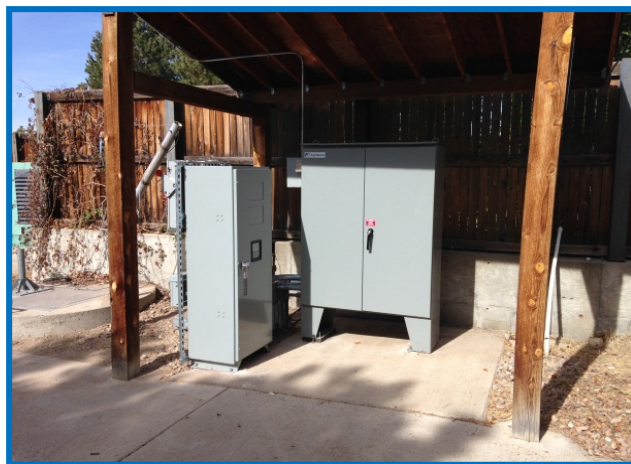
New Control Panel

The Meadows 5 Lift Station is approximately 27 years old but is a key part of our sewer collection system. The original panel was modified and upgraded a number of times over the years; however, most of the electrical equipment in the cabinet had reached the end of its useful life, was archaic and had limited communications with the Town's Supervisory Control and Data Acquisition (SCADA) network. The Town selected Velocity Plant Services for the replacement of the panel. The lift station had to remain operating during the panel replacement as the sewer system for our customers in this area cannot be shut down, even temporarily. The project team developed a plan to keep the lift station pumps operating with temporary power during the new panel installation. The panel installation took five days to complete. The total cost for this project was \$43,000.

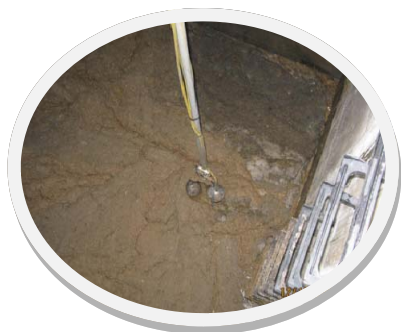
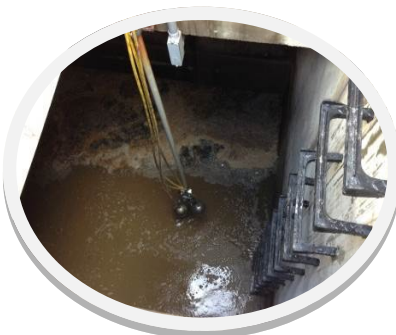
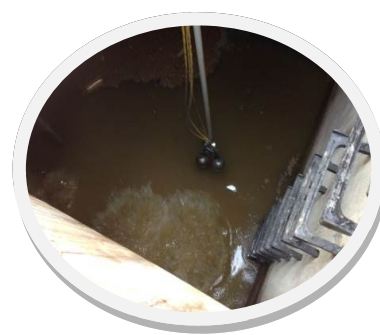
Before start-up

1 hour after start-up

24 hours after start-up

The Mitchell Creek Lift Station is located in the Founders Village subdivision and is responsible for pumping the wastewater generated in the Founders Village and Castlewood Ranch subdivisions into the gravity sanitary collection system. This facility has had an ongoing issue with fats, oil and grease (FOG) (for more information on FOG and keeping it out of the collection system, visit <http://www.crgov.com/faq.aspx?qid=280>) and solids accumulation within the wetwell. The solids material is able to separate from solution and float to the surface between pumping cycles, where it conglomerates into a solids sludge mat. Once this material separates from solution and forms a mat, it cannot be pumped out of the wetwell. This material has to be manually broken up, worked back into solution, and the wetwell continually pumped down in manual mode until the blanket is gone. This requires a crew of three, a fire hose, and a vacuum truck for approximately four hours each time. With labor and equipment, the cost for each cleaning is approximately \$1,000. The estimated annual cost to remove this material is approximately \$24,000. Installing a mixing system eliminated this labor-intensive process and will pay for itself in less than two years. The total cost for this project including labor, equipment and materials was \$48,365.

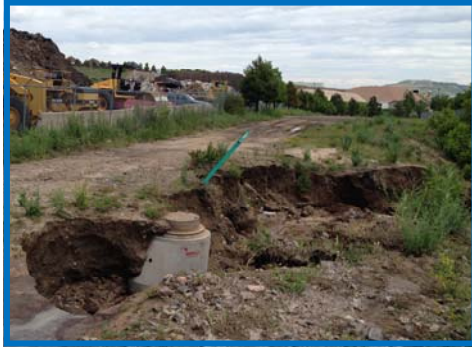
A sanitary sewer manhole was exposed along the north bank of Industrial Tributary. The utility was backfilled and protected using rock riprap. A channel realignment project is scheduled for 2016. The estimated cost of this future work is \$300,000.

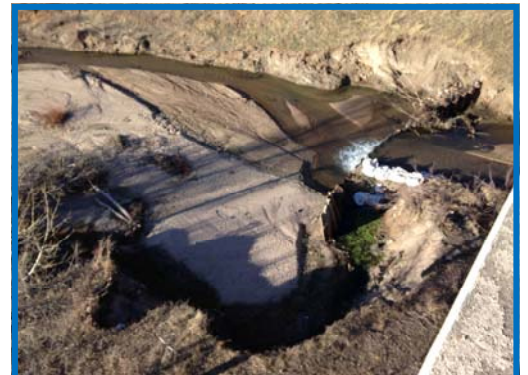
In 2015, high flows along East Plum Creek (EPC) caused the failure of a sheet pile cutoff wall protecting a 16" waterline. Town crews mobilized quickly to place large sand bags between the sheet pile and eroded bank to redirect flow back over the top of the sheet pile in an effort to maintain stream bed cover over the water main. A new sheet pile cutoff wall spanning the entire width of the 100-year floodplain is scheduled for construction in 2016. The estimated cost of this work is \$550,000.

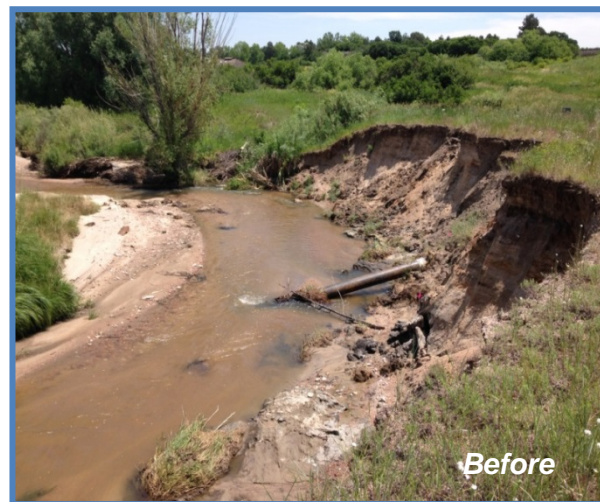
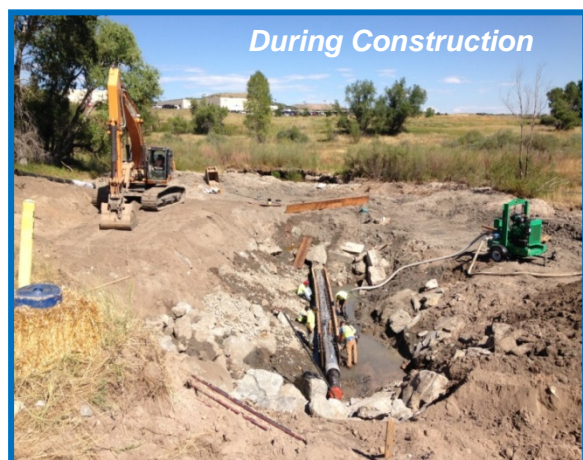
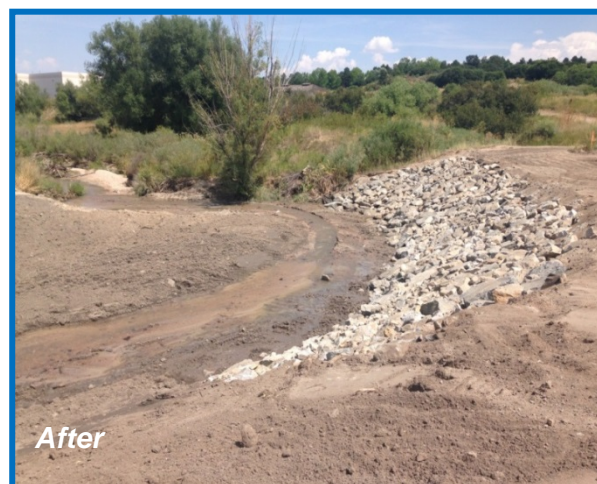
In May 2015, the Town became aware of an exposed potable waterline crossing East Plum Creek (EPC) at the Town's South Well Field, near the end of South Perry Street. The water line was originally constructed in the late 1980's with adequate cover and concrete encasement around the section of water line located under the EPC low flow channel alignment at the time. Over the past 20-30 years, the low flow channel has migrated further east. Higher than normal flows within EPC due to storm events resulted in bank erosion, and exposure of the shallower, un-encased section of water line.

The emergency repairs included removal and replacement of approximately 140 LF of water line in order to lower the line below the current streambed elevation. Additional concrete encasement was also constructed to provide protection for the replaced section of water line. Once the water line improvements were completed, the eastern bank was re-graded and riprap protection was placed along the bend to prevent future erosion.
