# CASTLE ROCK WATER

## JULY 2026 MONTHLY REPORT

## East Plum Creek Reach 5 Phase II Stabilization Project

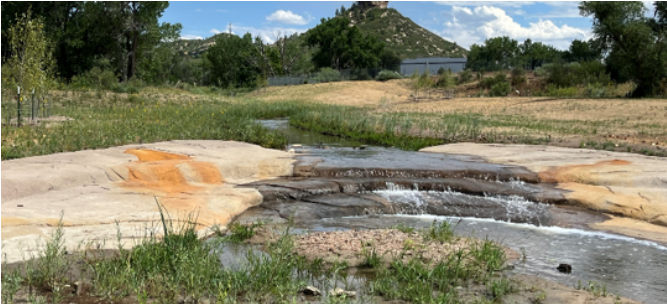
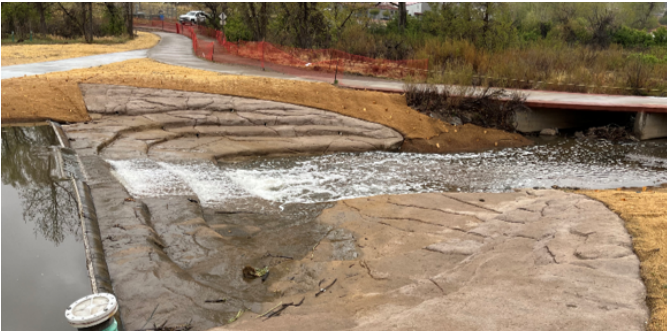
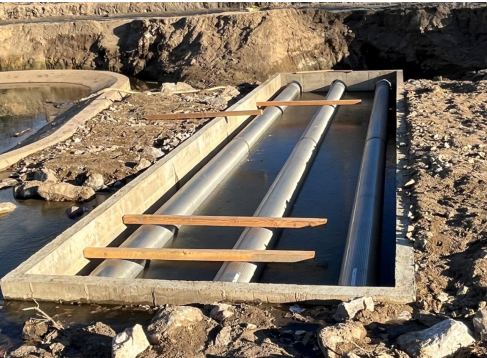
**Reducing** stream velocities and improve channel stability

by constructing two sculped concrete drop structures and installing extensive rip rap protection.

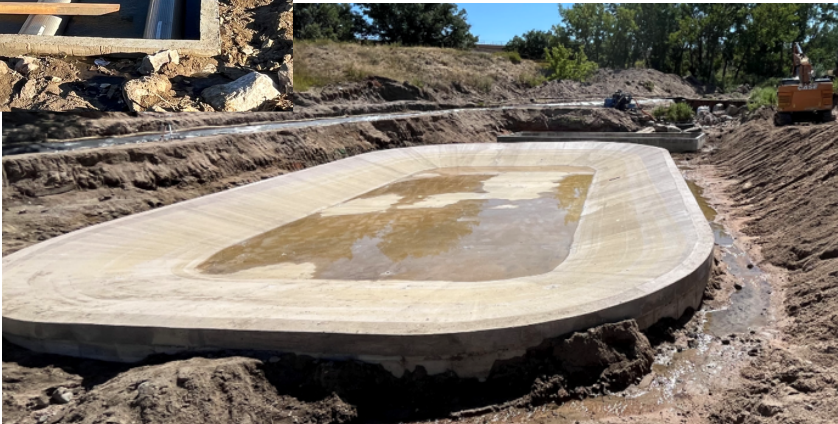
**Improving** the CR-1 diversion facilities through construction of a new infiltration gallery and

sediment basin, providing additional reliability for the Town's water rights operations during varying stream flow conditions.

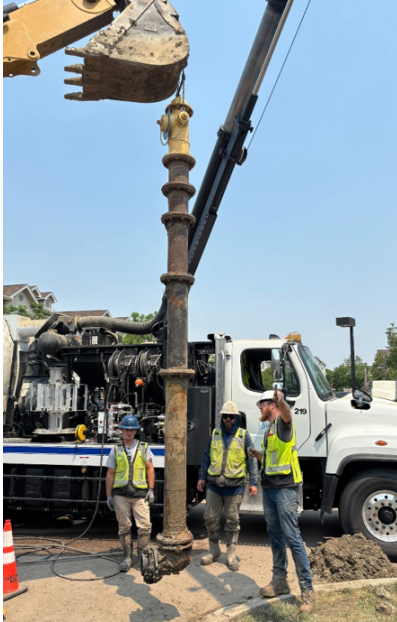
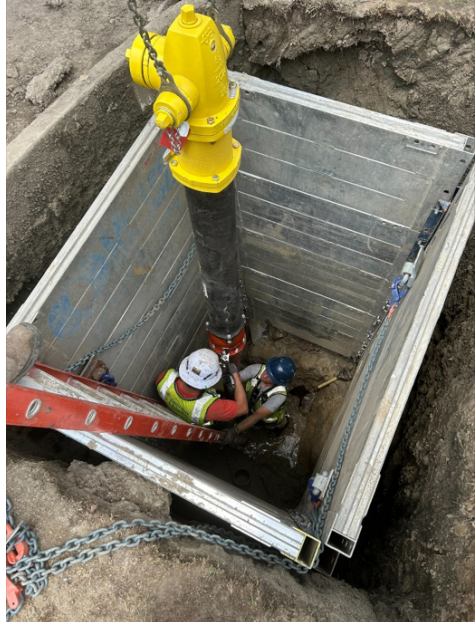
The Distribution team repaired an out-of-service hydrant in the Black Feather Apartment complex that had four extension couplings, which made it inoperable. The team had never installed a vertical show fire hydrant before, so this made the repair a fun challenge, especially given the work needed to be done at a depth of approx. 14 feet. The key advantage of a vertical show fire hydrant is that it brings a deep-buried hydrant up to grade without extension couplings, while maintaining a six-foot bury depth, making the hydrant more accessible for service.

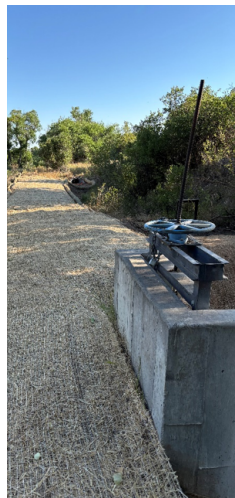
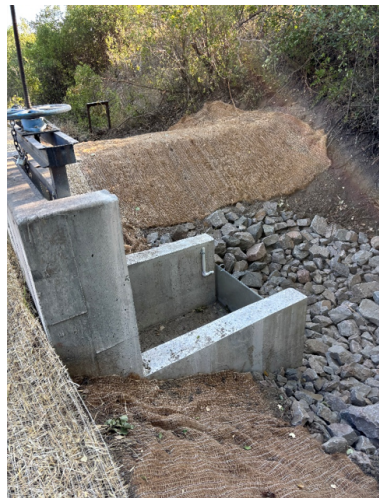
The Stormwater and Raw Water teams successfully completed the Meadows Ditch project by installing a weir plate and cutting out concrete panels in support of the Water Resources team. This collaborative effort enhanced the site's infrastructure and provided the necessary improvements to support ongoing water resources operations.

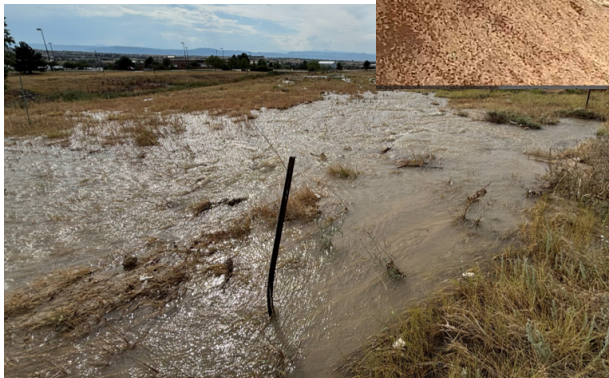
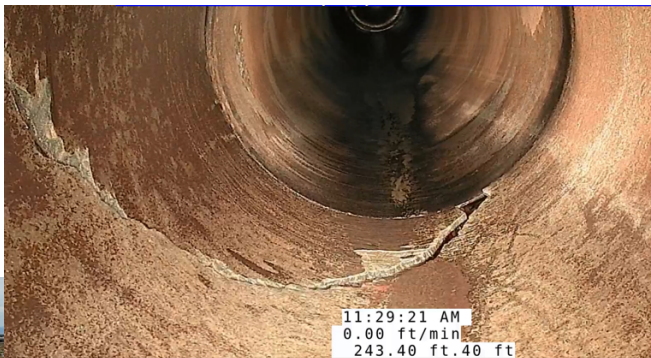
There was a leak on a 16" water main that runs under I-25 near Front Street and Sam Walton Dr. The valve was isolated, and repairs were made by a contractor.

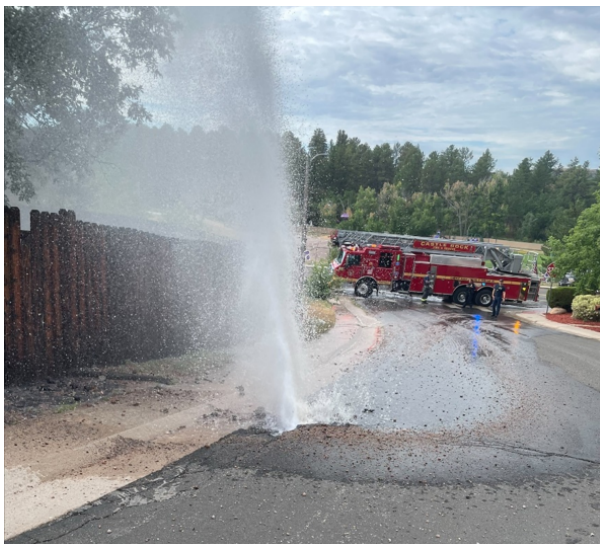
There was a water main break on Moore Drive. The break was caused by a corrosion hole on top of the pipe. A 12-inch repair clamp was used for the repair. There were 18 homes with lower-than-normal pressure for 3.5 hours.
