CASTLE ROCK WATER

FEB 2026 MONTHLY REPORT

Castle Rock Completes System-Wide Water Quality Maintenance

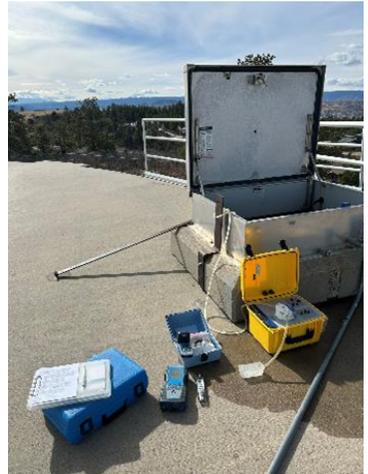
Testing kit at one of the storage tanks.

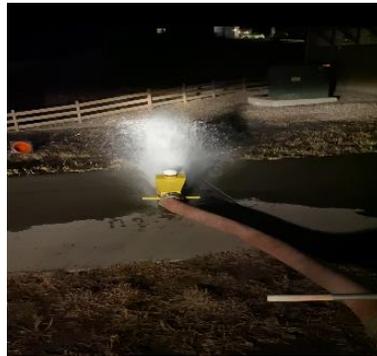
Nighttime flushing

- 493 fire hydrants flushed (Feb. 2 to 13), with several chlorine residual samples taken from each location to ensure water quality and completion of the flush
- 12.2 million gallons of water used for flushing and tank draining
- Over 300lbs of de-chlorination tablets were used during the flushing
- 308 water quality samples collected
- 53% of monthly bacteriological samples collected specifically in flushing zones (exceeding CDPHE requirements of 30–40%)
- 150 customer inquiries received

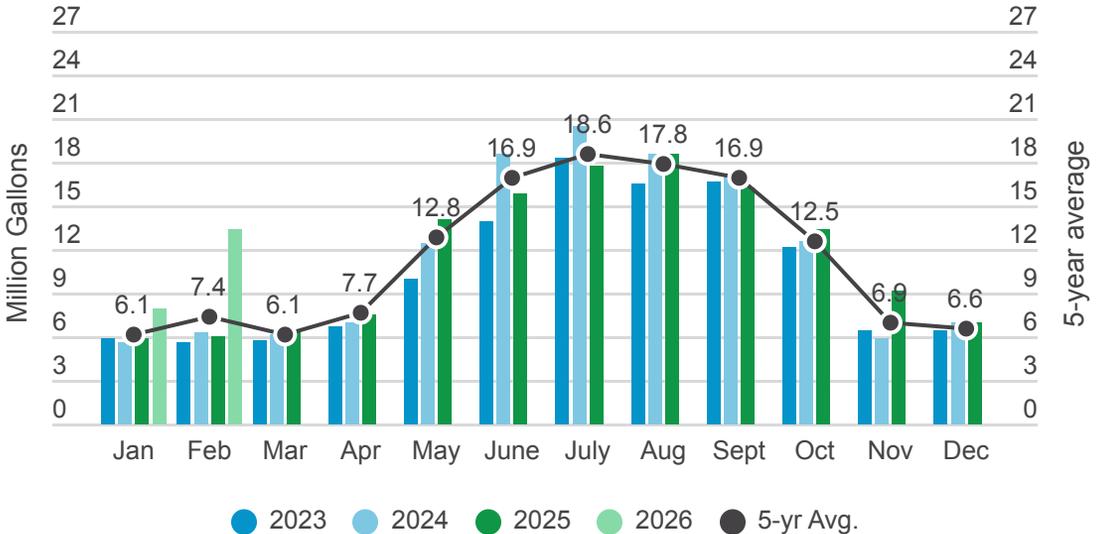
DAILY MAXIMUM DEMAND¹

- 13.4 million gallons/day (MGD)
- 5-year average: 7.4 MGD
- 82% higher than the 5-year average

MONTHLY DEMAND ¹

- The water demand total for February was 184.2 million gallons (MG) [565.3 acre-feet (AF)]
- 9% lower than the January 2026 total of 201.8 MG
- 19.6% increase from the previous year's February 2025 demand of 154 MG

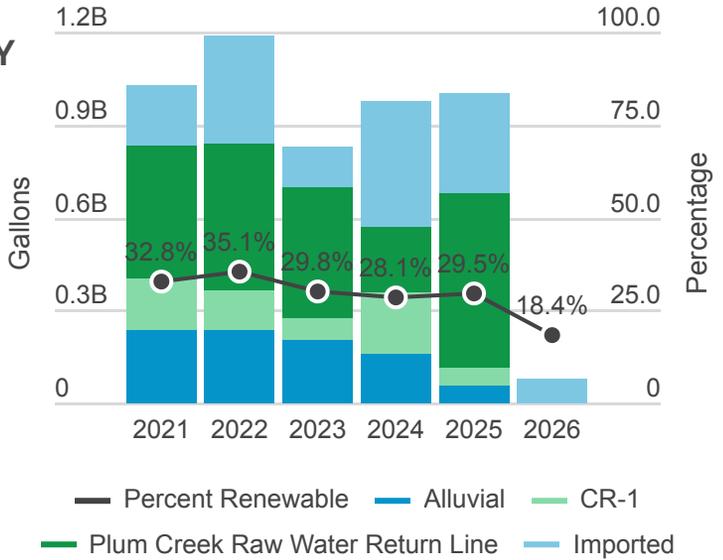
In total, renewable supplies accounted for 28.9% of the total water supply for the month (49.5 MG of 171 MG) and 23.7% of the annual water supply (80 MG of 336.9 MG)

- The CR-1 diversion produced an average of 0.0 MGD²
- The PC diversion produced an average of 2 MGD
- The 14 alluvial wells produced an average of 0.0 MGD²
- The renewable water production average was 1.77 MGD

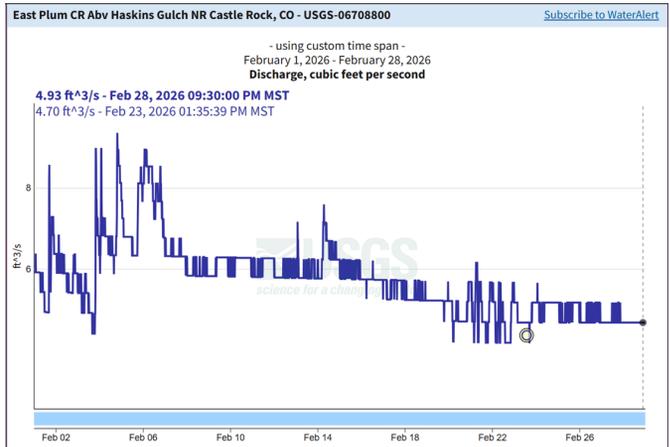
The hydrograph indicates the estimated flow in East Plum Creek basin.

- Flows ranged from 4.6 to 9.7 cubic feet per second (cfs)
- The monthly average streamflow was 5.8 cfs
- The 25-year mean is 7.2 cfs

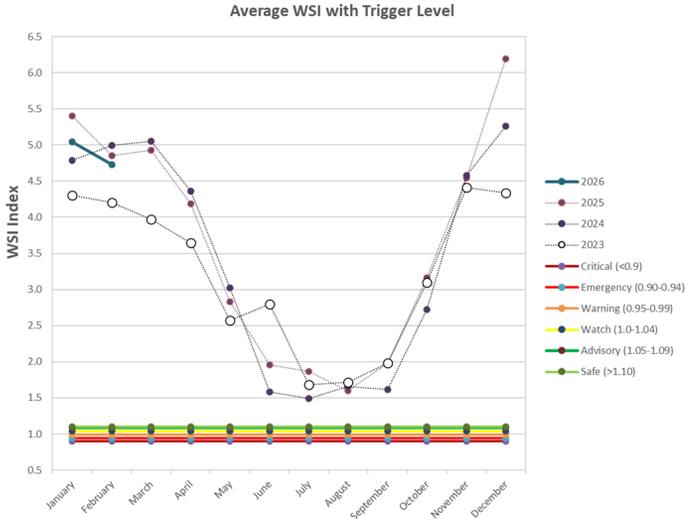
The Town of Castle Rock's Drought Management Plan uses a Water Supply Index (WSI) for the Town that accounts for local conditions relative to the Town's capability to address our water resources and daily water demands. Anything below 1.1 will trigger a drought stage relative to its severity.

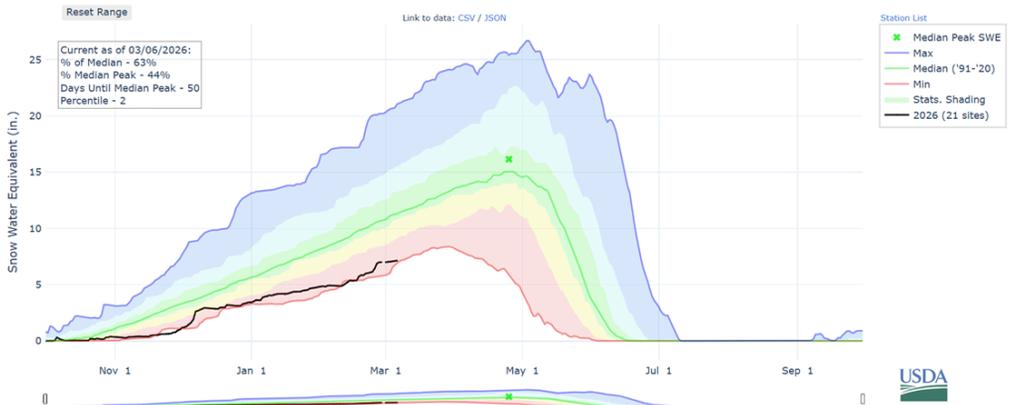
SNOW WATER EQUIVALENT IN SOUTH PLATTE

- Year-to-date precipitation at 73% of median
- Snow Water Equivalent (SWE) at 63% of median

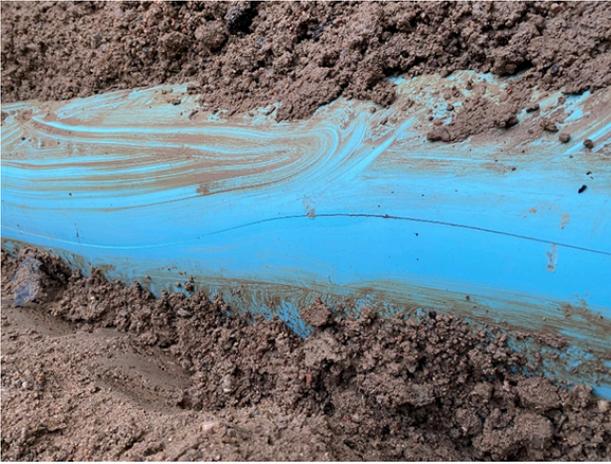
There was a leak on a fire suppression line on Ridge Trail Lane. Staff worked alongside our contractor to complete the repair. Eleven homes experienced less than normal pressure for three hours.

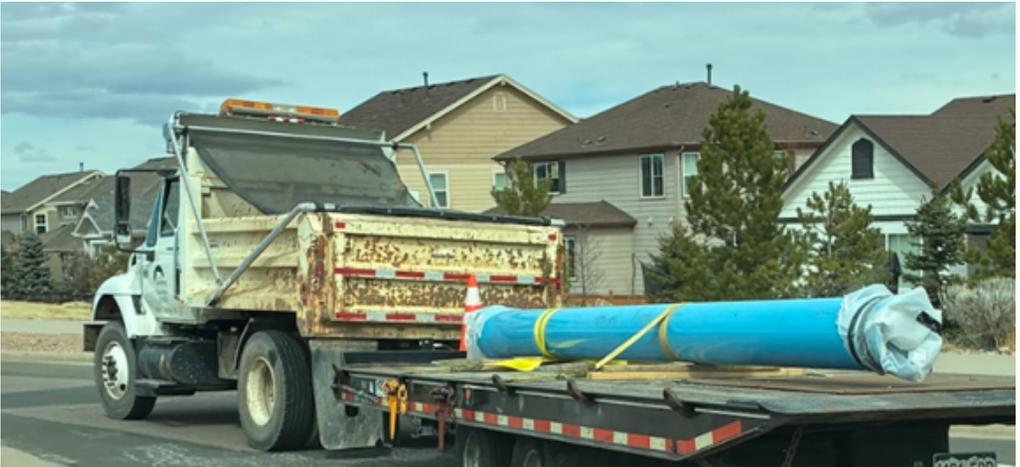
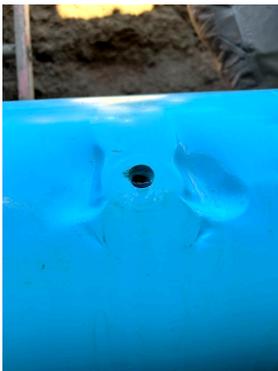
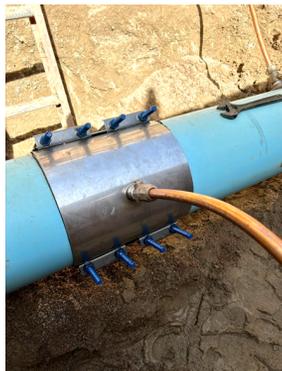
There was a second water main break on Sabino Lane less than 24 hours after the first. The team found two broken saddles. Ten homes were without water for 6 hours.

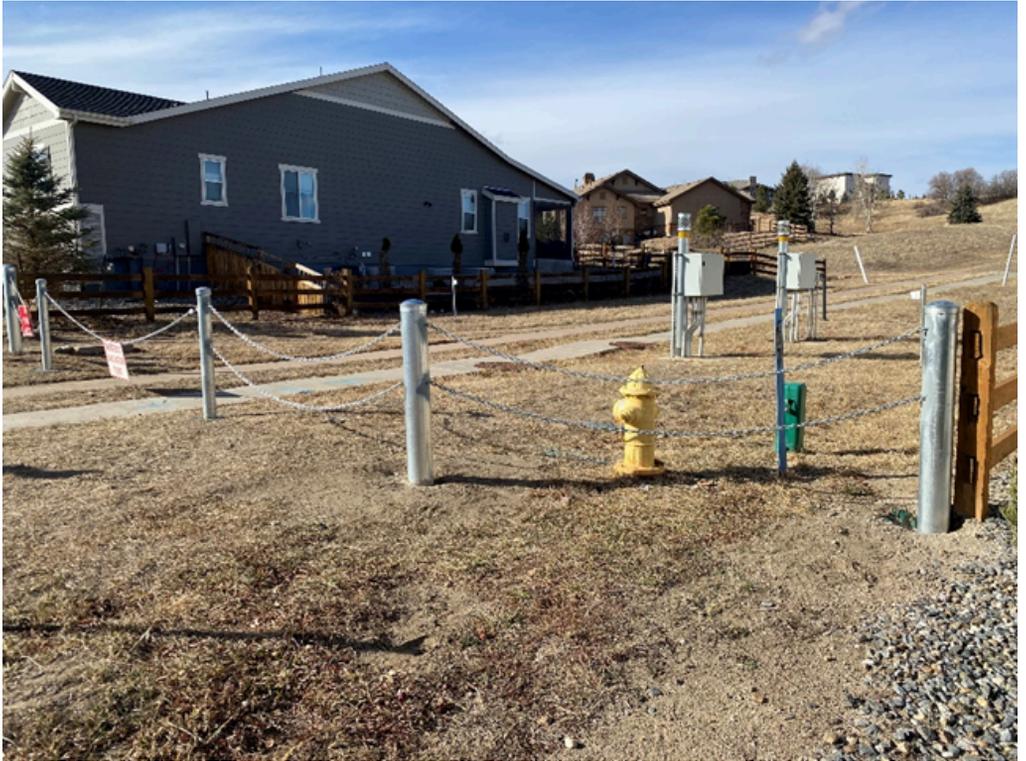
Protecting Critical Infrastructure

Plant Maintenance identified a serious issue at the Pinery Interconnect after discovering the site had lost power. This location's power is directly tied to the reliability of critical water infrastructure. The interconnect allows CRW and Pinery Water to exchange water during an emergency, so restoring service quickly was essential.

Our investigation determined the outage was caused by a vehicle strike that damaged an electrical pedestal. Reece Anderson responded immediately, restored power, and installed a traffic-grade ground box to better protect the electrical infrastructure, especially given the history of golf carts using the emergency access route.

Mike Wilder coordinated with the Cobblestone HOA and CRFD to develop a solution that preserved emergency access while improving site protection. This was important because the HOA has experienced ongoing issues with residents using emergency access as a shortcut to the golf course. Mike installed two additional bollards and reinforced the chain barrier to deter non-emergency access and reduce the risk of repeated damage.
