2021 - Castle Rock Water End of Year CIP Report

Table of Contents

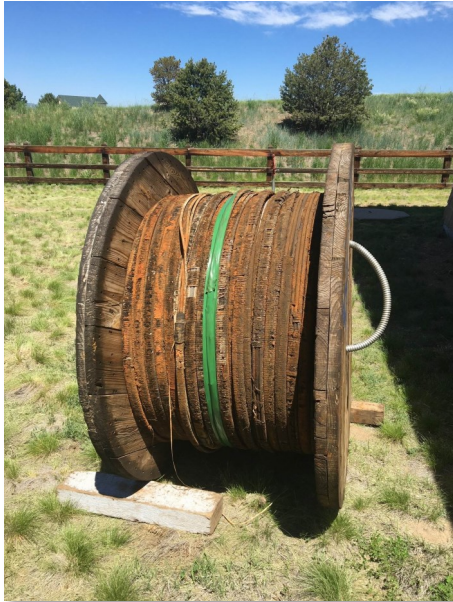
Old cable from Well CR-86 that needed to be replaced

In March 2021, Town Council approved the Denver Basin Wells Rehabilitation, Pumping Equipment Replacement and Well Abandonment Project, which was a planned rehabilitation project for select Denver Basin aquifer wells. In order to complete the project prior to demand season, the contract was split between two contractors. Colorado Pump was awarded four wells for rehab and one well for abandonment in the amount of \$621,514.08, and Applied Ingenuity was awarded three wells for rehab in the amount of \$504,442.05. Total project authorization was in the amount of \$1,125,956.13, with \$800,000 budgeted in 2021 and the remainder carried over from 2020 remaining funds. This project is expected to finish \$21,901.05 under budget, including six change orders for additional hours spent on sand pumping and pulling equipment for CR-39 and CR-41, use of mud dispersant for CR-117, new cable and PVC pipe for CR-86, special acid treatment for a calcium bridge found in CR-72R, as well as additional post-rehab special acid treatment for CR-72R.

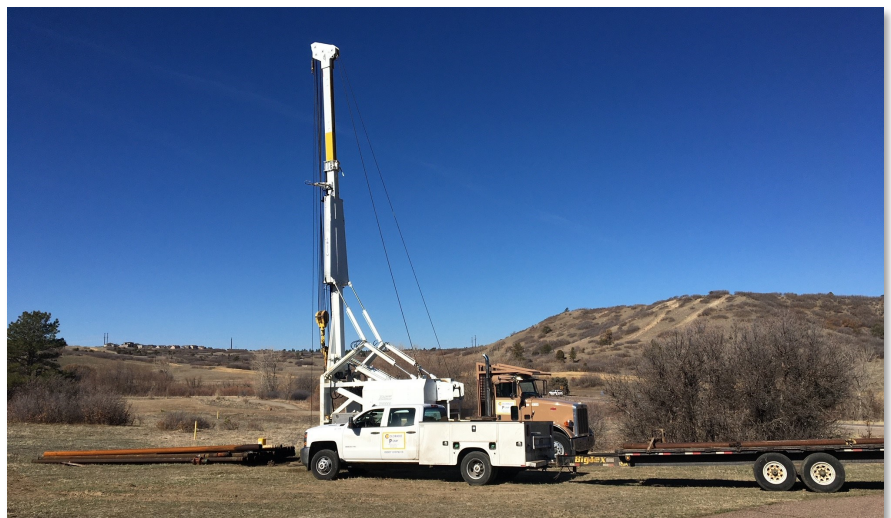
Colorado Pump pulling equipment at CR-72R

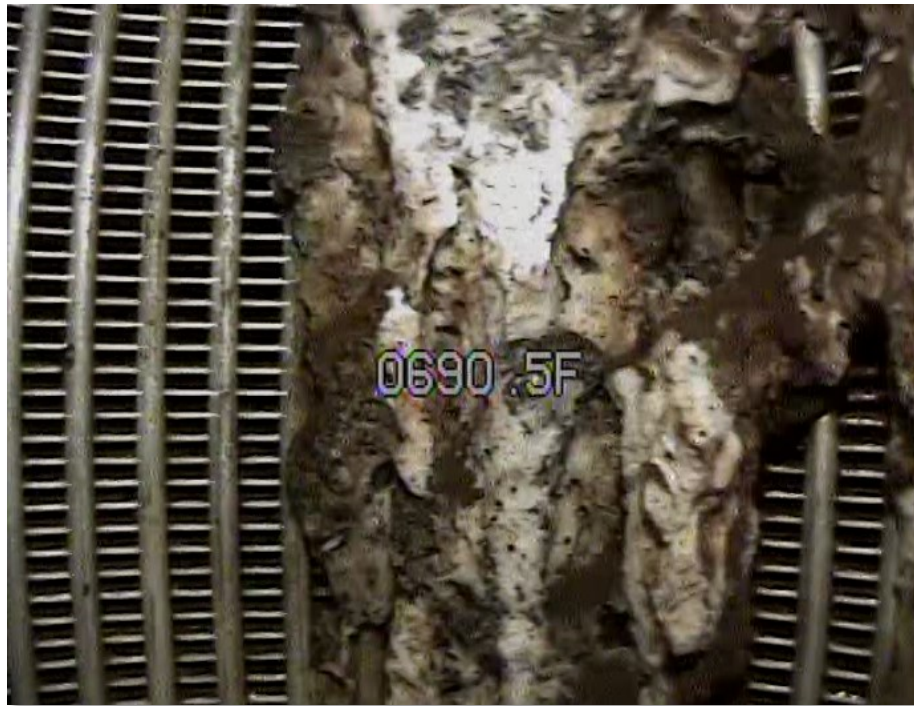
Well video image showing the calcium bridge at 690.5 feet below the surface after the first round of rehabilitation

The program was designed to help maintain water production yields from our well assets and to reduce the likelihood of emergency well failures. Each year staff reviews well data for all of the wells to identify which wells are showing declines in well yield, and wells with older pumping equipment. The following wells were identified for the 2021 Denver Basin Rehabilitation and Pumping Equipment Project: Arapahoe Aquifer Wells CR-39, CR-86, CR-73R, and CR-117. Also, Denver Aquifer Wells CR-72R, CR-217, and CR-41. The combined daily production from the wells is approximately 2.5 million gallons per day. Staff redesigned the pumping equipment for better efficiency. The project also included the abandonment of one well, CR-31, located at the Town's Enderud Well Site, as required by the State. This project was completed in November 2021, but was substantially complete in July 2021. Rehabilitation of CR-217 was pushed out to the fall of 2021.

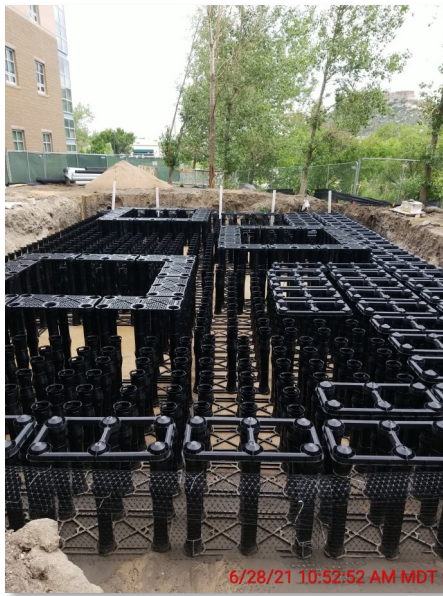
Silva Cells Under Construction

The base design of the project would have applied a traditional extended detention basin that would have required the installation of a suspended deck over the top of the stormwater facility resulting in undesirable odors, insects and views to public users of the plaza area. Maintenance of the facility would have also been challenging resulting in complications, hazards and complaints. Upgrades incorporated low impact development practices to reduce stormwater runoff from the plaza area through infiltration. Upgrades also allow for public plaza seating over the stormwater facility infrastructure in a manner much more compatible with the proposed uses and maintenance requirements. These upgrades provide the Town with the opportunity to showcase state of the art stormwater practices in downtown urban infill settings that benefit water quality and reduce impacts to receiving waters.

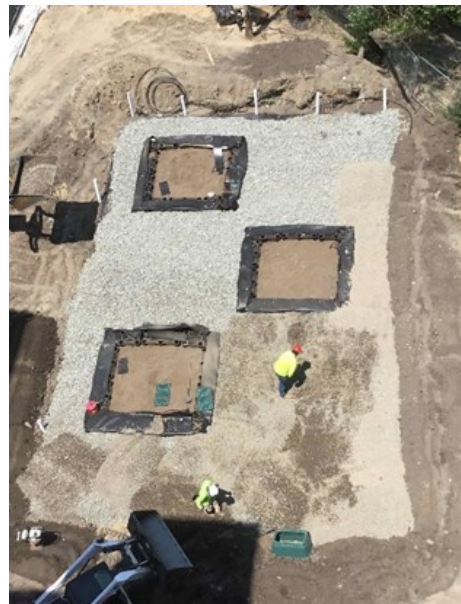
Porous Paver Subgrade Over Silva Cells

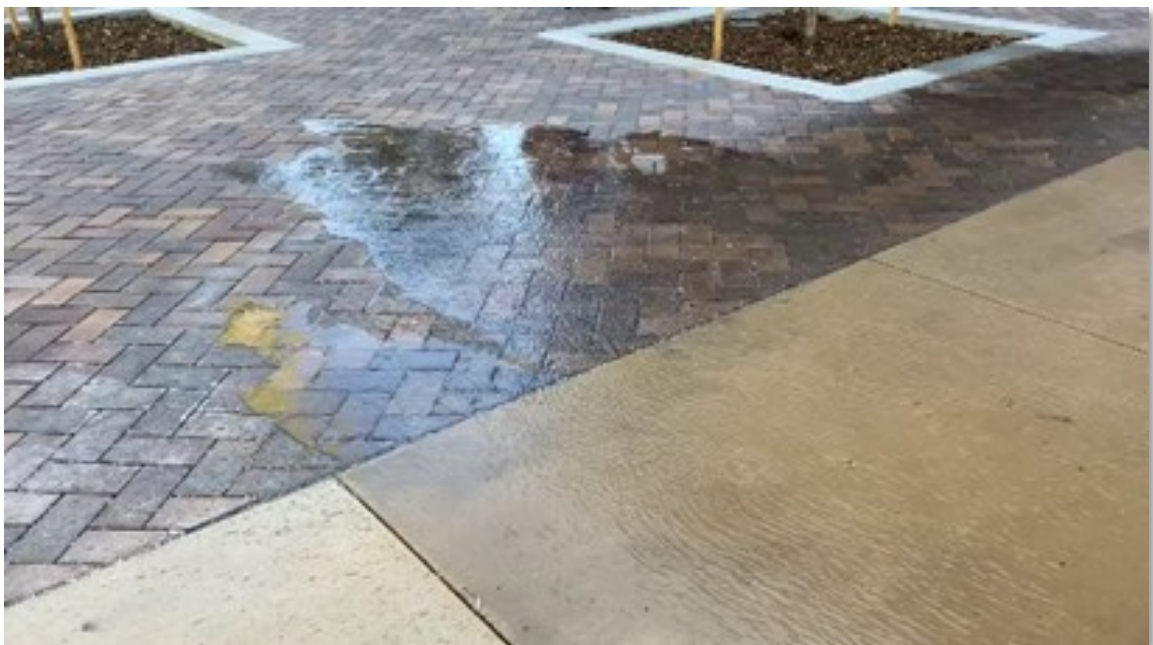
The Town conducted a demonstration using water from a fire hose and found the system to be effective.

Porous Paver Infiltration over Silva Cells during Demonstration

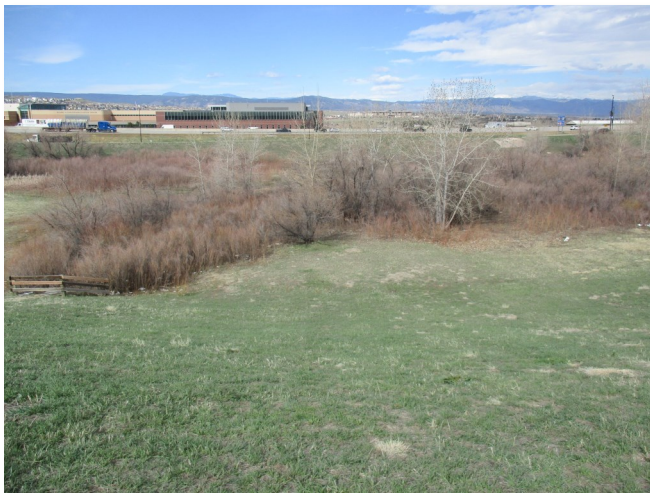
Castle Rock Water completed improvements to the Metzler Ranch Regional Detention Pond, located in the northwest corner of Metzler Ranch Community Park east of Front Street and south of Sam Walton Lane. Retrofit improvements and analysis of the regional detention pond were completed in 2005. The analysis concluded that approximately 3.5 acre-feet of additional water quality capture volume was needed to restore the design capacity of the facility. Twenty-three volunteer trees and other vegetation had taken over the pond bottom, causing maintenance and operational difficulties.

Before work began

This project removed the volunteer trees and shrubs from the pond bottom, removed approximately 7,400 cubic yards of sediment that had entered the stormwater system, and added structure improvements at each inlet pipe and at the outlet structure to bring the pond up to current design standards. Maintenance access was also added to provide equipment access for ongoing operation and maintenance. Twenty-three trees were planted in strategic locations to replace those removed during construction. Completion of the retrofit construction added 4.8 acre-feet of water quality capture volume necessary to restore the design capacity of the facility.

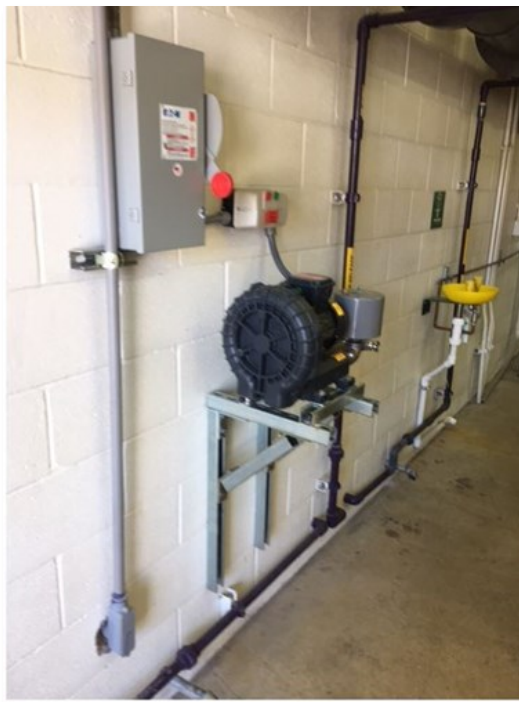
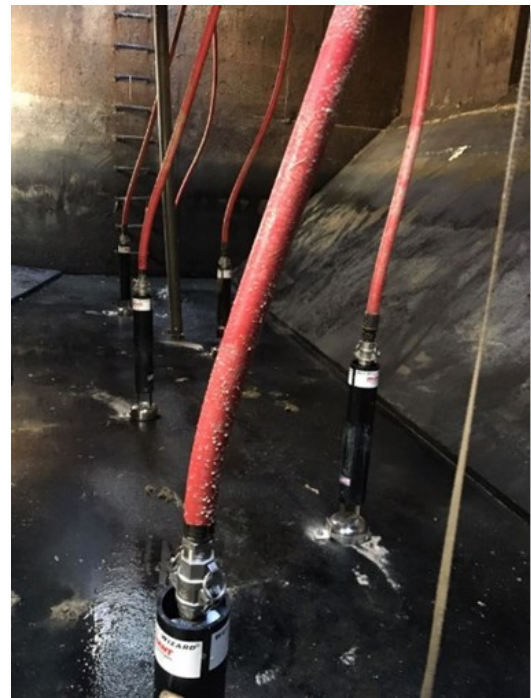
The original mixing system at the Castle Oaks lift station did not do a good job of breaking up the fats, oil, and grease (FOG), which caused a buildup of solids in the wet well, requiring frequent attention by lift station operators. A buildup of solids also results in the development of hydrogen sulfide gas, which is corrosive and results in odor problems at the lift station and collection system.

Wet Well Wizard Blower and Ejector System

Staff replaced the entire wet well mixing system with a Wet Well Wizard mixer. This aeration system has been installed at two other Castle Rock Water lift stations, with excellent results. The Wet Well Wizard is a completely different type of mixing system, utilizing a topside blower unit, connected to four ejectors which are placed onto the floor of the wet well. This system has flexible hosing connected to each ejector, instead of hard PVC diffuser piping. This enables easy removal of the unit from the top, outside of the wet well, for maintenance.

The Reliant Wizard system aggressively agitates and liquefies the solids in the wet well, preventing FOG buildup. This constant agitation, with highly forced air, introduces oxygen to the water, which encourages aerobic microbes to form, digesting organic wastes and reducing odors downstream. Ultimately the Wet Well Wizard reduces the amount of Biocide chemical needed, saving the Town over \$30,000 through the first eleven months of 2021, compared to the same time frame in 2020. The project cost was \$22,295.

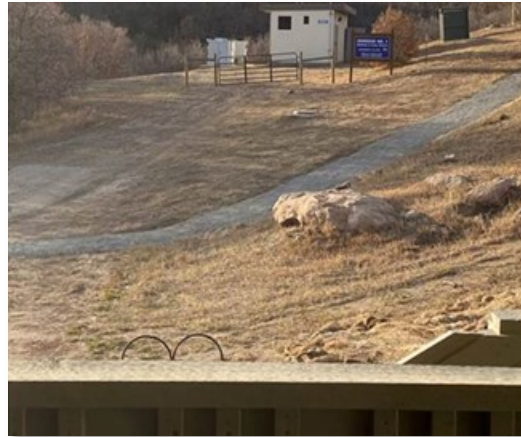
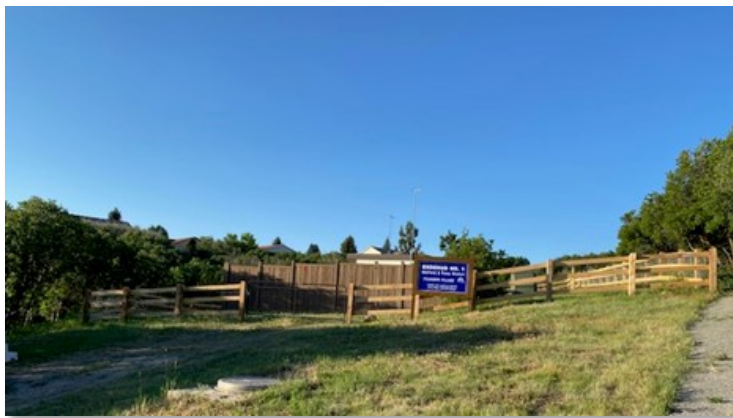
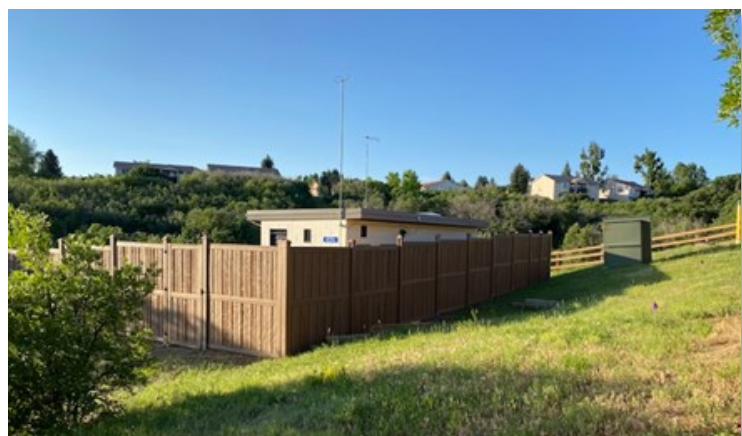
Newly Constructed Fencing at Enderud Well House

Staff worked with the neighborhood's Homeowner's Association (HOA) to gain approval of the fencing design, which is in accordance with current Terrain HOA standards. This fencing will add another layer of security to the well site. Additional security is already in use at this site, such as security lighting, internal cameras, and security badge access controlled doors. The cost of the project was \$45,434.

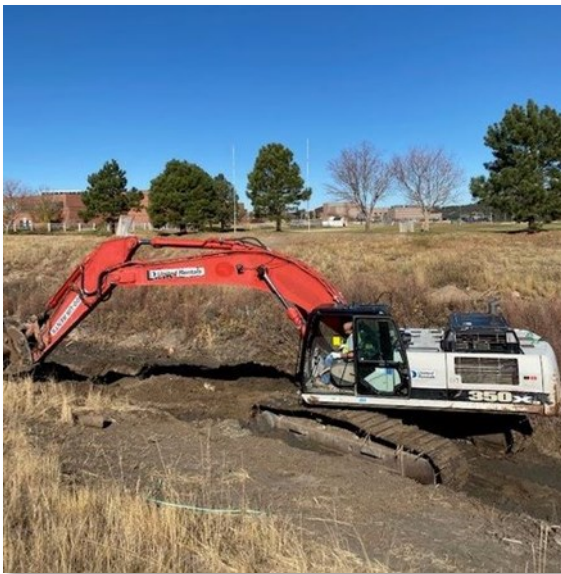
The water intake structures at CR1 and Plum Creek Diversion (PC Diversion) experience extreme sand accumulation in the stream channel due to spring runoff, summer storms, and monsoonal weather upstream on East and West Plum Creek. The silt, sand, and gravel combine to fill the intake channel and cover the intake screen, forcing the pumps to cycle and turn off due to lack of flow. Additional sand is expected to accumulate in the newly constructed PC Diversion pump station wet well and inlet channels. This accumulation inside the wet well can be mitigated by timely and frequent sand removal, before it enters the intake structure, thus reducing wear and tear on the sand pumps.

Linkbelt Excavator Conducting Storm Pond Remediation Operations

This excavator will be used immediately after storms, preventing sand loading. These sand loads clog the diversion structure, at times when our water rights dictate that the most water can be taken from the stream, ultimately restricting water production. The use of an excavator for sand removal makes it possible to maintain production consistently throughout the year.

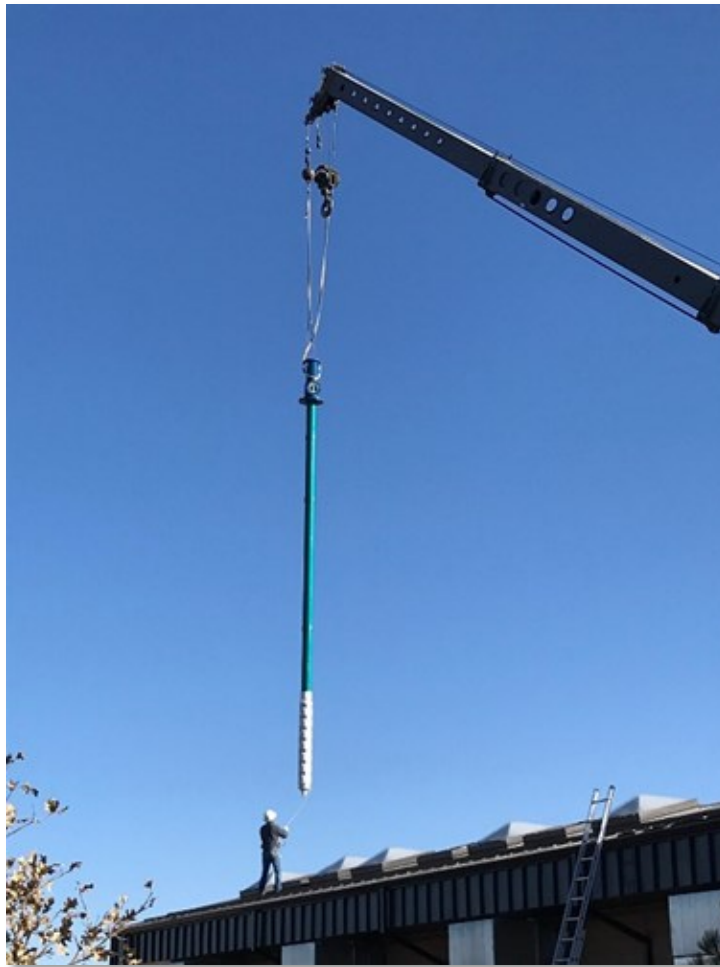
Castle Rock Water's engineering staff recently determined that due to increasing population growth, the Ray Waterman Green Zone pumps should be upsized with higher capacity to better meet current and future demands. Furthermore, with expected increases in WISE water imported flows, larger high service pumps are needed to move the additional water throughout the Green Zone distribution system. The two new Green Zone pumps are sized to increase pumping capacity from 2,780 gpm to 3,400 gpm, each. These improvements, along with the previous third pump 870 gpm capacity upgrade, increase the total Green Zone pumping capacity by 1,240 gpm or 1.78 MGD.

Green Zone Pump Installation

The new FlowServe pumping equipment was manufactured and delivered to the Canfield Drilling pump repair facility in Ft Morgan, Colorado. Castle Rock Water plant maintenance staff pulled one pump at a time for replacement; shipping each pump to Canfield for disassembly and rebuild. Upgrading one pump at a time allowed the pump station to continue to operate normally during the pump upgrade process. The cost of this project was \$79,292.

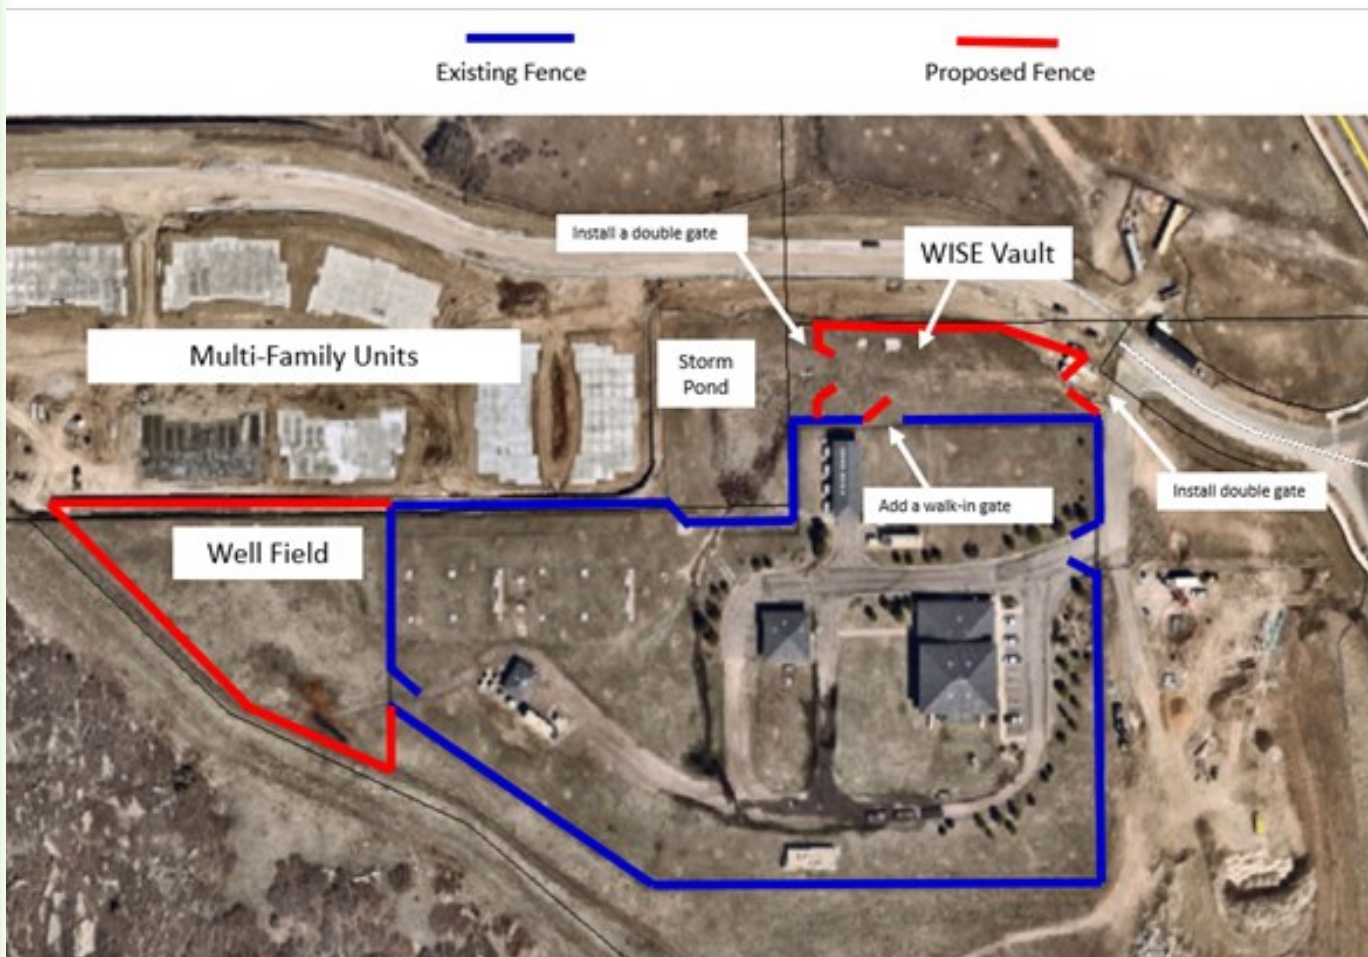
In order to improve the physical security at the Ray Waterman Water Treatment Facility (RWWTF), staff contracted with Commercial Fence & Iron Works. The pre-existing fence, shown by the blue line in the diagram below, surrounded the treatment plant, pump house and southern wellfield. Now additional areas of six-foot black vinyl chain link fence, shown by the red line in the diagram below, enclose the Water Infrastructure Supply Efficiency (WISE) vault and the western well field. Man gates and double vehicle access gates were also included in this project.

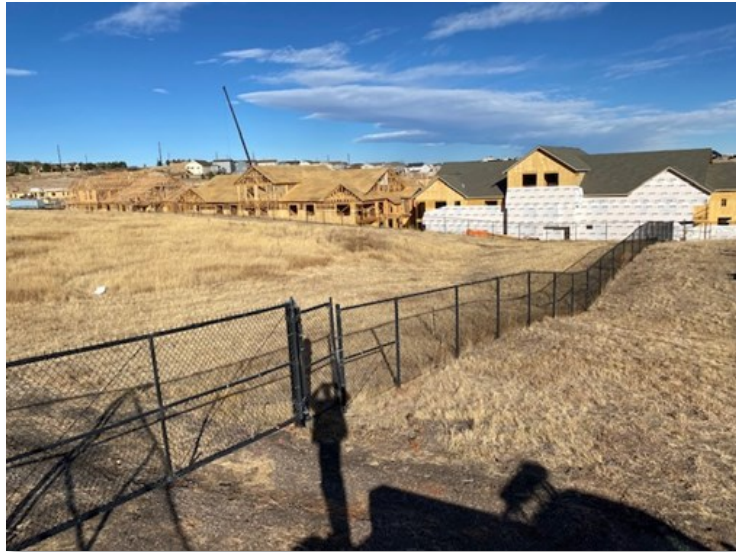
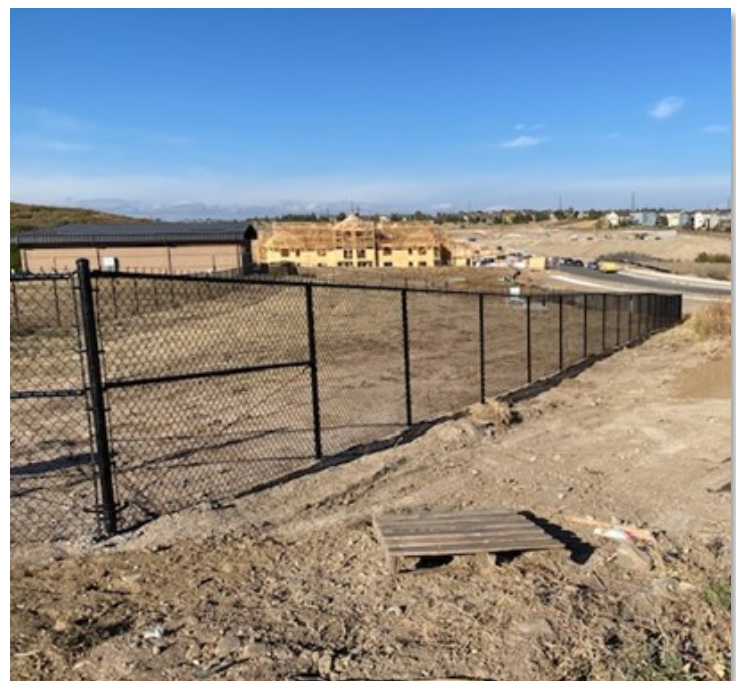
Recent development in the Terrain neighborhood has brought numerous multi-family housing units to the edge of the treatment facility's property boundaries. The fencing that now encompasses all of the facilities at RWWTF prevents access to treatment plant facilities and equipment, protecting Castle Rock Water infrastructure from unauthorized intrusions. The cost of this project was \$49,334.

Ray Waterman Fencing Extensions

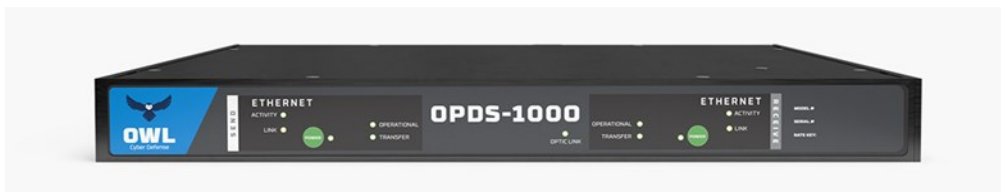
The SCADA team began implementing their five-year Master Plan Upgrade project. The first phase was to ensure a safe and secure SCADA system. This was accomplished by installing a Data Diode, which separates the SCADA system from the Town's IT system. This device provides an air gap, separating the SCADA network from the "Business" side of the Town's network, protecting the system from unauthorized users.

Owl Data Diode

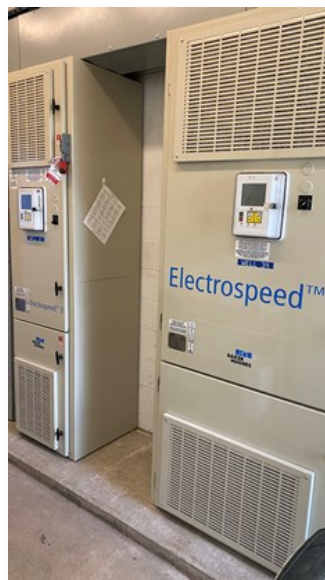
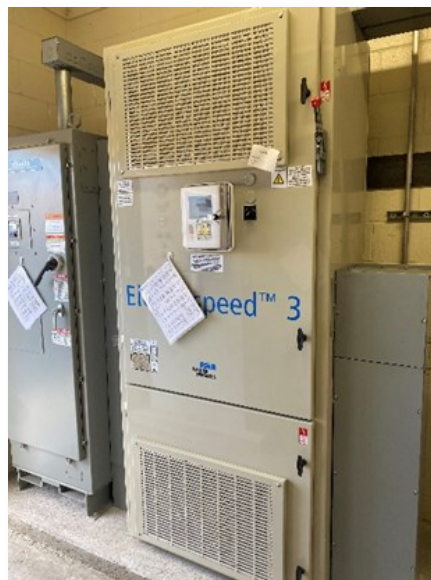
The Centrilift Variable Frequency Drives (VFDs) at the Weaver 1 Well Facility (Weaver 1) were installed in 2000, and were no longer supported by Centrilift as repair parts are not available. Considering the criticality for water production and the concern over long procurement times, 10-12 weeks, staff made the decision to replace the drives before they failed. The Toshiba HX7 VFD at Well 67 suffered an arc flash and catastrophic failure, requiring immediate replacement.

Wells 39, 41 & 67 Centrilift VFDs

Staff contracted with Applied Ingenuity, to replace the obsolete and failed VFD drives with Centrilift drives, as they are a Master Plan approved drive, were lower in price, did not require additional sine wave filters, and provided the best value for the Town. The cost of this project was \$184,083.
