CASTLE ROCK WATER

JULY 2025 MONTHLY REPORT

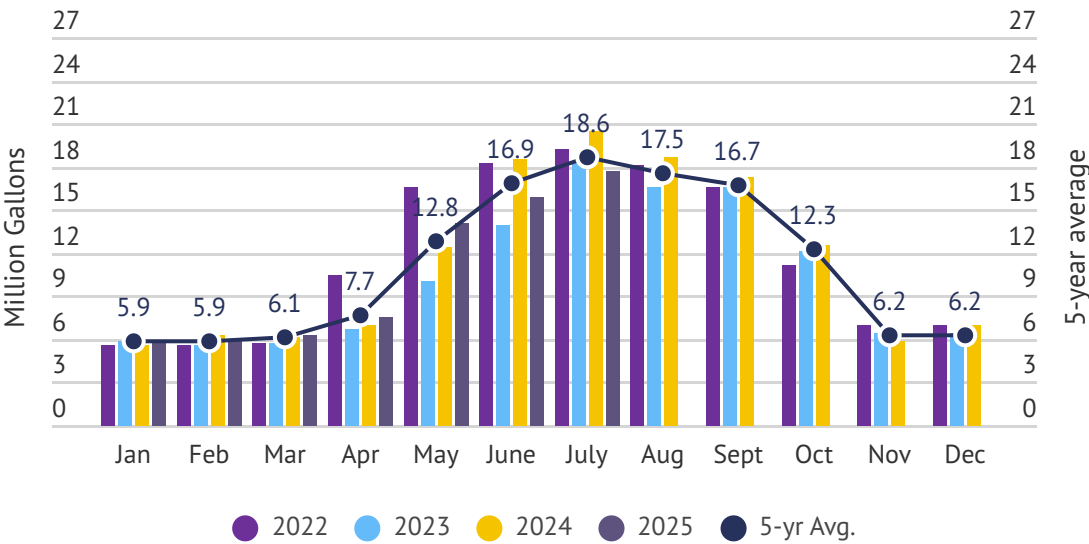
DAILY MAXIMUM DEMAND

- 17.7 million gallons/day (MGD)
- 5-year average: 18.6 MGD
- 5% lower than the 5-year average

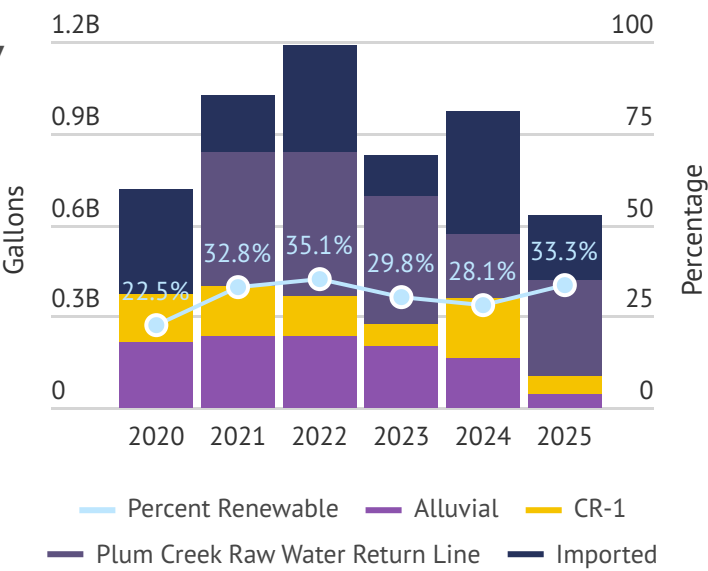
RENEWABLE WATER SUPPLY

In total, renewable supplies accounted for 35.07% of the total water supply for the month (170 MG of 484 MG) and 33.27% of the annual water supply(630 MG of 1,894 MG)

- The CR-1 diversion produced an average of 0.33 MGD
- The PC diversion produced an average of 3.61 MGD
- The 14 alluvial wells produced an average of 0.15 MGD
- The renewable water production average was 5.97 MGD

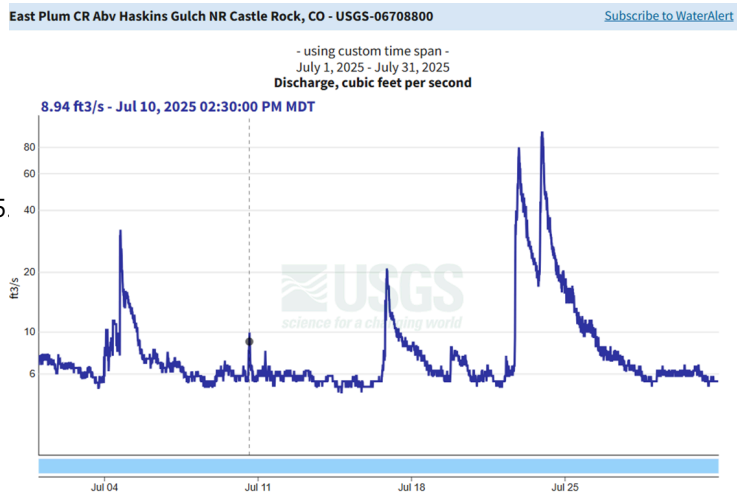
EAST PLUM CREEK FLOWS

The hydrograph indicates the estimated flow in East Plum Creek basin.

- Flows ranged from 5.10 to 95 cubic feet per second (cfs)
- The monthly average streamflow was 9.05 cfs
- The 26-year mean is 11.9 cfs

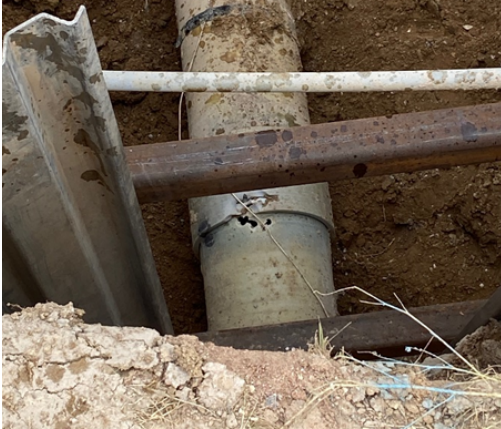
This leak was coming from our 16" Ravenna Pipeline that feeds the Ravenna Golf Course.

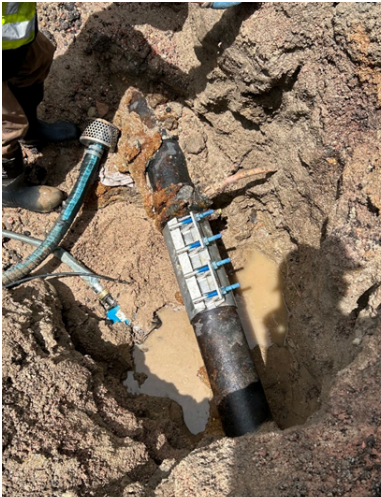
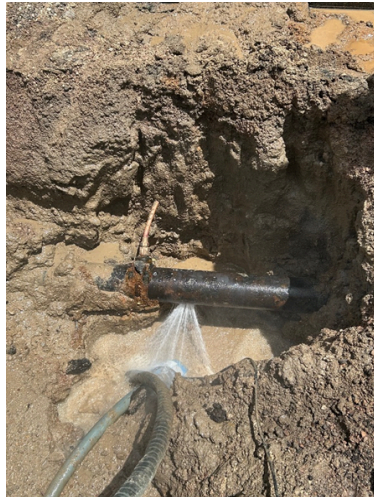
The Distribution team repaired a leaking valve on Tabor Dr. where the stem of the 8" valve came out of the body. There were 31 homes without water for three hours.
