## **In-House Stormwater Maintenance Saves Town \$100,000**

# East Plum Creek Emergency Waterline Report Project

## 2015 Water Demands

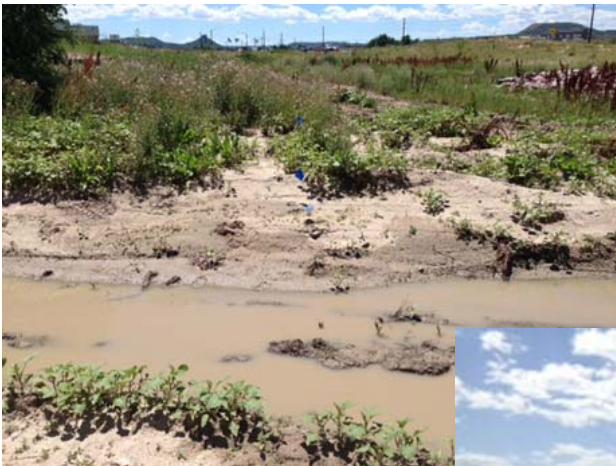
*Channel before maintenance*

In August, the Stormwater Maintenance Team returned to Tributary B (a.k.a. Primrose), to make additional improvements downstream from where they previously cleared two 84-inch diameter pipes of sediment. The project, which involved installing a check dam, removing extensive amounts of sediment and vegetation from the channel, and re-sloping the sides, was initially intended to be completed by a contractor. However, due to the lowest bid being \$150,000, our maintenance team was certain they could provide a better product at a much more competitive price. After two weeks of hard work and removing nearly 1,800 cubic yards of material, the team completed the project at a cost of just under \$37,000.

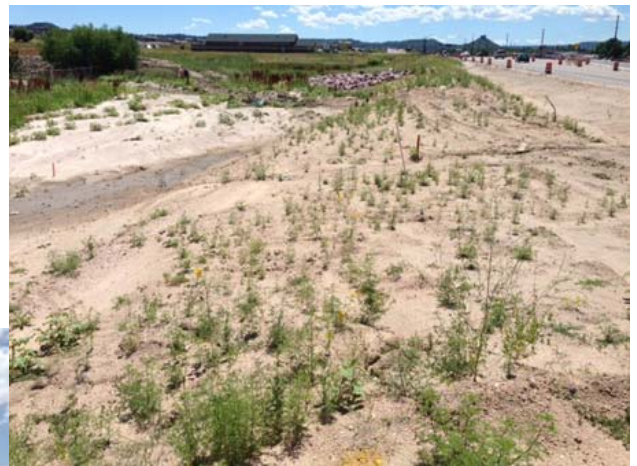
*Stormwater crew removing excess sediment*

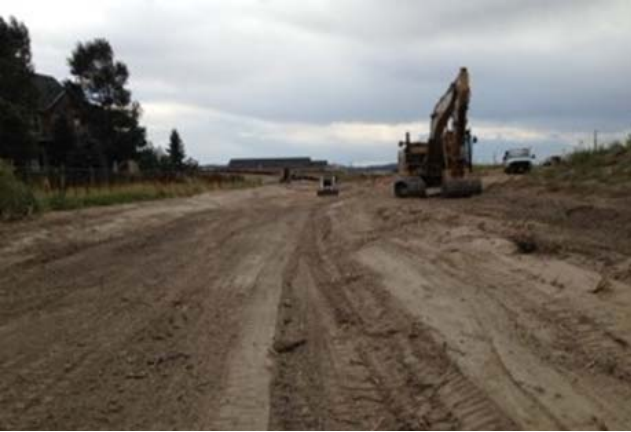
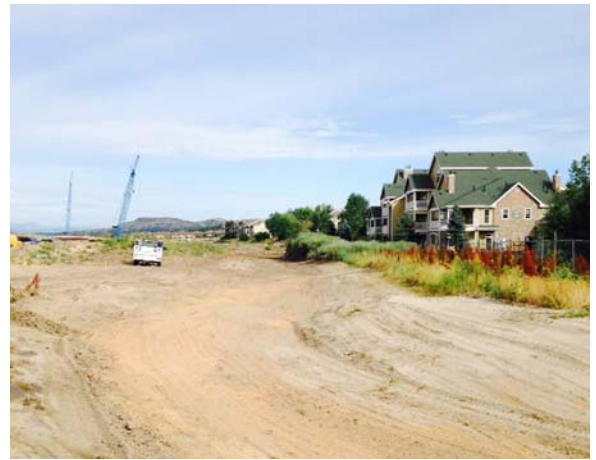
*Channel after maintenance*

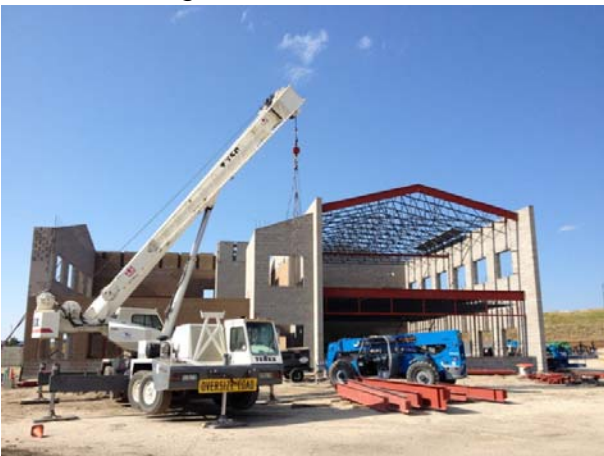
*Steel installation in progress*

The Utilities Operations and Maintenance (O&M) Building received some “bones” this month with the welcome arrival of steel to the construction site. The contractor worked throughout August installing steel trusses, joists, beams, and other structural components of the building. The concrete masonry unit walls have been substantially completed with crews continuing to clean and patch areas as adjustments are needed to accommodate equipment and components throughout building. There have been some concerns raised in regards to the exterior color of the building. The current smurf-like appearance of the building is only a weatherproofing barrier over some of the concrete block and will soon be covered with metal panels of a more agreeable color.

Roof decking was installed on the northwest corner of the building and the majority of concrete deck for the 2<sup>nd</sup> floor of the building was poured. With these areas now covered, activity within the building is beginning to increase. Wall framing has been completed in many areas and mechanical ducts, electrical conduit, and plumbing are also in progress. Stairway installation began at the end of the month and door and window frame installations are continuing. The concrete slab on grade was poured in the meter testing shop this month and the concrete outlet structure in the stormwater detention pond was also formed and poured. Construction of the building remains on track within the established budget (approximately \$4.5 million) and is on schedule for substantial completion in December 2015.

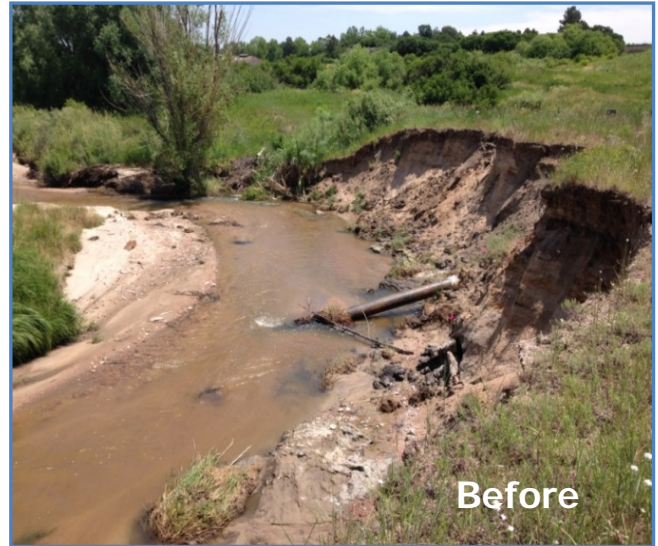
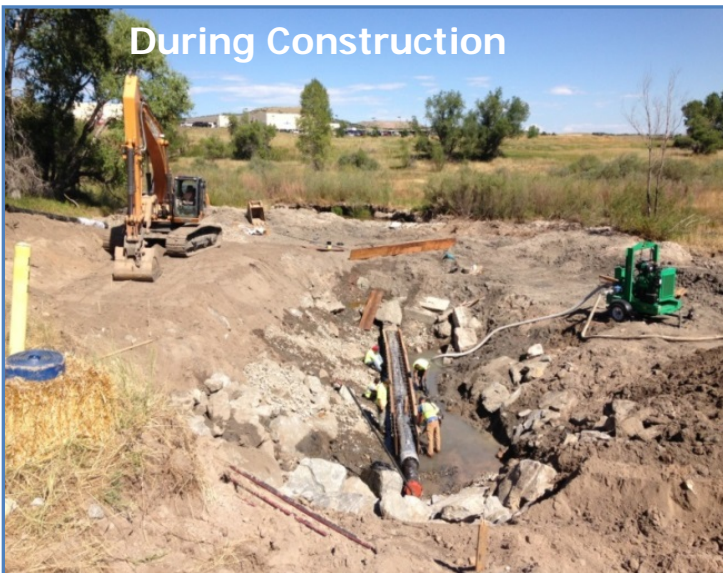
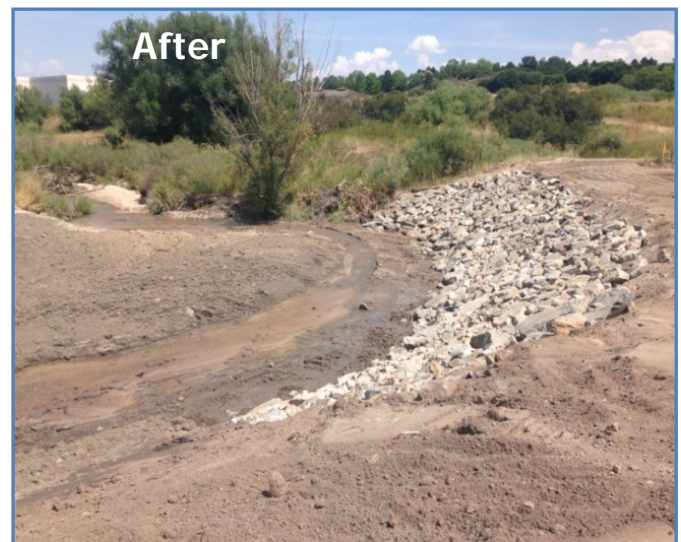
In May 2015, the Town became aware of an exposed potable water line crossing East Plum Creek (EPC) at the Town's South Well Field, near the end of South Perry Street. The water line was originally constructed in the late 1980s with adequate cover and concrete encasement around the section of water line located under the EPC low flow channel alignment at the time. Over the past 20-30 years, the low flow channel has migrated further east. Higher than normal flows within EPC due to storm events this year resulted in bank erosion, and exposure of the shallower, un-encased section of water line.

The emergency repairs included removal and replacement of approximately 140 linear feet of water line in order to lower the line below the current streambed elevation. Additional concrete encasement was also constructed to provide additional protection for the replaced section of water line. Once the water line improvements were completed, the eastern bank was regraded and riprap protection was placed along the bend to prevent future erosion.

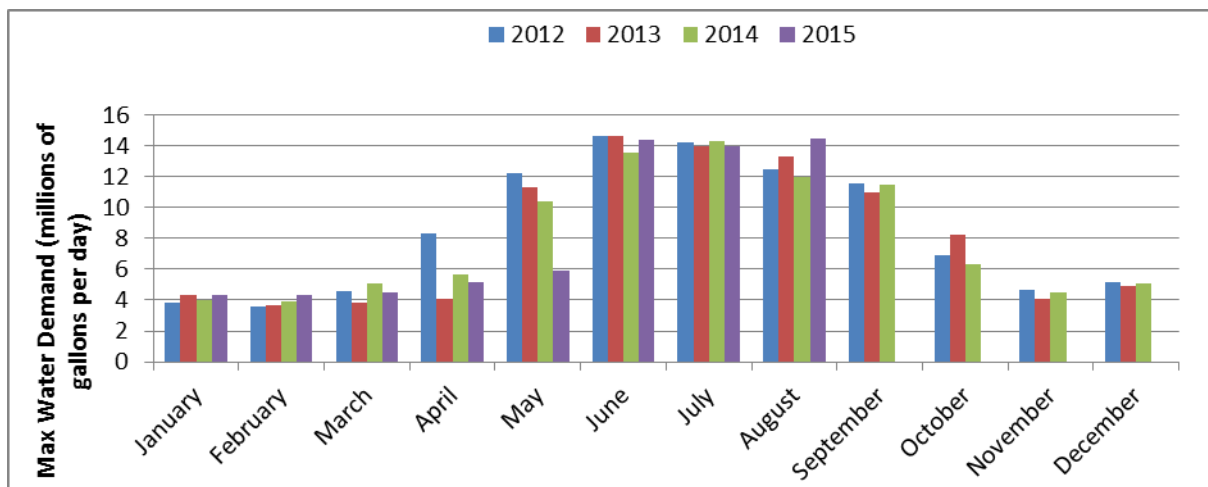
### Maximum Daily Water Demands

The maximum daily water demands are plotted by month from 2012 to the current month. As observed, the maximum demand of 14.5 million gallons per day (MGD) for August is about the same as the July maximum of 14.0 MGD. Summer time maximum demands inform us of the size of the infrastructure necessary to provide water service over short periods of time and help us to plan future water resources needs. An average of the winter month (November, December, January, and February) usages, reflect indoor or base demand. The water demand total for August was 390 million gallons (MG), which was a 15% increase from the July 2015 total of 329.2 MG, and an increase (25%) from August 2014 demand of 291 MG.

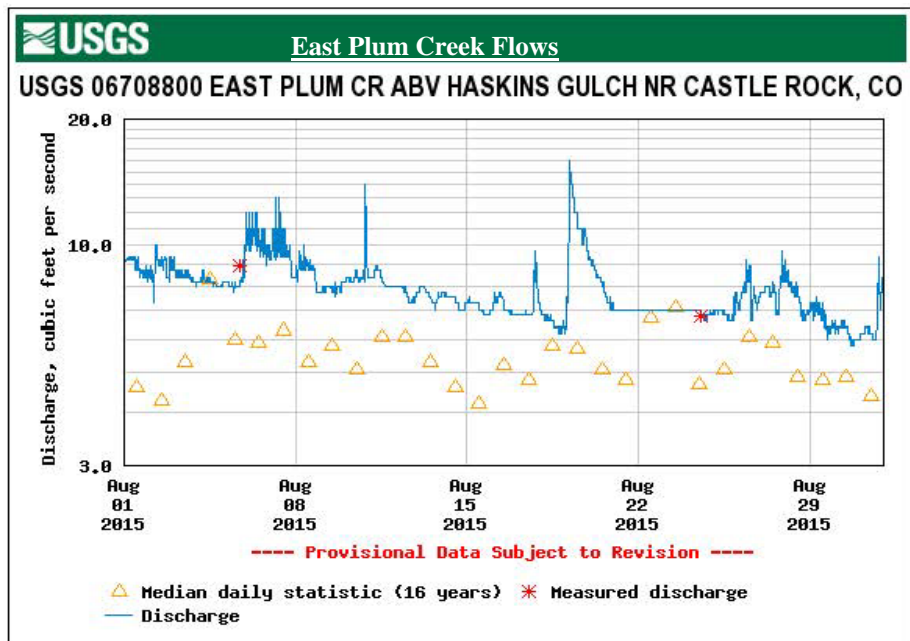
The flow hydrograph represents stream flows in East Plum Creek taken from the stream gauge located at Haskins Gulch. The hydrograph shows that the Plum Creek basin experienced stream flows between 8 to 40 cubic feet per second (cfs). There have been several active calls on the main stem of the South Platte River. Several of the calls have higher adjudication dates than our Meadows Alluvial Wells which is our Central Well Field. This means that those wells are now out-of-priority, so the depletions from those wells will now be covered by our nontributary return flows and/or our Douglas Park water rights. This also means that the Town will now have slightly less reusable water going down Plum Creek. The priority date on a river call may change each day depending on the stream flow available, and the seniority of the diversions that need water on that day.

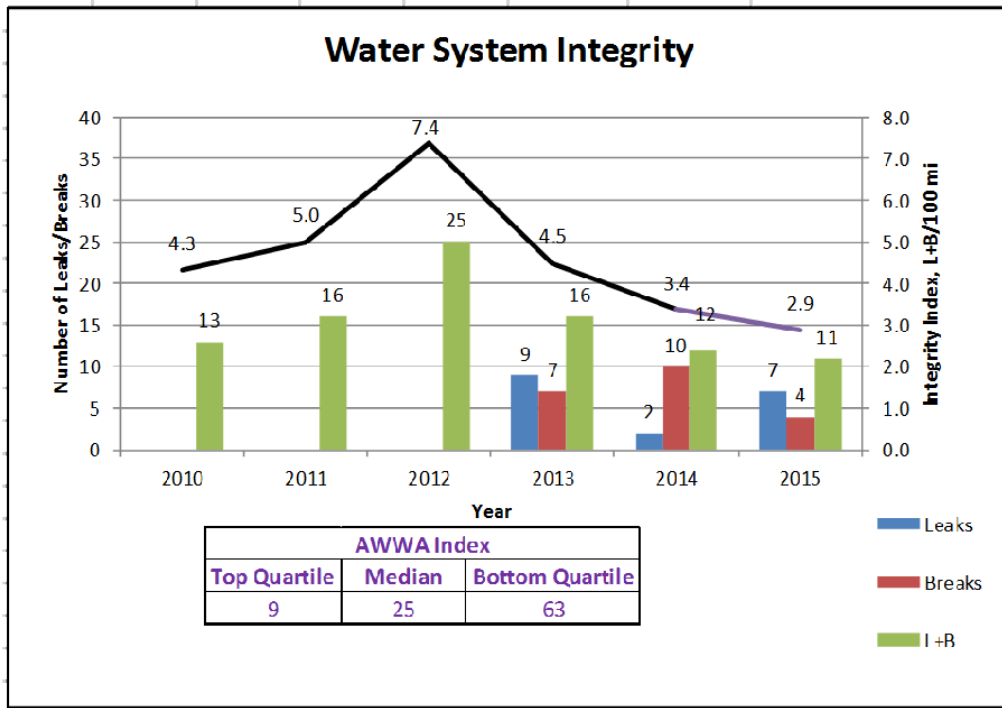
# Water System Integrity

There were four service line breaks, and one main line break this month. An overall rating of 2.88 breaks per 100 miles kept us in the top quartile as compared to national standards for 2014. We are on-track to be in the top quartile again in 2015 based on performance year-to-date.

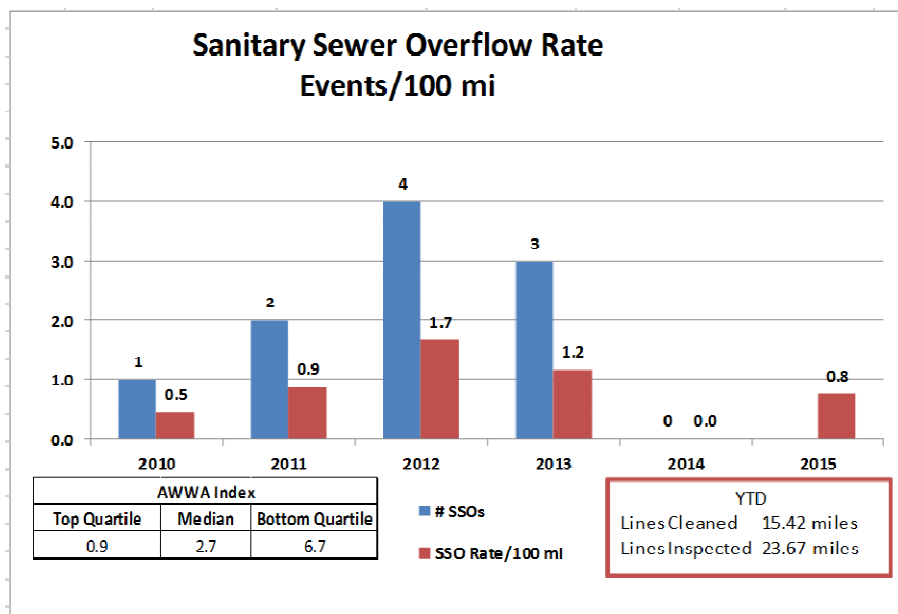
# Sanitary Sewer Overflows

We ended 2014 with no sewer over-flows or backups which is the best performance over the last five years. Our total sewer overflows to-date in 2015 is three. Our 5-year average is 0.38 events per 100 miles, which is in the Top Quartile (the best) of American Water Works Association (AWWA) entities participating in the national benchmarking. *The lower the number the better the performance!*

Our team runs a camera through the sewer mains to look for problems. When problems are identified they are cleared with a high pressure water jet. In 2014, the camera was run through 21.4 miles of pipe, and we cleaned 18.7 miles. So far in 2015, we have inspected 23.7 miles of pipe, and cleaned 15 miles.

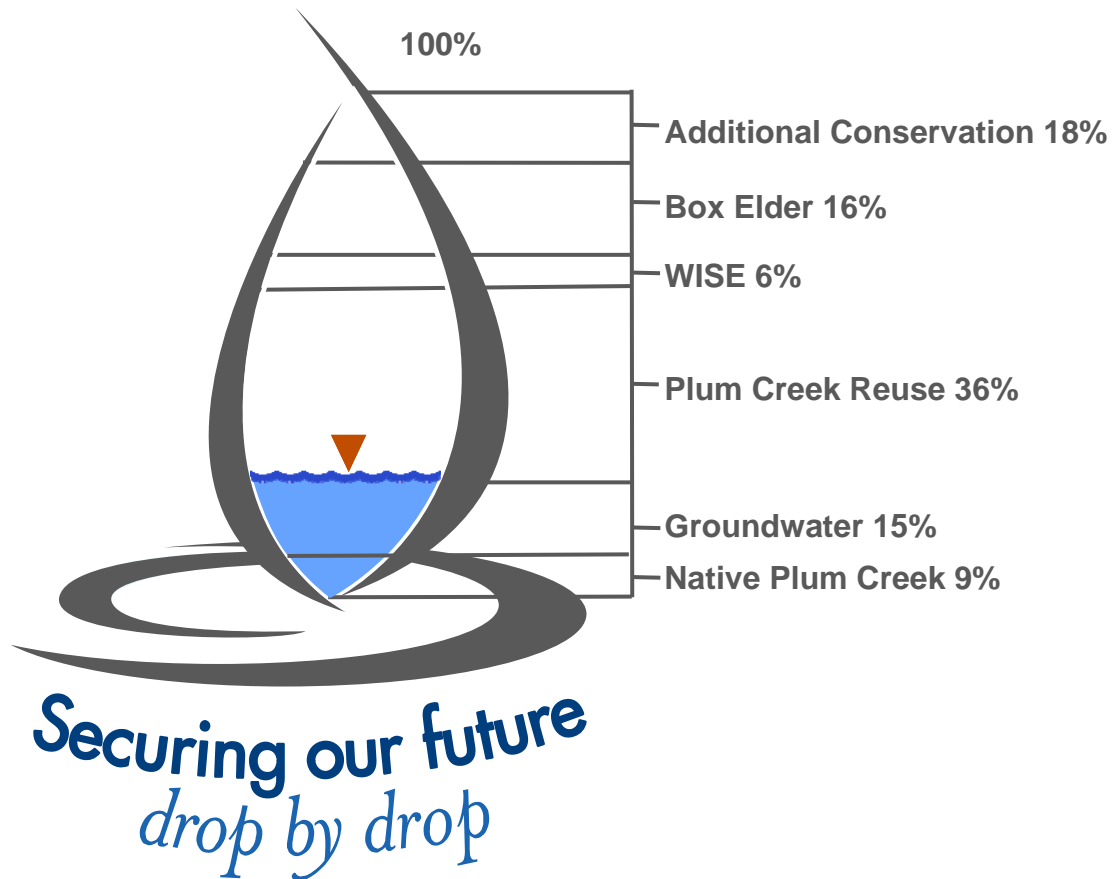
This graph also shows the impact that each of the long term renewable water or legacy water projects will have on the available renewable water supply.

1. Creation of a well replacement master plan. Since as shown in the graph above, groundwater will continue to be a significant part of our overall water supply, it was critical to prepare this master plan to ensure that the long term viability of this resource is protected. The plan contemplates using groundwater to help meet peak demands and to ensure water supplies during drought and dry years.
