# CASTLE ROCK WATER

## JUNE 2026 MONTHLY REPORT

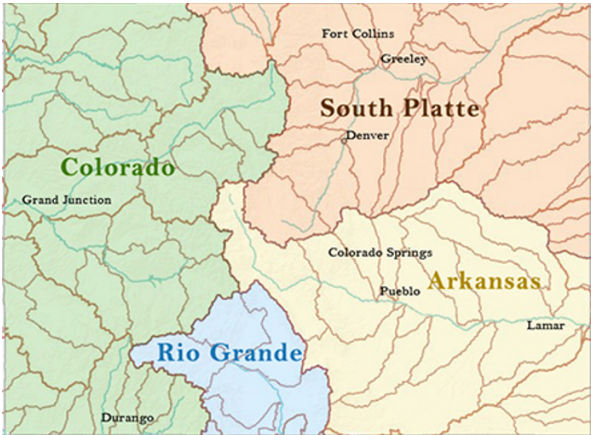
Figure 1

The state of Colorado has had an unprecedented year in terms of above normal temperatures and far below normal snowpack. To refine the picture to relate to our Town, we use data from our specific river basin to evaluate water supply conditions. The Town of Castle Rock is within the South Platte River Basin, in the northeast section of the State, shown light orange in Figure 1.

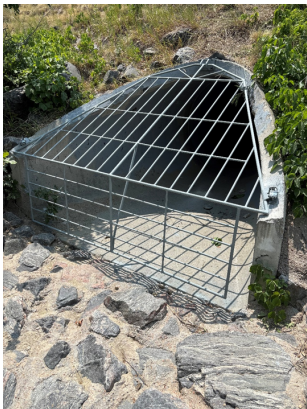
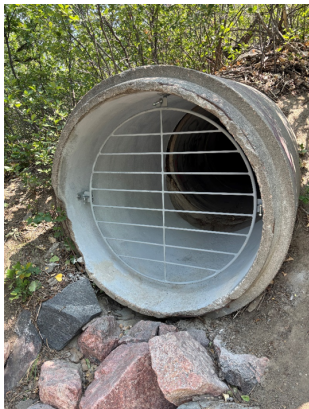
The Stormwater team was contacted by the Castle Rock Police Department regarding kids accessing the stormwater system at the base of Rock Park. They were using the 54" pipes to go under Front Street to the trail, and CRPD had reports of crime happening in the stormwater pipes. They requested our assistance in making them more secure. We contacted a contractor to fabricate custom grates and installed them as soon as they came in. CRPD appreciated our collaboration to prevent further incidents in our infrastructure.

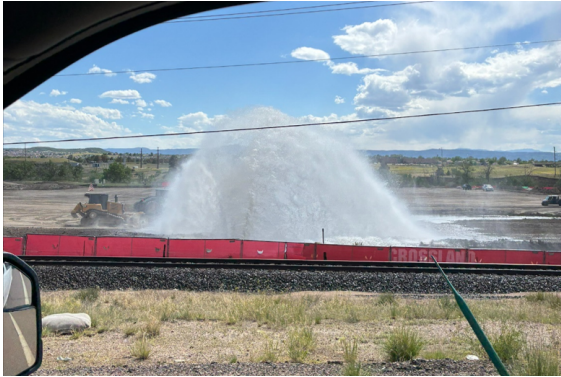
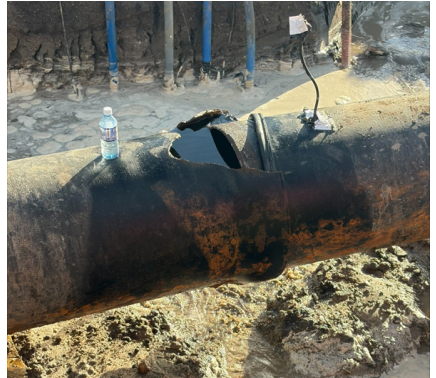
A contractor hit a 24" waterline near Timber Mill Pkwy and Hwy 85. Until the line could be isolated and slowly shut down, businesses and residents in the Promenade, Yellow Zone area were temporarily without water for less than an hour.

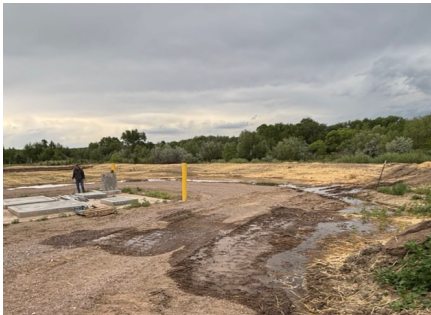
The team found a hole in our 16" fiberglass water line at Plum Creek Diversion just south of the discharge vault. We verified that the leak was not at a new water main connection installed by our contractor. We excavated down to the main and installed a 16" repair clamp. This line is isolated and didn't affect pumping to PCWPF.

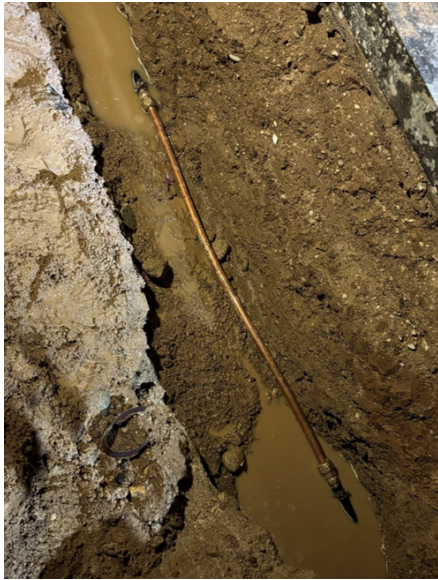
A boring company hit a water line on Wagon Wheel and Still Meadow in Founders. The team showed up and performed tests to figure out where the water was coming from. The team shut off backflows and closed water valves on the raw water main. While closing the valves on the raw water main, the water slowed down. This led the team to believe it was a leak on the raw line. After-hours emergency contractors were called to make the repairs. After excavating, the contractor found that it wasn't the raw water main but an irrigation main for the HOA.

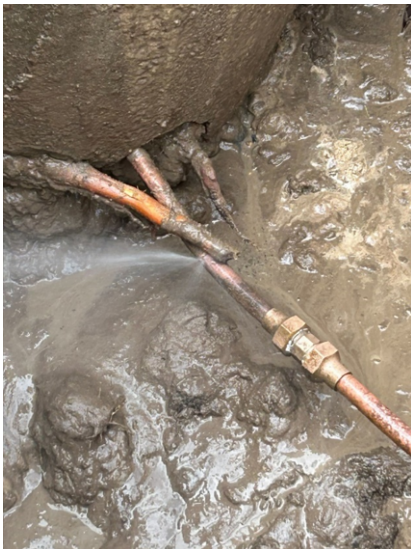
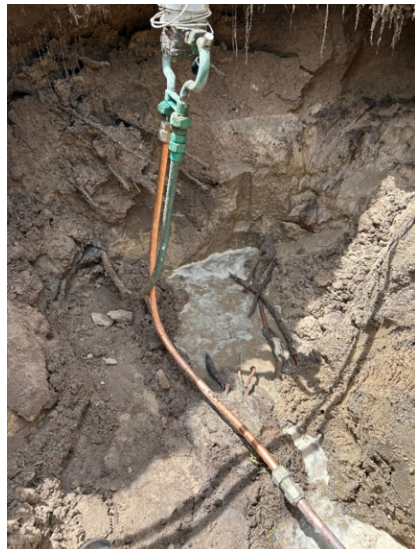
There was a service line leak on Ash Ave on a 3/4-inch copper line before the meter pit. The leak was caused by tree roots rubbing on the service line. The distribution team cut out the faulty piece of copper along with the tree roots and ran a new piece into the meter pit and up to the meter. Water was shut off to 8 homes for 1 hour and 45 minutes for the team to safely make the repair.
