# CASTLE ROCK WATER

## SEPT 2025 MONTHLY REPORT

## Relining of the Chlorine Tanks

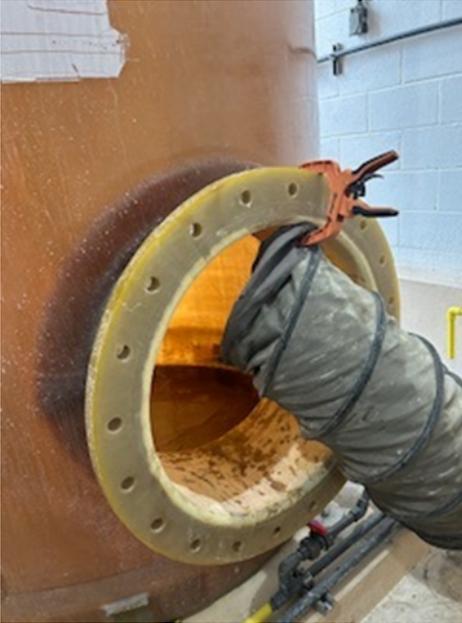
Heat tube hooked up to dry resin

During routine cleaning on May 8, 2025, it was discovered that the fiberglass-reinforced plastic (FRP) linings in both bulk sodium hypochlorite tanks at Meadows had deteriorated after nearly 20 years of service. The CORVE 8300 liner was starting to peel away from the tank walls, which clogged chlorine filters and injectors, posing a serious risk to disinfection reliability. If left unaddressed, this could have exposed the FRP shell directly to chlorine, thereby increasing the risk of leaks or even tank failure – a significant safety and environmental concern. To correct the issue and extend the life of the tanks, the Plant Maintenance Team utilized a fiberglass repair contractor who:

- Removed the old liner by grinding
- Repaired any damaged FRP shell using fiberglass mat saturated with resin
- Installed a new 100-mil Derakane 411 vinyl ester liner with a Nexus veil for maximum chemical resistance
- Applied a primer, resin layers, and a resin-rich topcoat for durability
- Allowed the resin to fully cure, using heat/steam to accelerate curing if needed

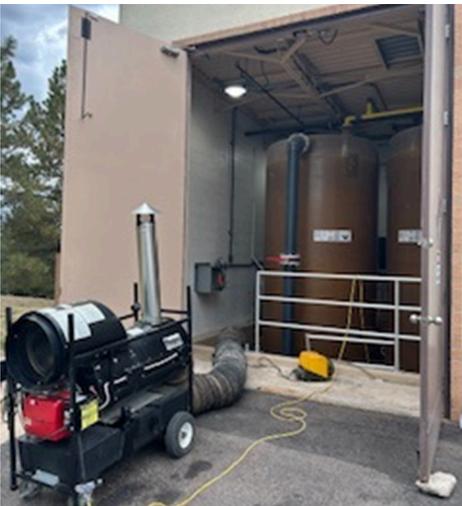
Heat dryer setup outside CL2 tanks

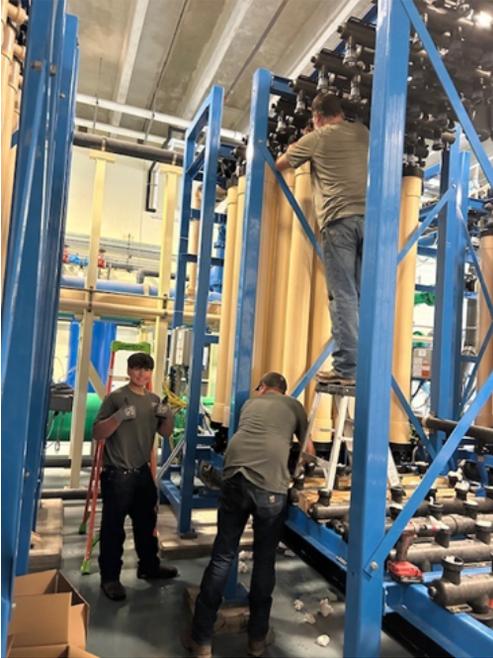
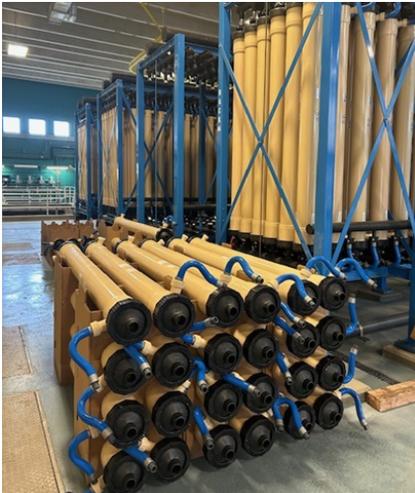
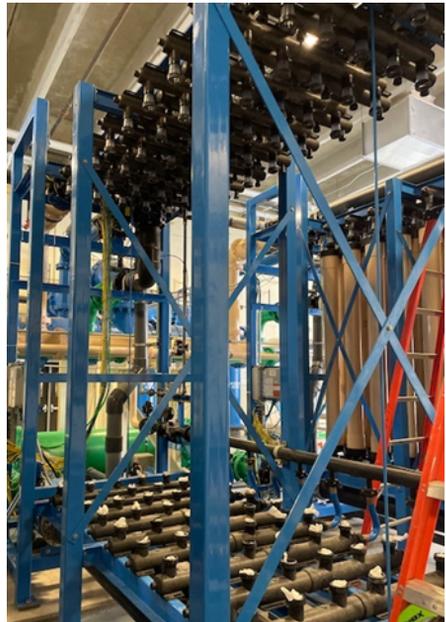
The Plant Maintenance team replaced 78 Aira membranes that have been in service since 2013 on Pall Rack #3. Operations and maintenance teams worked together, coordinating the work to minimize plant downtime and ensure proper installation. The old membranes were carefully removed and the racks were prepared for the installation of the new membranes. The new units were installed with precision and expertise gained from replacing the membranes on racks #1 and #2, following manufacturer guidelines and safety procedures. The team finished the work, and the system was restored to full capacity in a timely manner, taking only two days to complete.

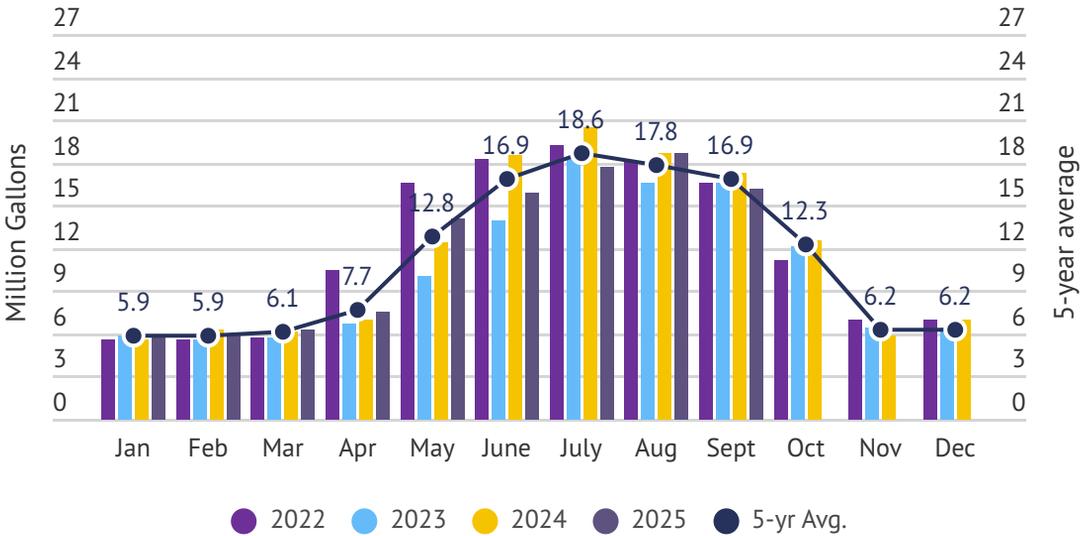
### DAILY MAXIMUM DEMAND

- 16.2 million gallons/day (MGD)
- 5-year average: 16.9 MGD
- 4% lower than the 5-year average

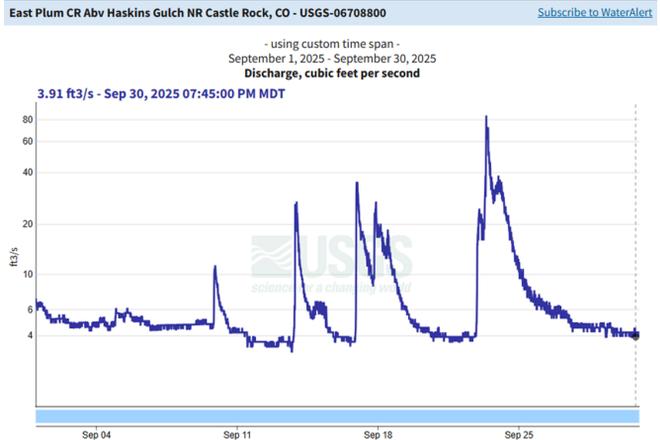
The hydrograph indicates the estimated flow in East Plum Creek basin.

- Flows ranged from 3.0 to 84.1 cubic feet per second (cfs)
- The monthly average streamflow was 7.3 cfs
- The 26-year mean is 4.6 cfs

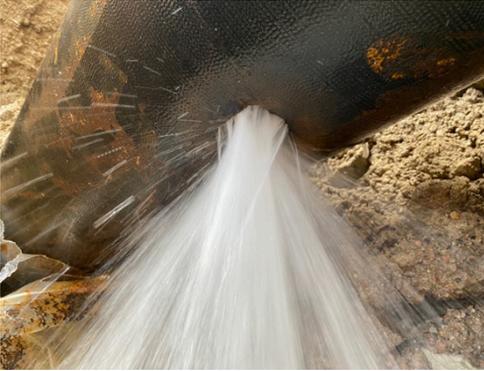
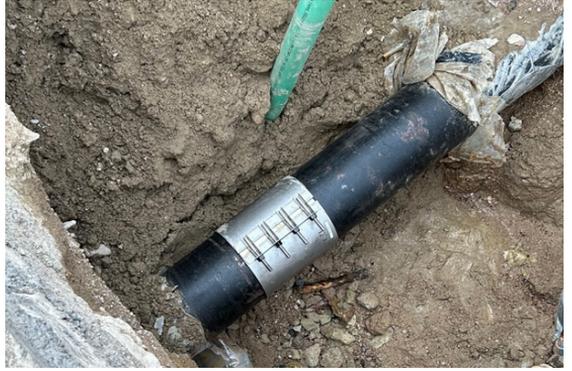
*A contractor hit a 12" DIP Water Main on 5th Street. Our distribution team made the repairs and only one customer had reduced water pressure for about 3 hours during the repair.*

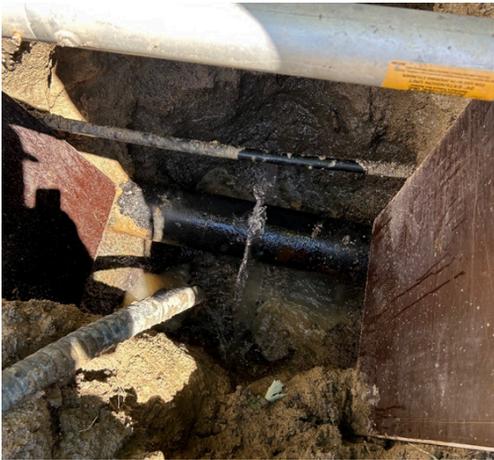
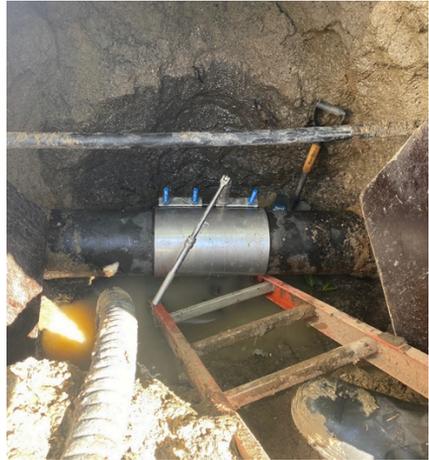
*The On Call team responded to a main break on Sunset Court. The team identified a beam break on 8-inch ductile iron pipe. Three homes had reduced water pressure for two hours.*
