## MONTHLY REPORT

SEPT. 2021

### CRW Administration & Customer Service Building and Engineering Building Remodel Project

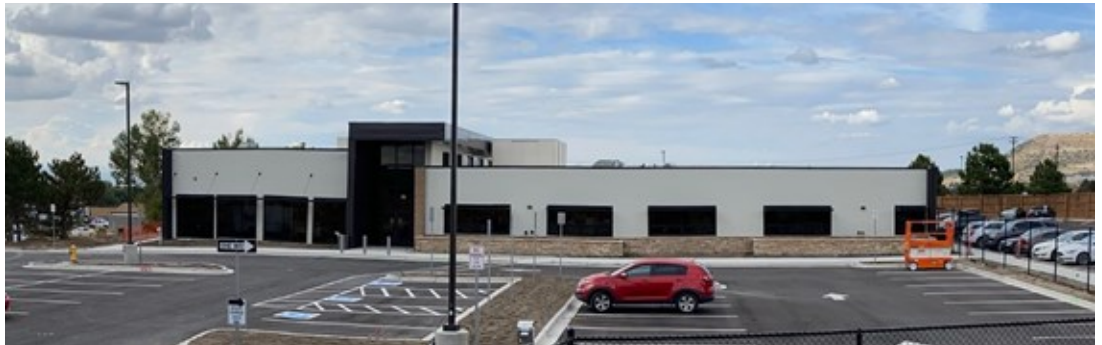
Construction of the Castle Rock Water (CRW) Administration and Customer Service Building awarded to Golden Triangle Construction (GTC) in the amount of \$3,944,200 achieved the milestone of substantially complete on September 17, 2021. Project includes completion of a new, more accessible, 12,188 square foot building and retrofitting office space in the existing building, now named the Engineering Building. The new building includes space for meeting rooms, conference rooms, customer service reception, meter and billing services, staff offices, break room kitchenette, and lavatory facilities. A photovoltaic system with panel area of almost 1,400 square feet has been installed on the building roof. The 25 kW power generating system,

*The new CRW administration & Customer Service Building.*

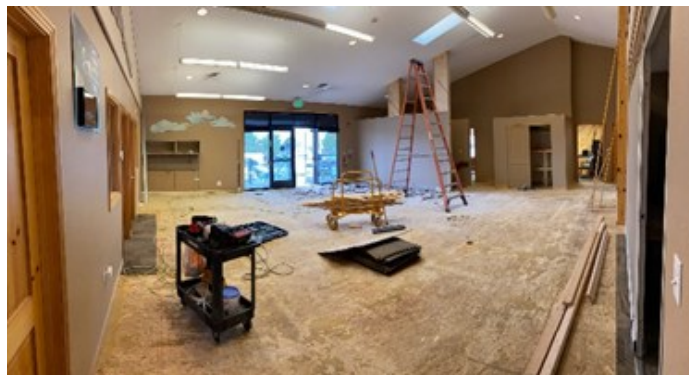
with GTC, HB&A (the project architect) and Town staff working on the Engineering Building remodel phase. Work includes framing, drywall installation, and rough-in for mechanical, electrical, and plumbing. Office spaces are being reconfigured and completion for this phase is scheduled for October 28. The overall project is proceeding within budget and on schedule for final completion by November 11, 2021.

*Remodel work in Engineering Building.*

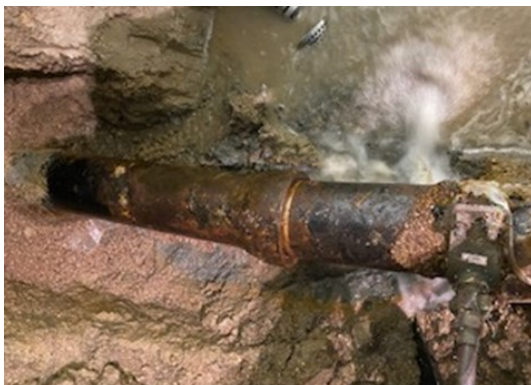
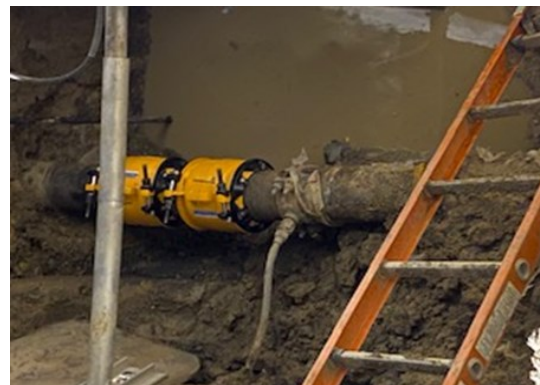
There was a main break in Plum Creek on 6" cast iron pipe. The team worked until the early hours of morning to conduct the repair. Nine homes were out of water for less than four hours.

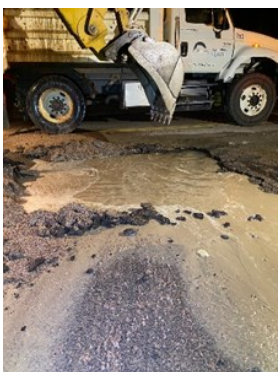
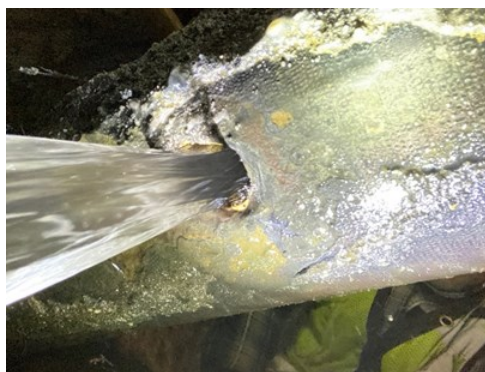
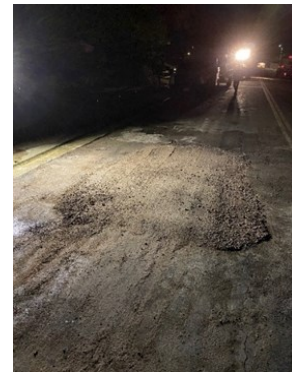
A main break occurred in the Oakwood Dr. area. A large hole developed in the unwrapped 8" ductile iron pipe. A 24" clamp was used to repair the damaged pipe. No homeowners were out of water during this repair.

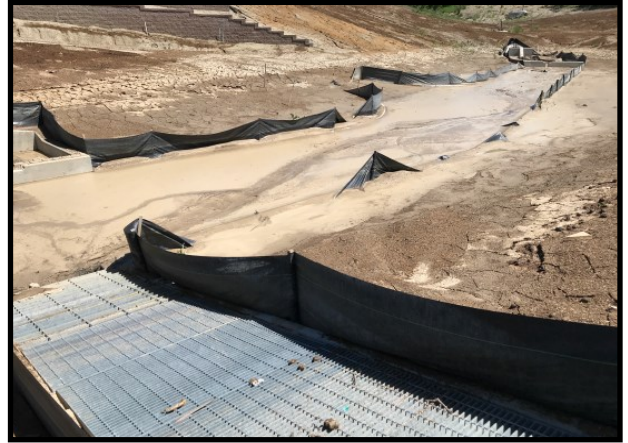
*The developer of this stormwater pond responded immediately and avoided a stop work order when a sudden storm hit during soil preparations for native seeding, filling the pond with sediment and damaging control measures.*

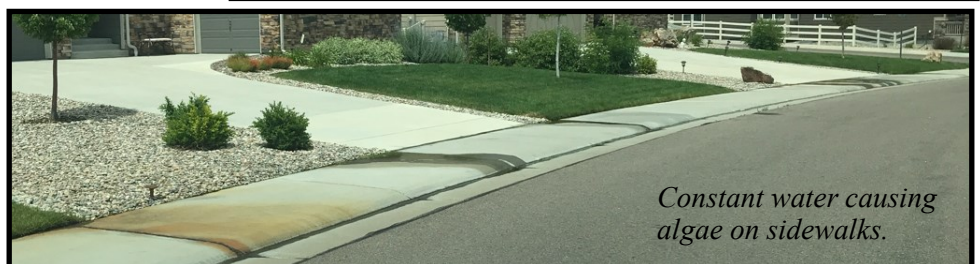
*Constant water causing algae on sidewalks.*

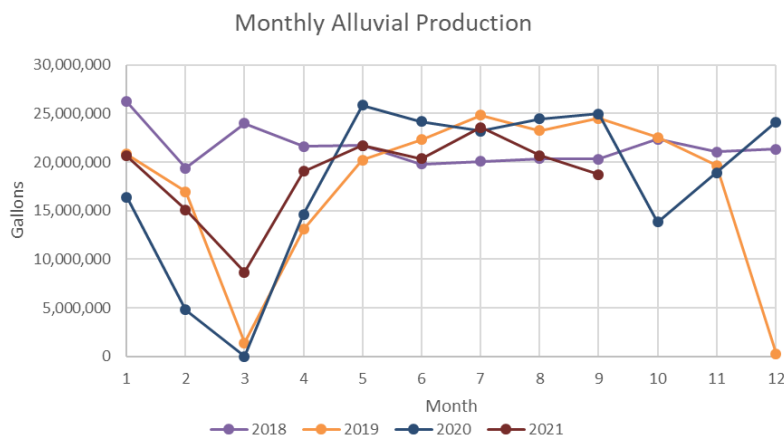
- The graph shows the monthly production of the Town's alluvial well system, which helps to supply PCWPF. The production from the alluvial wells in Sept. was 18.7
- We had three alluvial well rehabilitations completed this year.

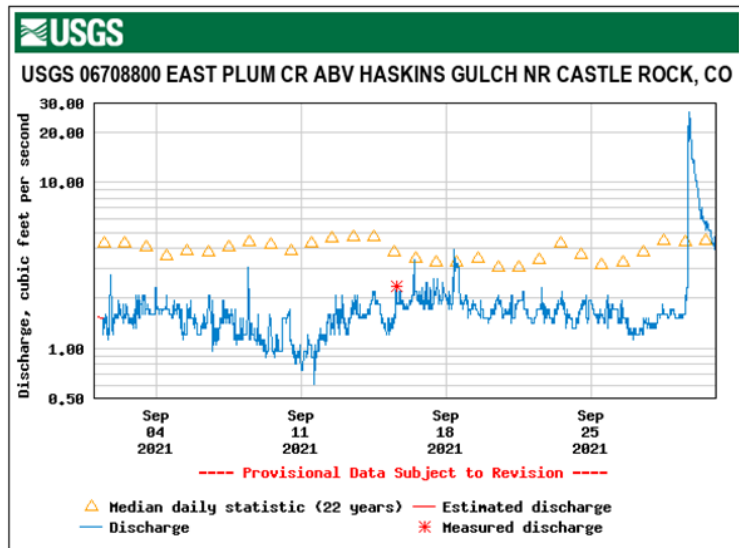
The flow hydrograph represents stream flows in East Plum Creek (EPC) taken from the stream gauge located above Haskins Gulch. The hydrograph shows that estimated flows in the East Plum Creek basin ranged between 0.6 and 25 cubic feet per second (cfs) during the month of September,

with an average streamflow of 1.9 cfs. This month's average streamflow of 1.9 cfs is below the 20-year median of 3.7 cfs.

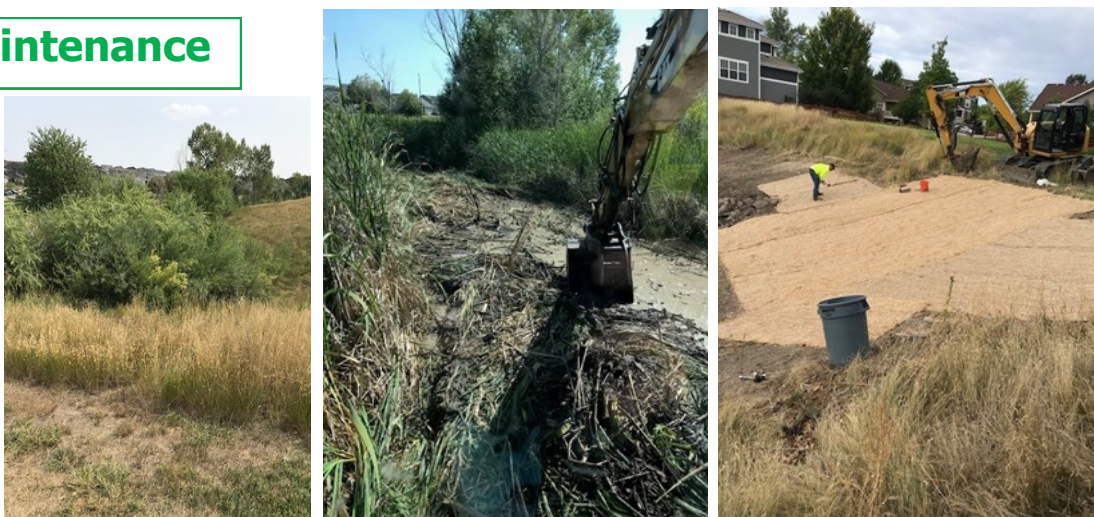
As part of the Failed Outfall maintenance program, the Stormwater team removed 244 Yards of organic matter and debris to renovate an outfall in The Meadows, near Meadows Parkway and Cherokee.
