## HISTORIC PRESERVATION BOARD APPLICATION

PROJECT NAME: Window and Door Restoration for the Douglas Masonic LodgePROPERTY ADDRESS / GENERAL LOCATION: 300 Wilcox StreetLEGAL DESCRIPTION: Range 8, Township 67, Block 19, Lot 7 in Castle Rock, ColoradoPROJECT DESCRIPTION: Please see enclosed Project Description, floor plan & photos to better understand the scope of work.  
The project will include exterior door restoration and window restoration. See Attachment A and Budget Worksheet.

DOUGLAS MASONIC  
LODGE  
NO. 153 A.F. & A.M.

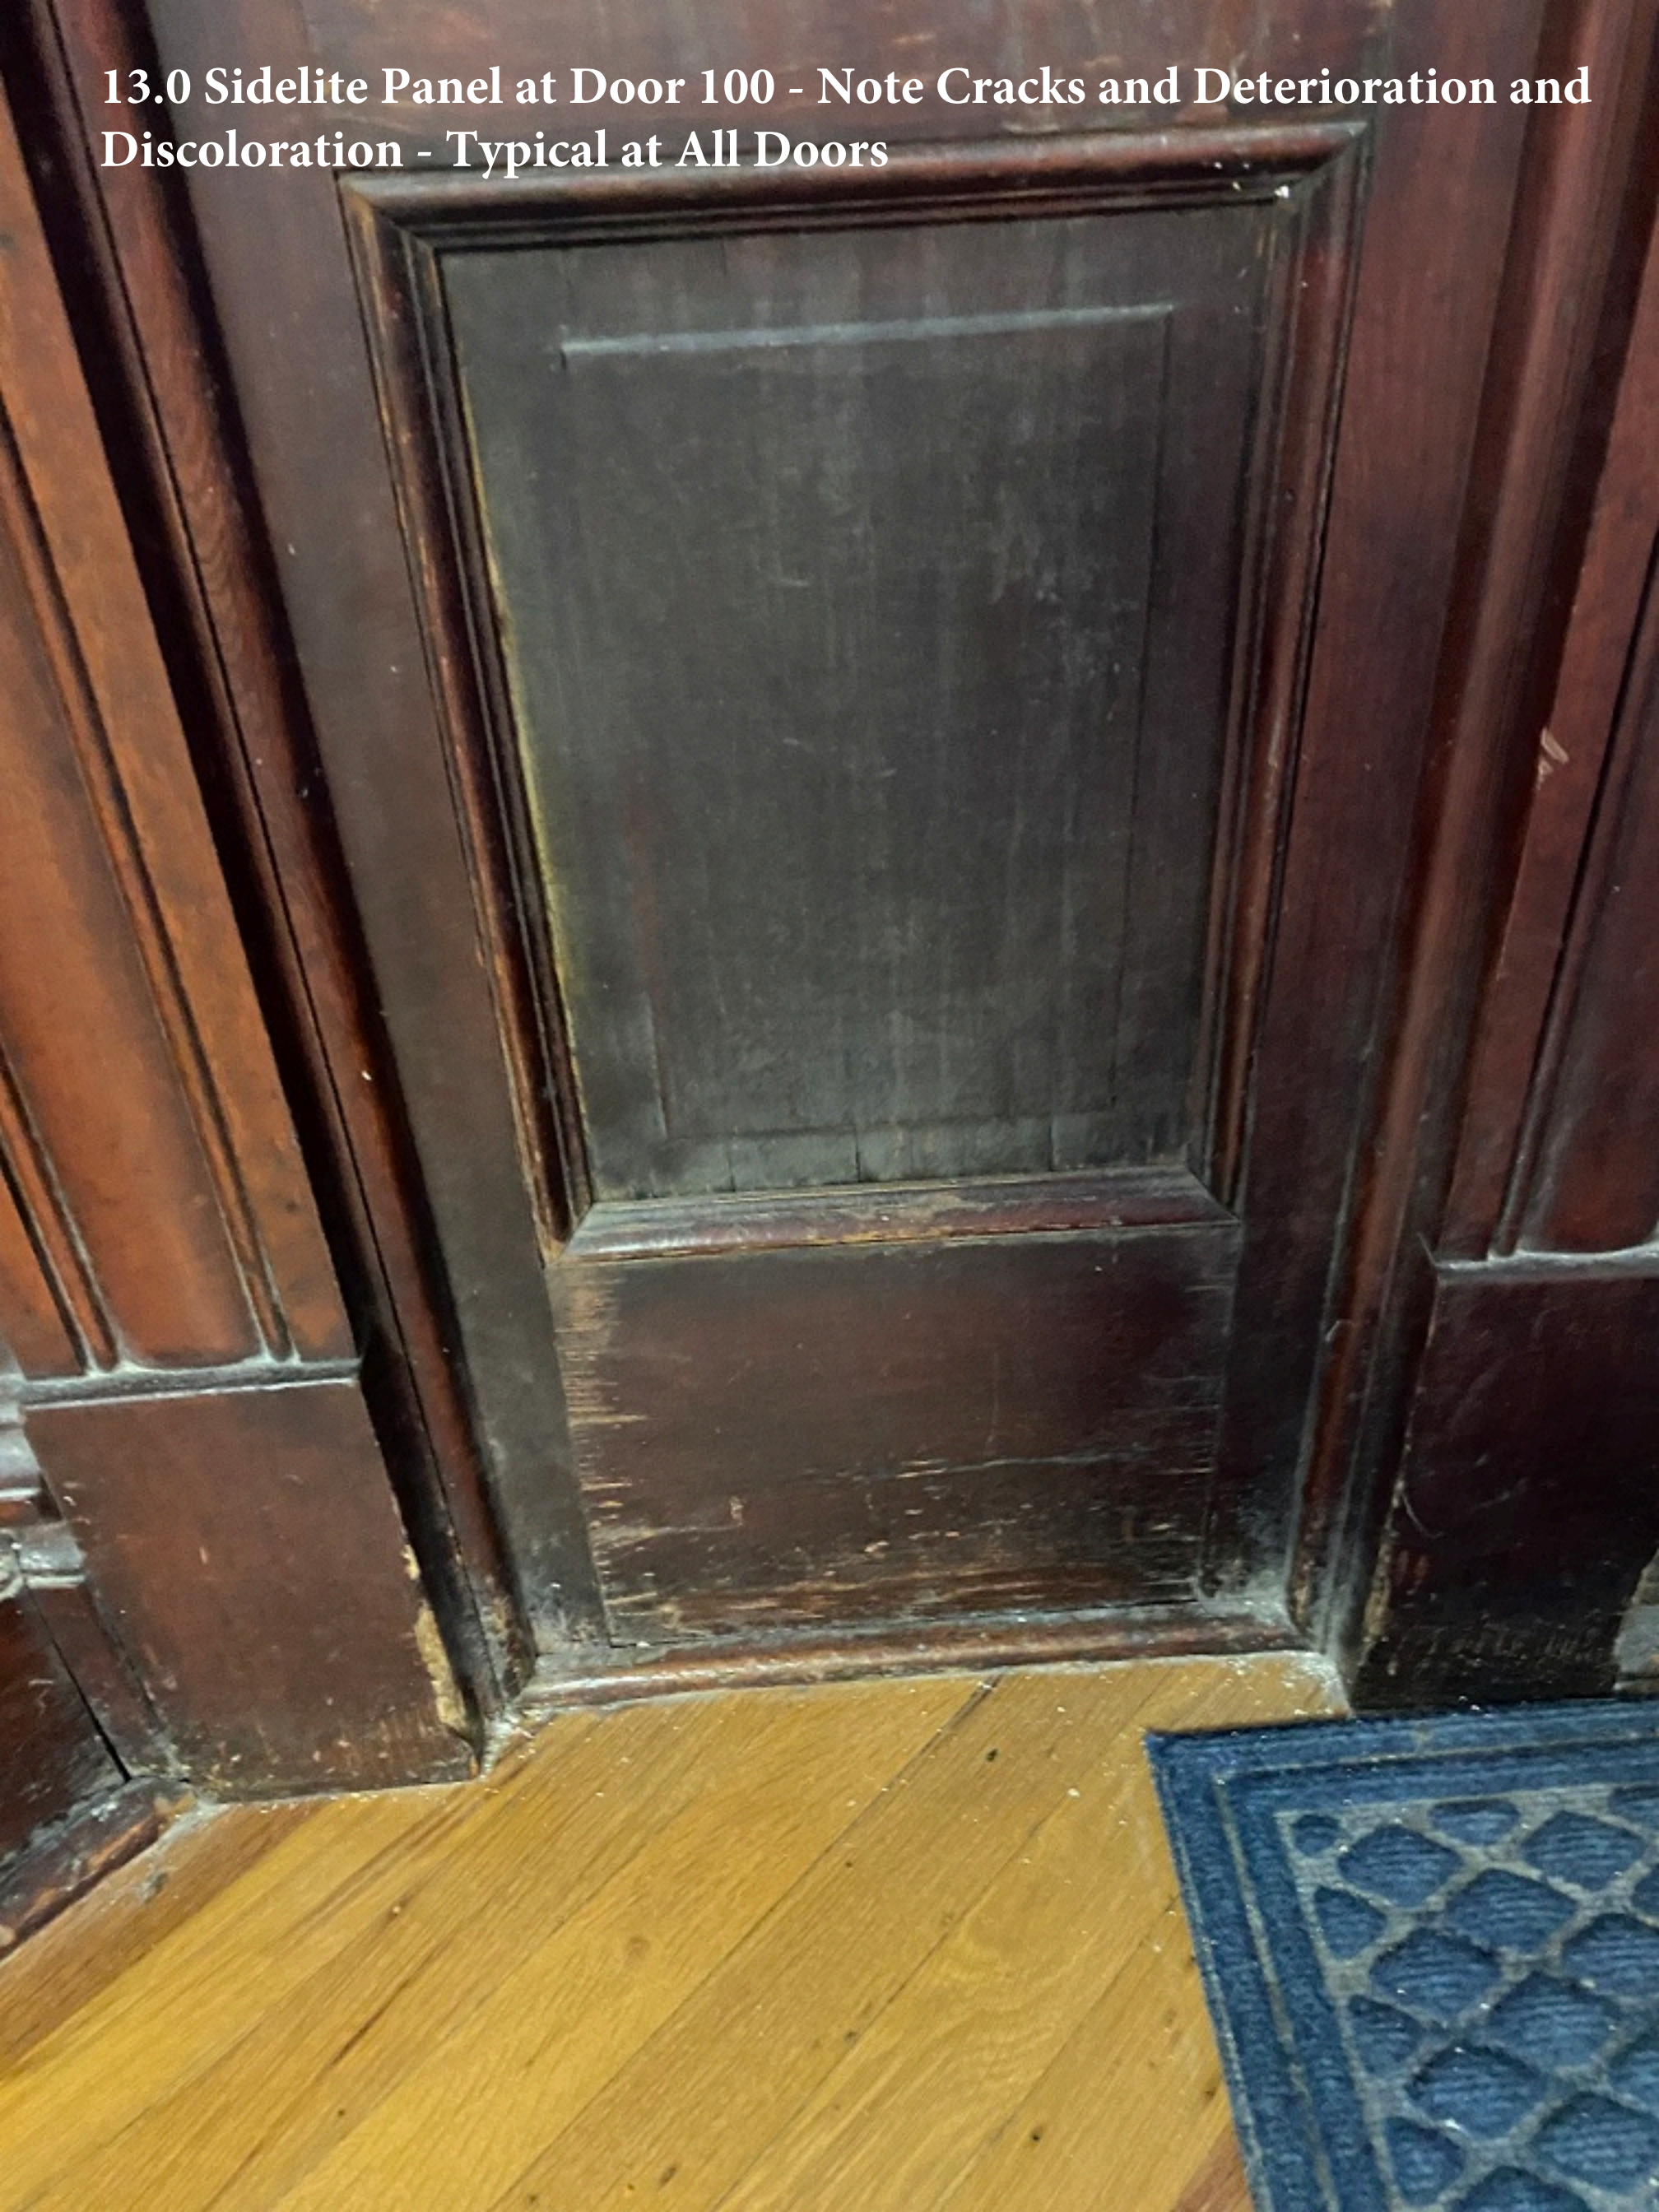
**14.0 Door 101 - Deterioration at Jambs and Panels - Splits Transfer Through the Entire Panel From the Exterior to the Interior - Typical All Doors**

All the Doors will require Class I (routine maintenance), Class II (structural stabilization) and Class III (parts replacement) repairs. As a part of the Class I repairs, the doors, transoms, and sidelight frames and joints will be tightened, the doors will be reglazed and new weatherstripping will be installed. The Class II repairs will require removing the paint to bare wood completing epoxy consolidation. This will include repairs to split panels, filling open joints where rot exists and rebuilding areas of the door that are gouged or partially missing. We will also be doing epoxy consolidation at the thresholds. Class III repairs will include Dutchmen repairs where the wood is too deteriorated to utilize epoxy or is missing in its entirety. We anticipate that some door bottoms may require replacement and most of the brick mold will require either dutchmen repairs or complete replacement with replica trim. Additionally, the historic wood glazing stop will be replaced with glazing putty as we did on the windows during their restoration. Wood glazing stops do not last with the hot sun, causing them to warp and the glass loosen in the opening.

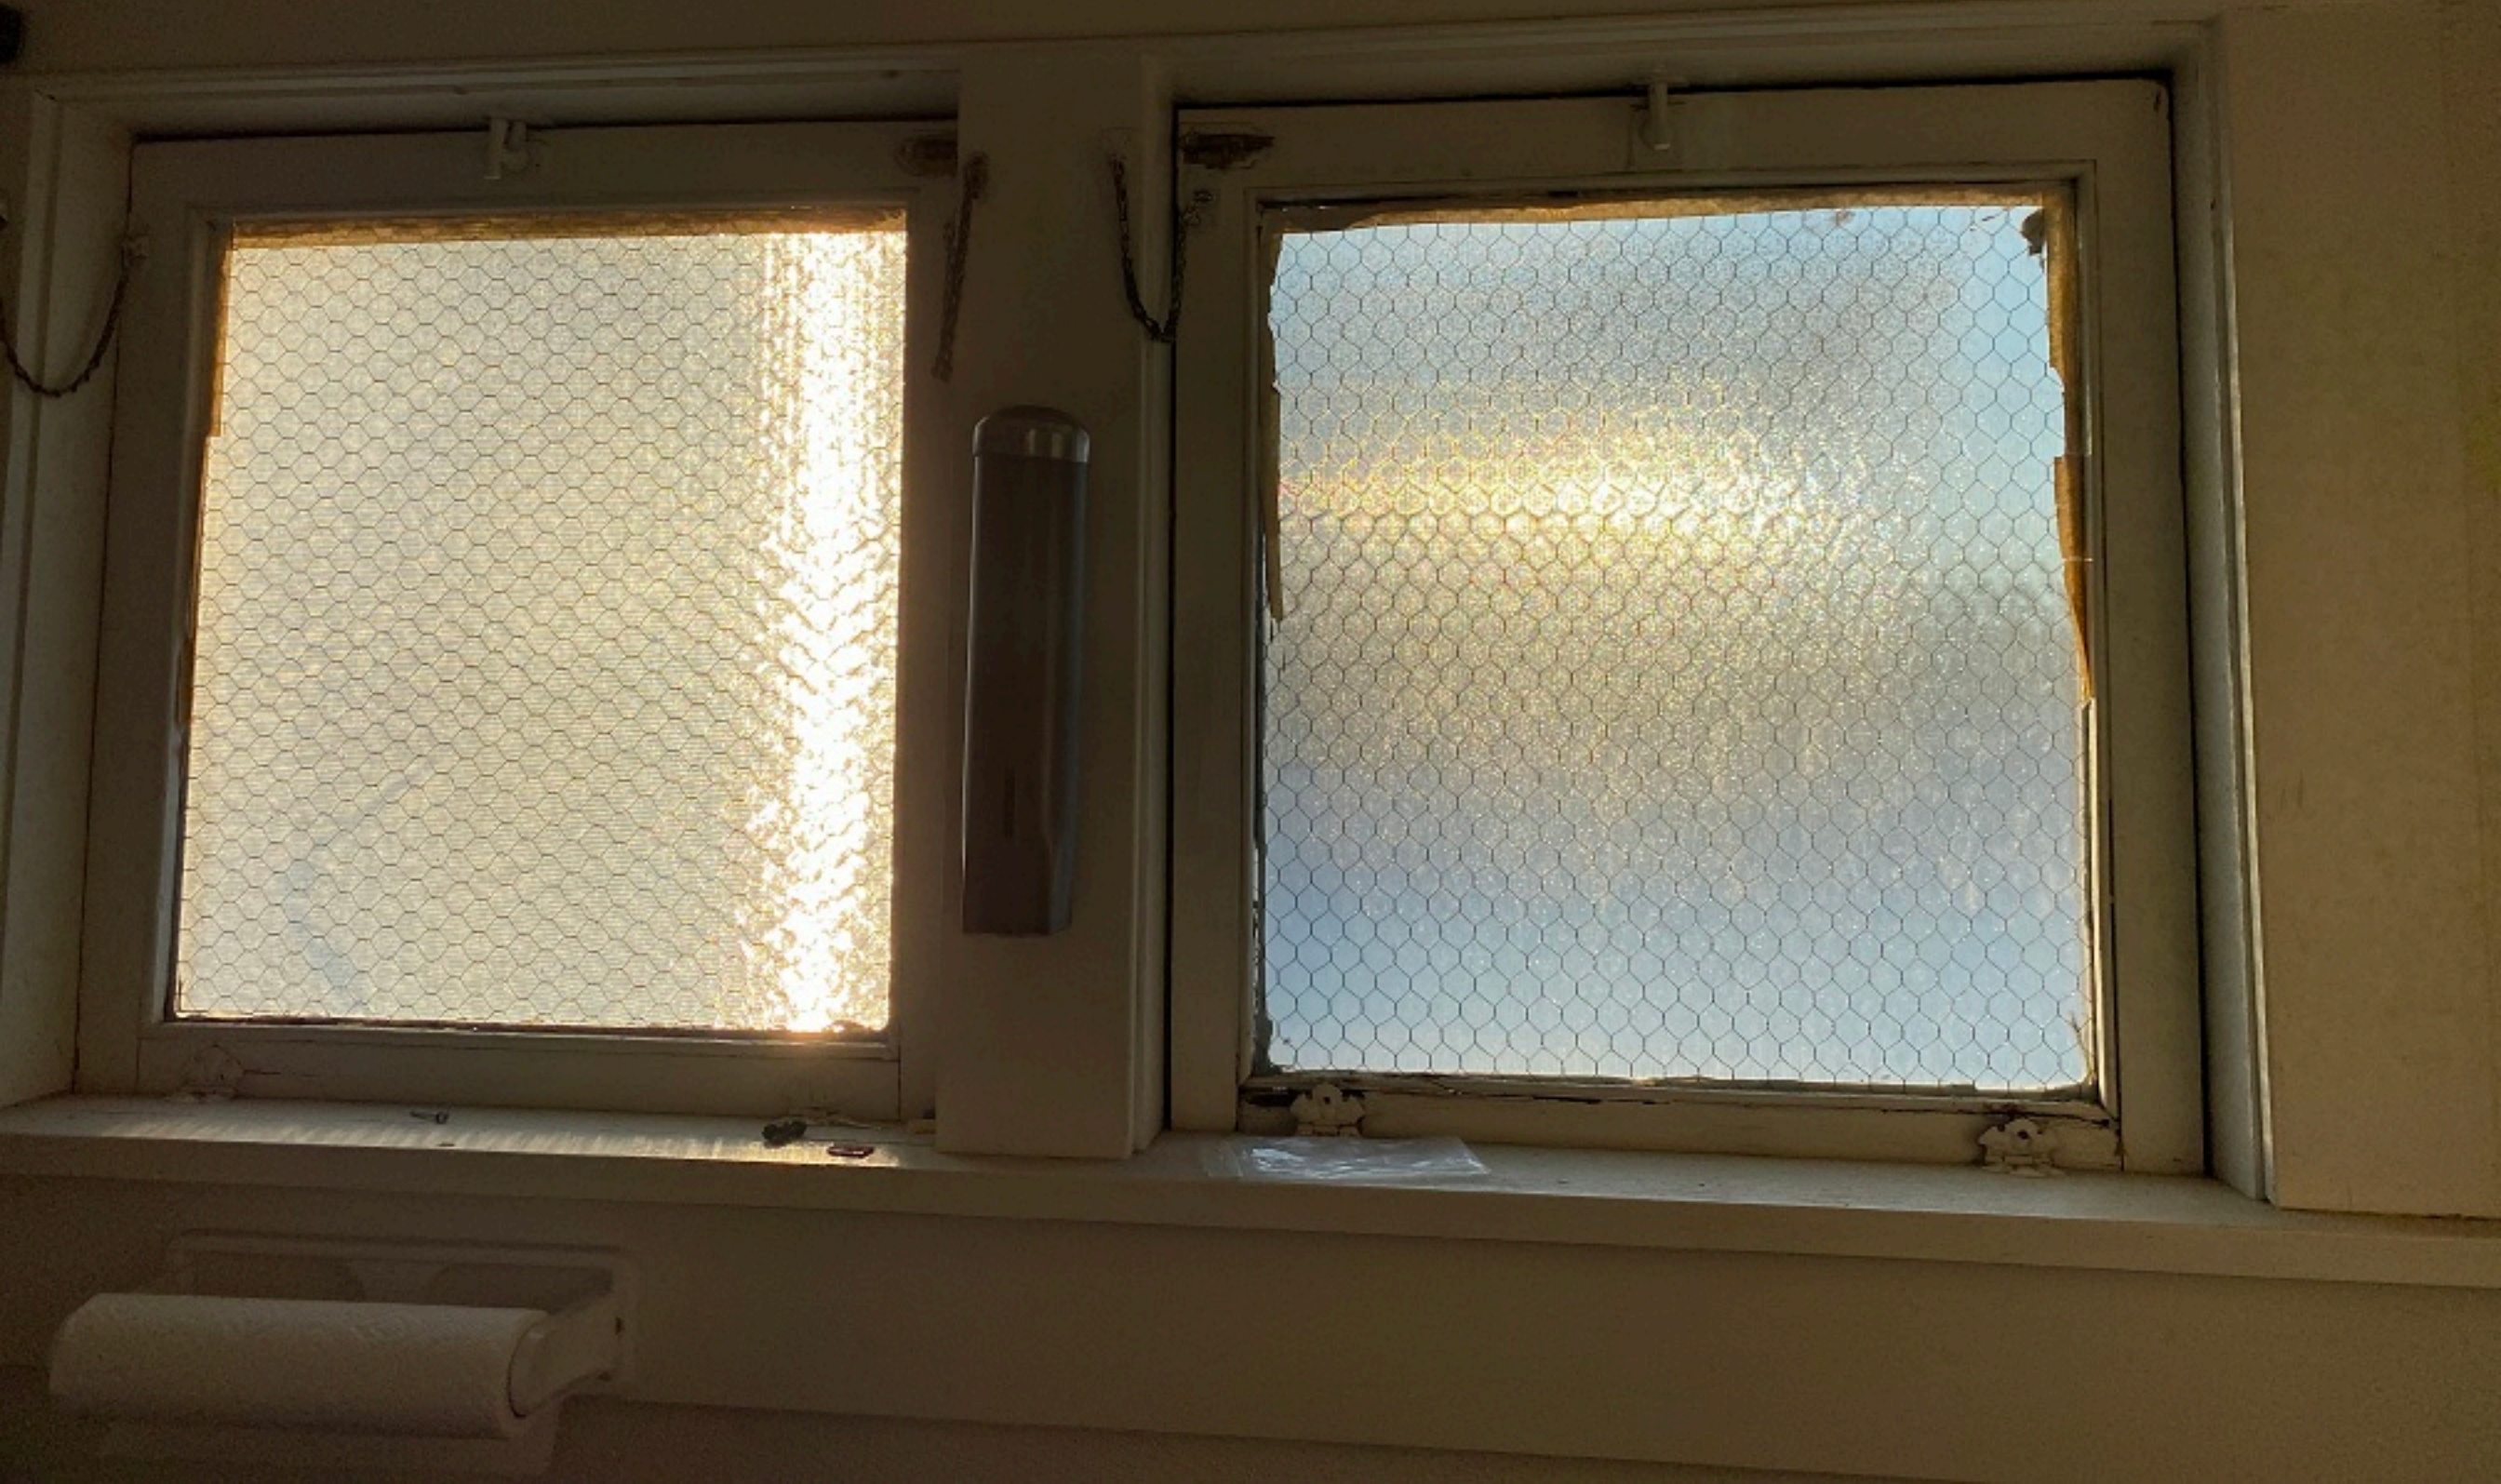
**26.0 Deteriorated Bottom Rail at Window E and Damaged Wood Glazing Stop at Window E**

Windows D & E will be restored, completing Class I, Class II and Class III Repairs. There will be some dutchmen repairs required at the bottom rail due to rot and new roof flashing will be installed to flash into the adjacent roofing on the exterior. The window hardware will be replaced with replica hardware where it has been damaged and restored where possible. The windows will be painted the historic color on the exterior and painted white on the interior as they were historically.

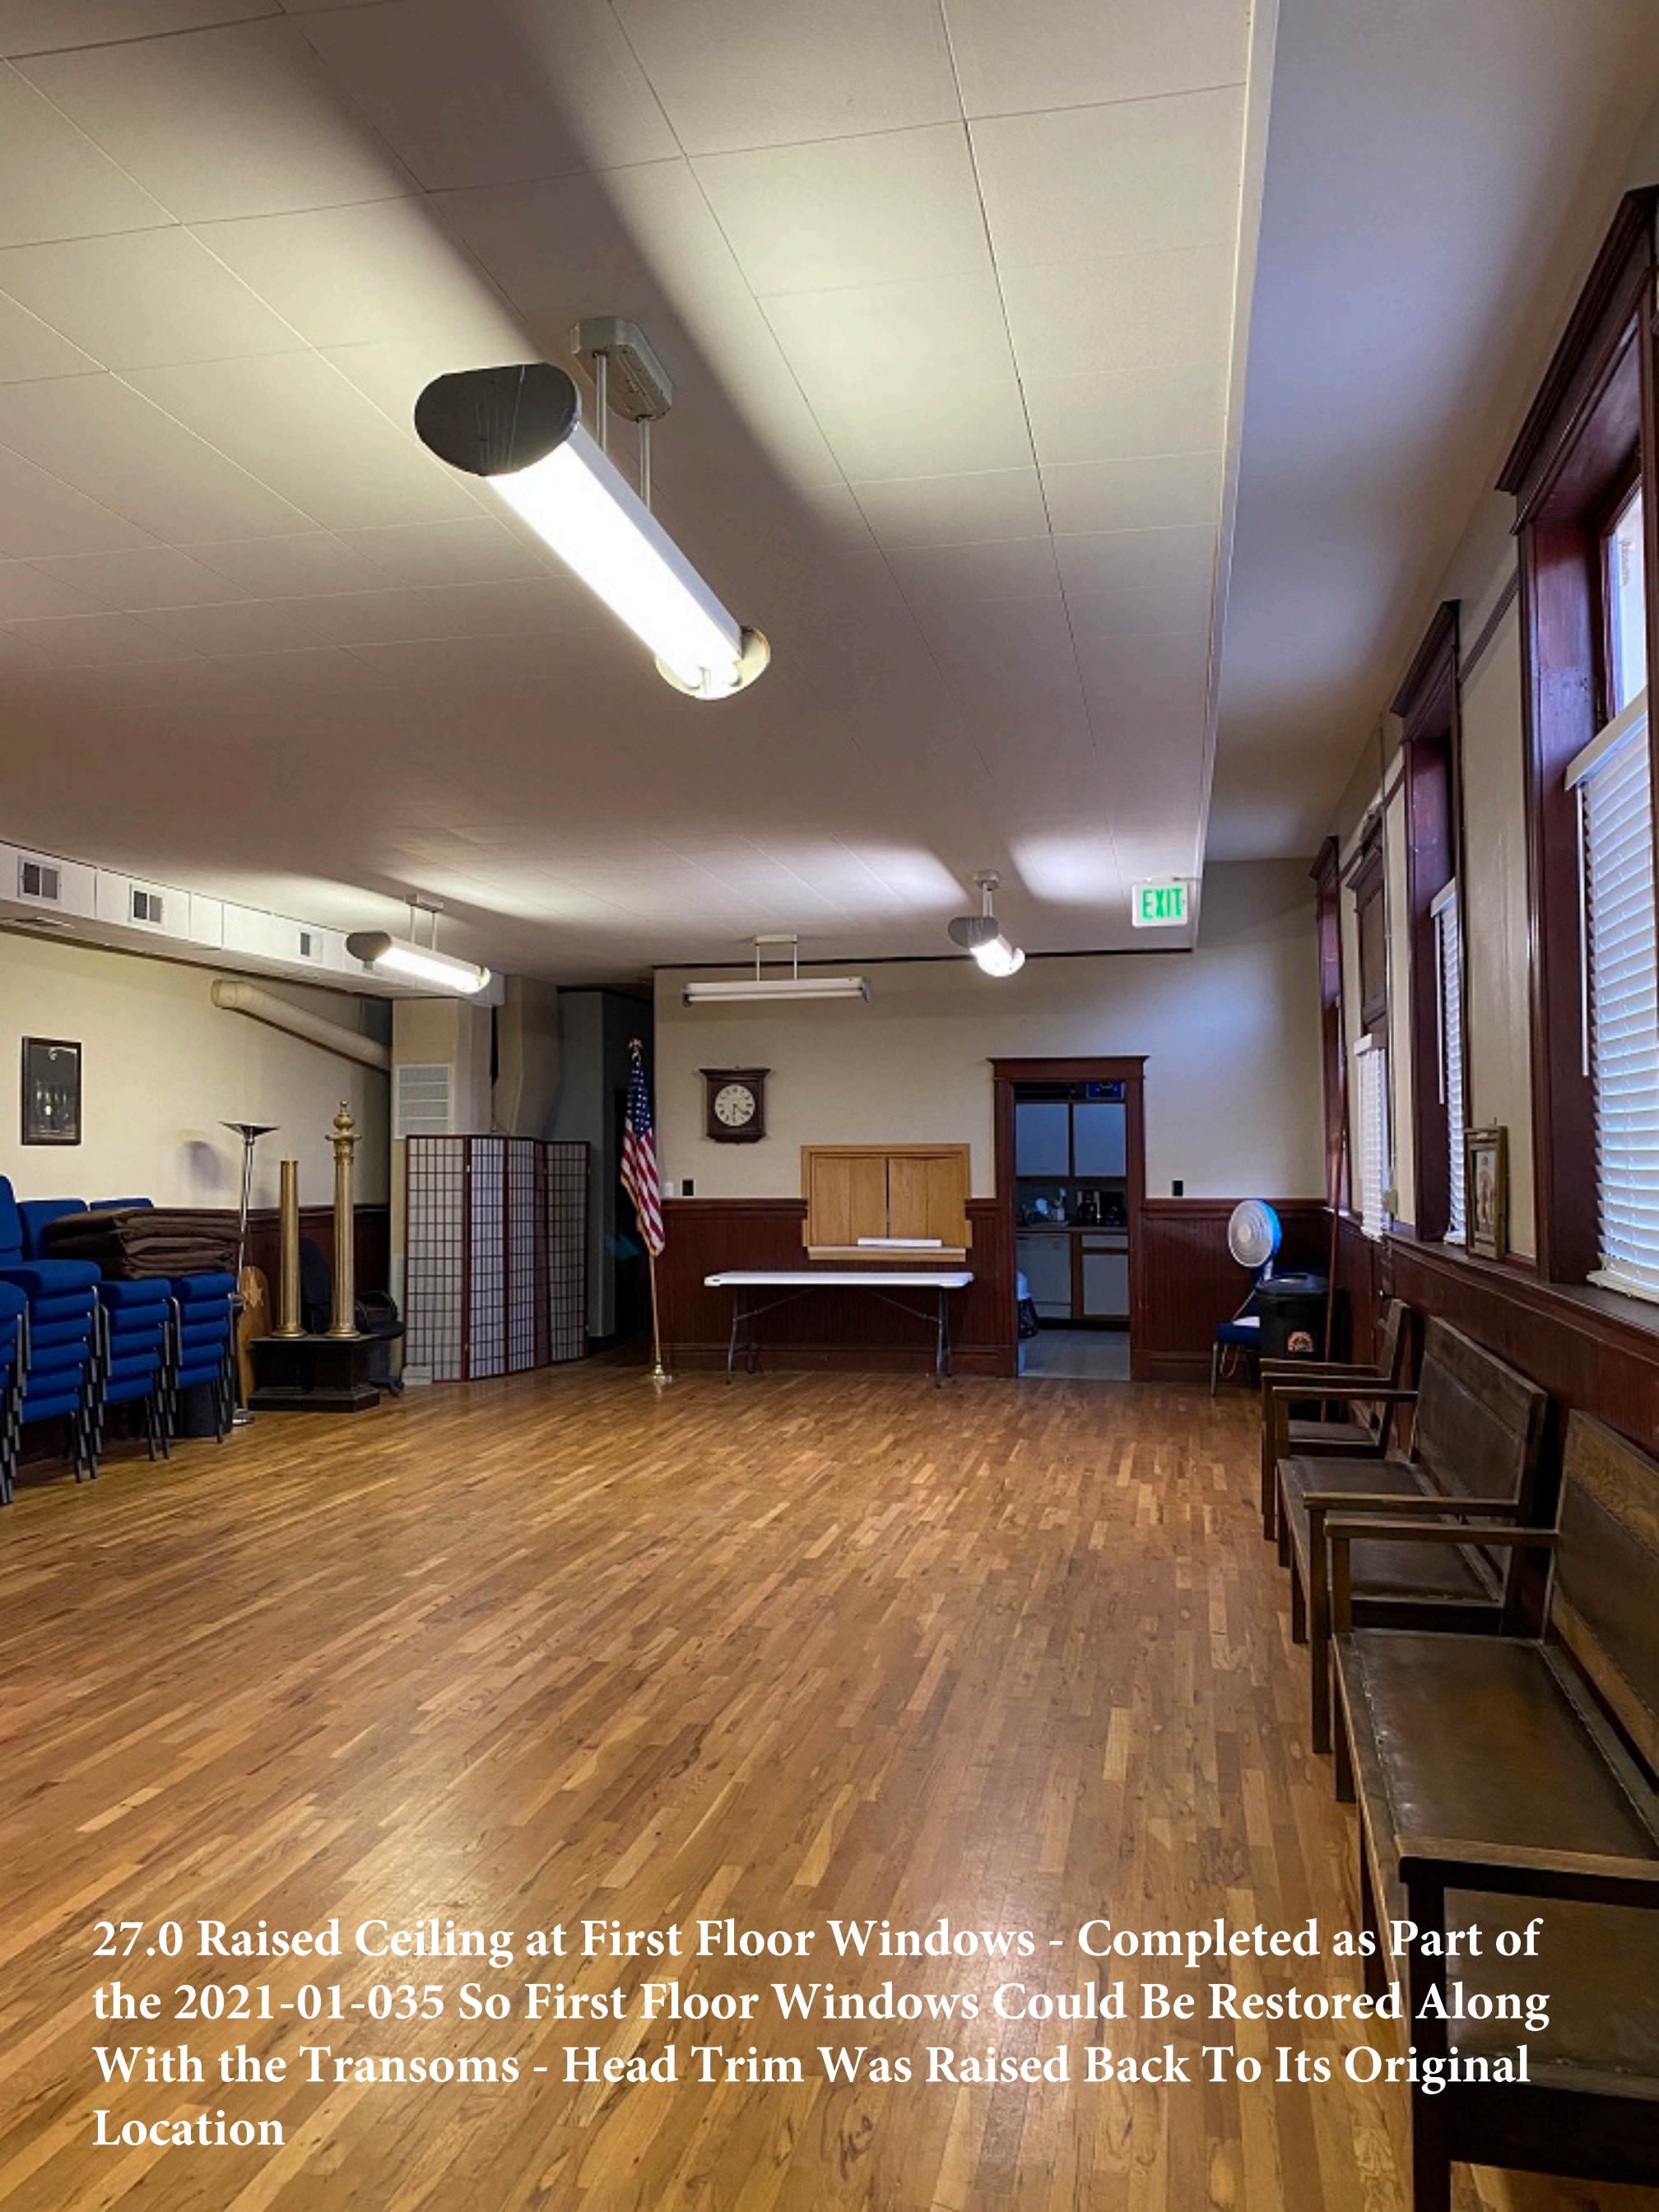
27.0 Raised Ceiling at First Floor Windows - Completed as Part of the 2021-01-035 So First Floor Windows Could Be Restored Along With the Transoms - Head Trim Was Raised Back To Its Original Location
