COLORADO CULTURAL RESOURCE SURVEY

Architectural Inventory Form

1. Resource Number: 5DA.217
2. Temporary Resource Number: 838
3. County: Douglas
4. City: Castle Rock
5. Historic Name: Christensen House (Victoria's House)
6. Current Building Name: Castle Rock Chamber of Commerce
7. Building Address: 420 Jerry Street
8. Owner Name and Address: Castle Rock Chamber of Commerce; 420 Jerry Street, Castle Rock 80104

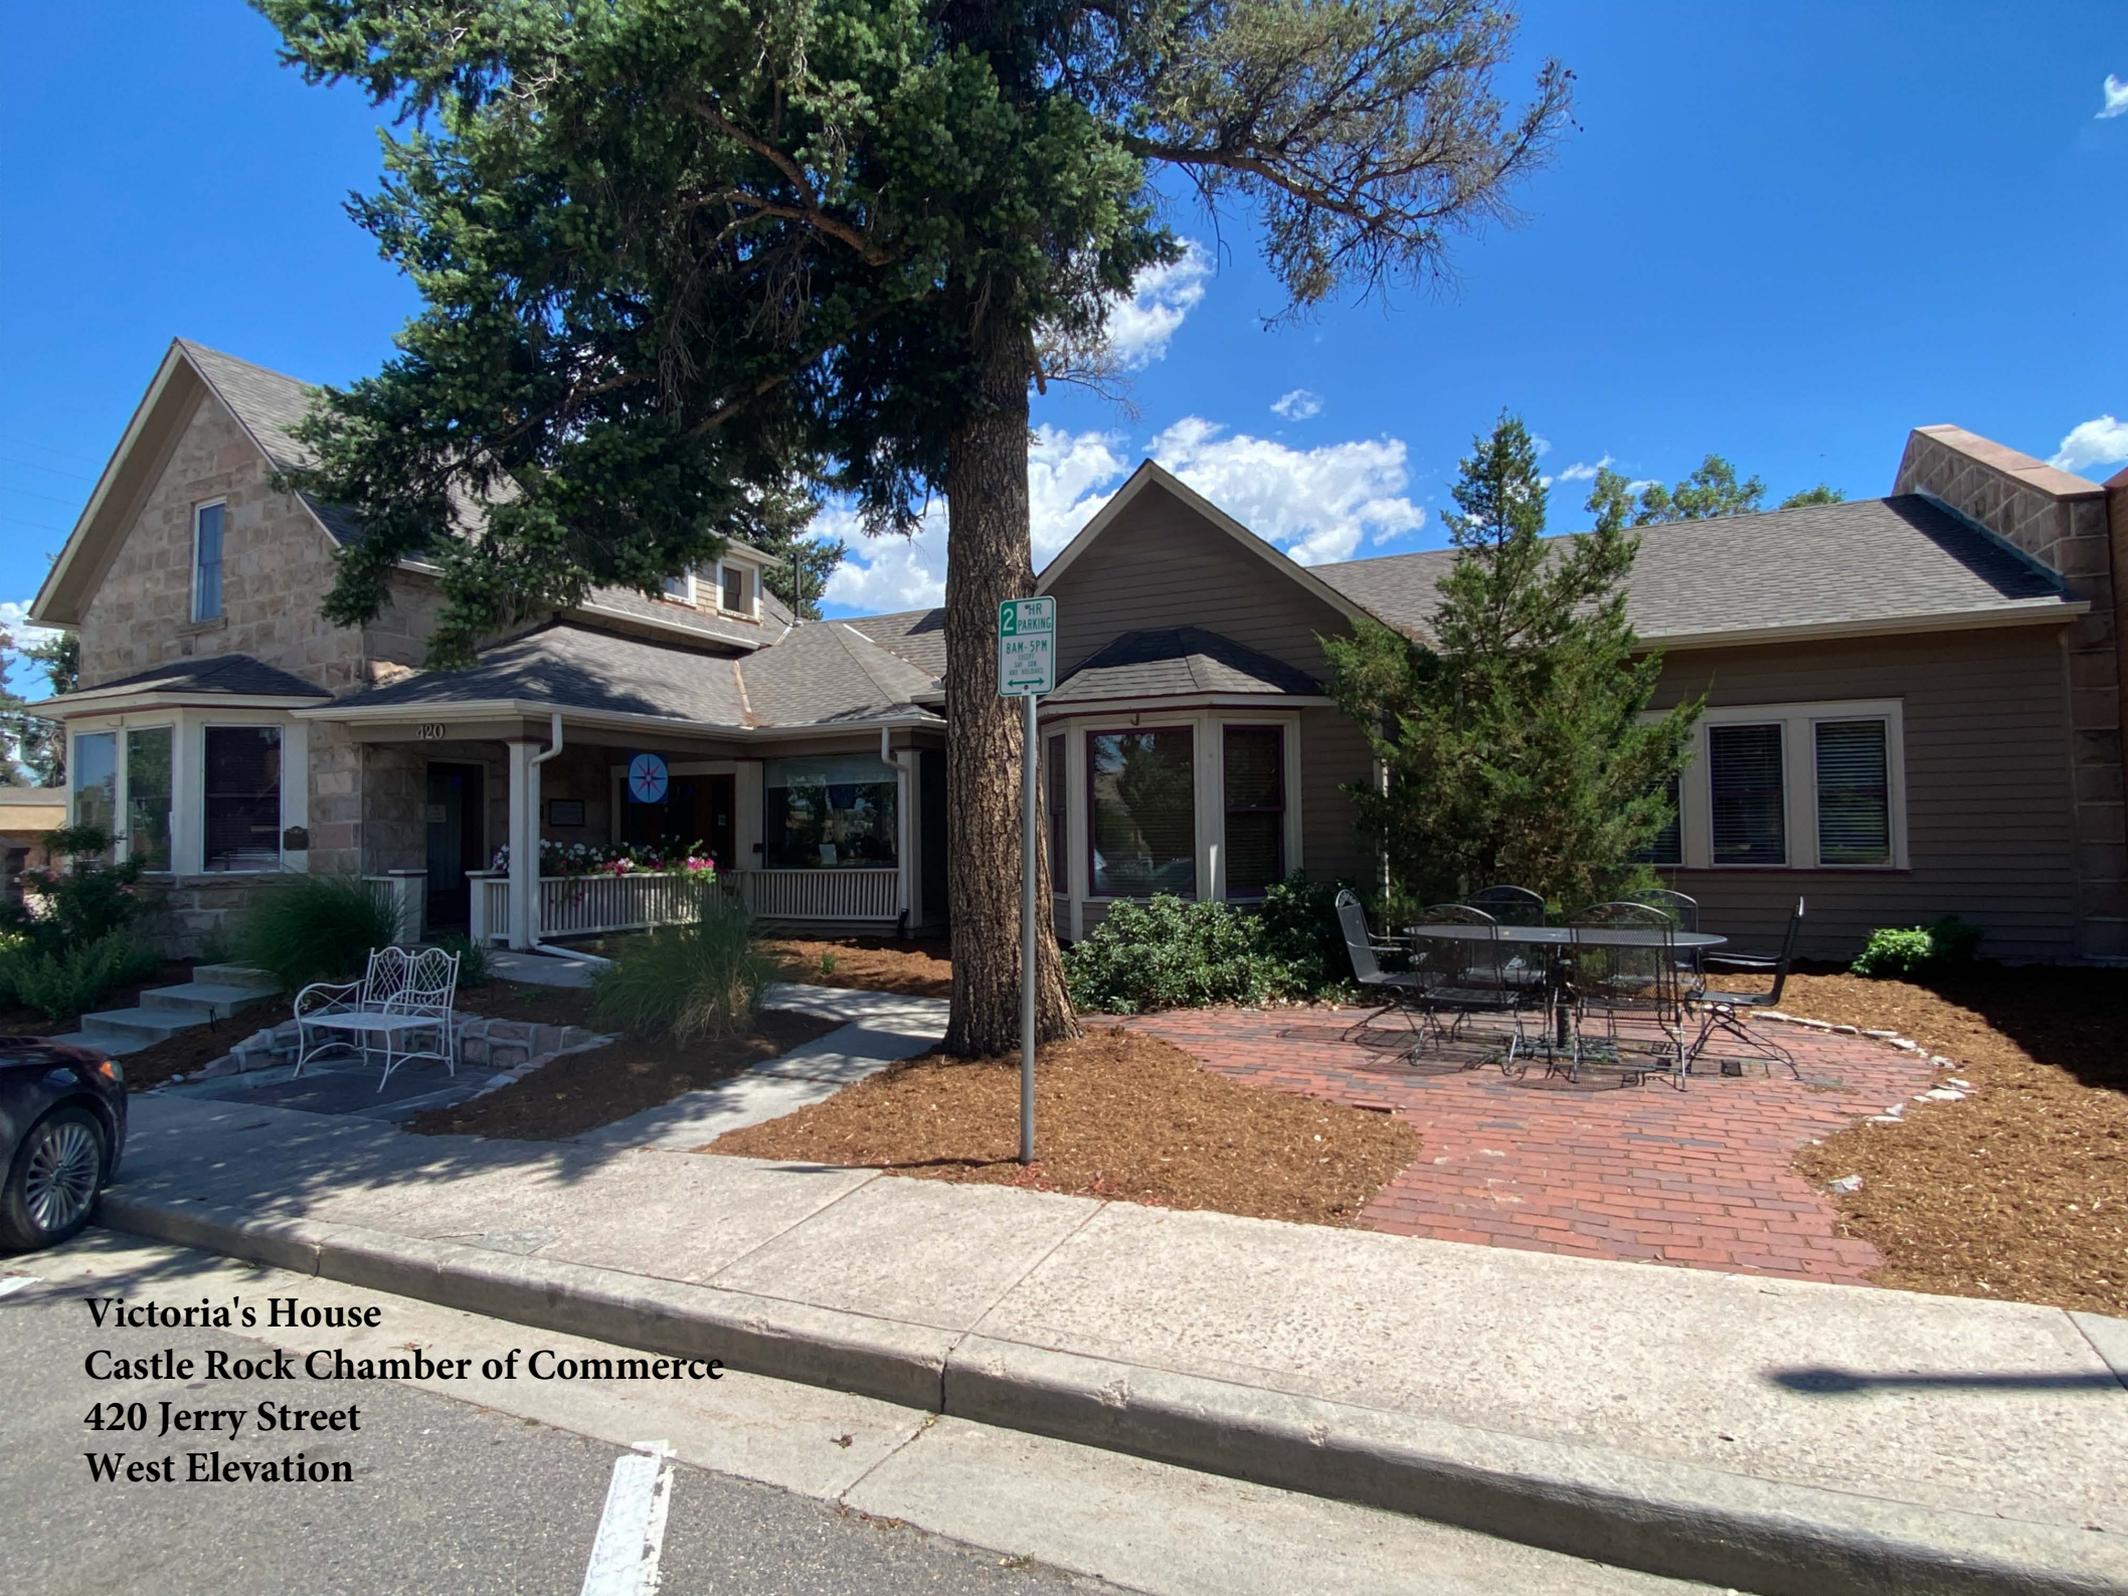
**Victoria's House
Castle Rock Chamber of Commerce
420 Jerry Street
West Elevation**

West Elevation: The west elevation of the original building is described above under Front Façade. The remainder of the west elevation is a string of additions that were added onto the west elevation of the original

building and to the south end of the original building. The addition connected to the west elevation of the original building, is accessed from the porch described above under Front Façade. The entrance door is a contemporary wood door with a single glazed lite with single glazed sidelights on either side. To the south of the doors is a large plate glass window.

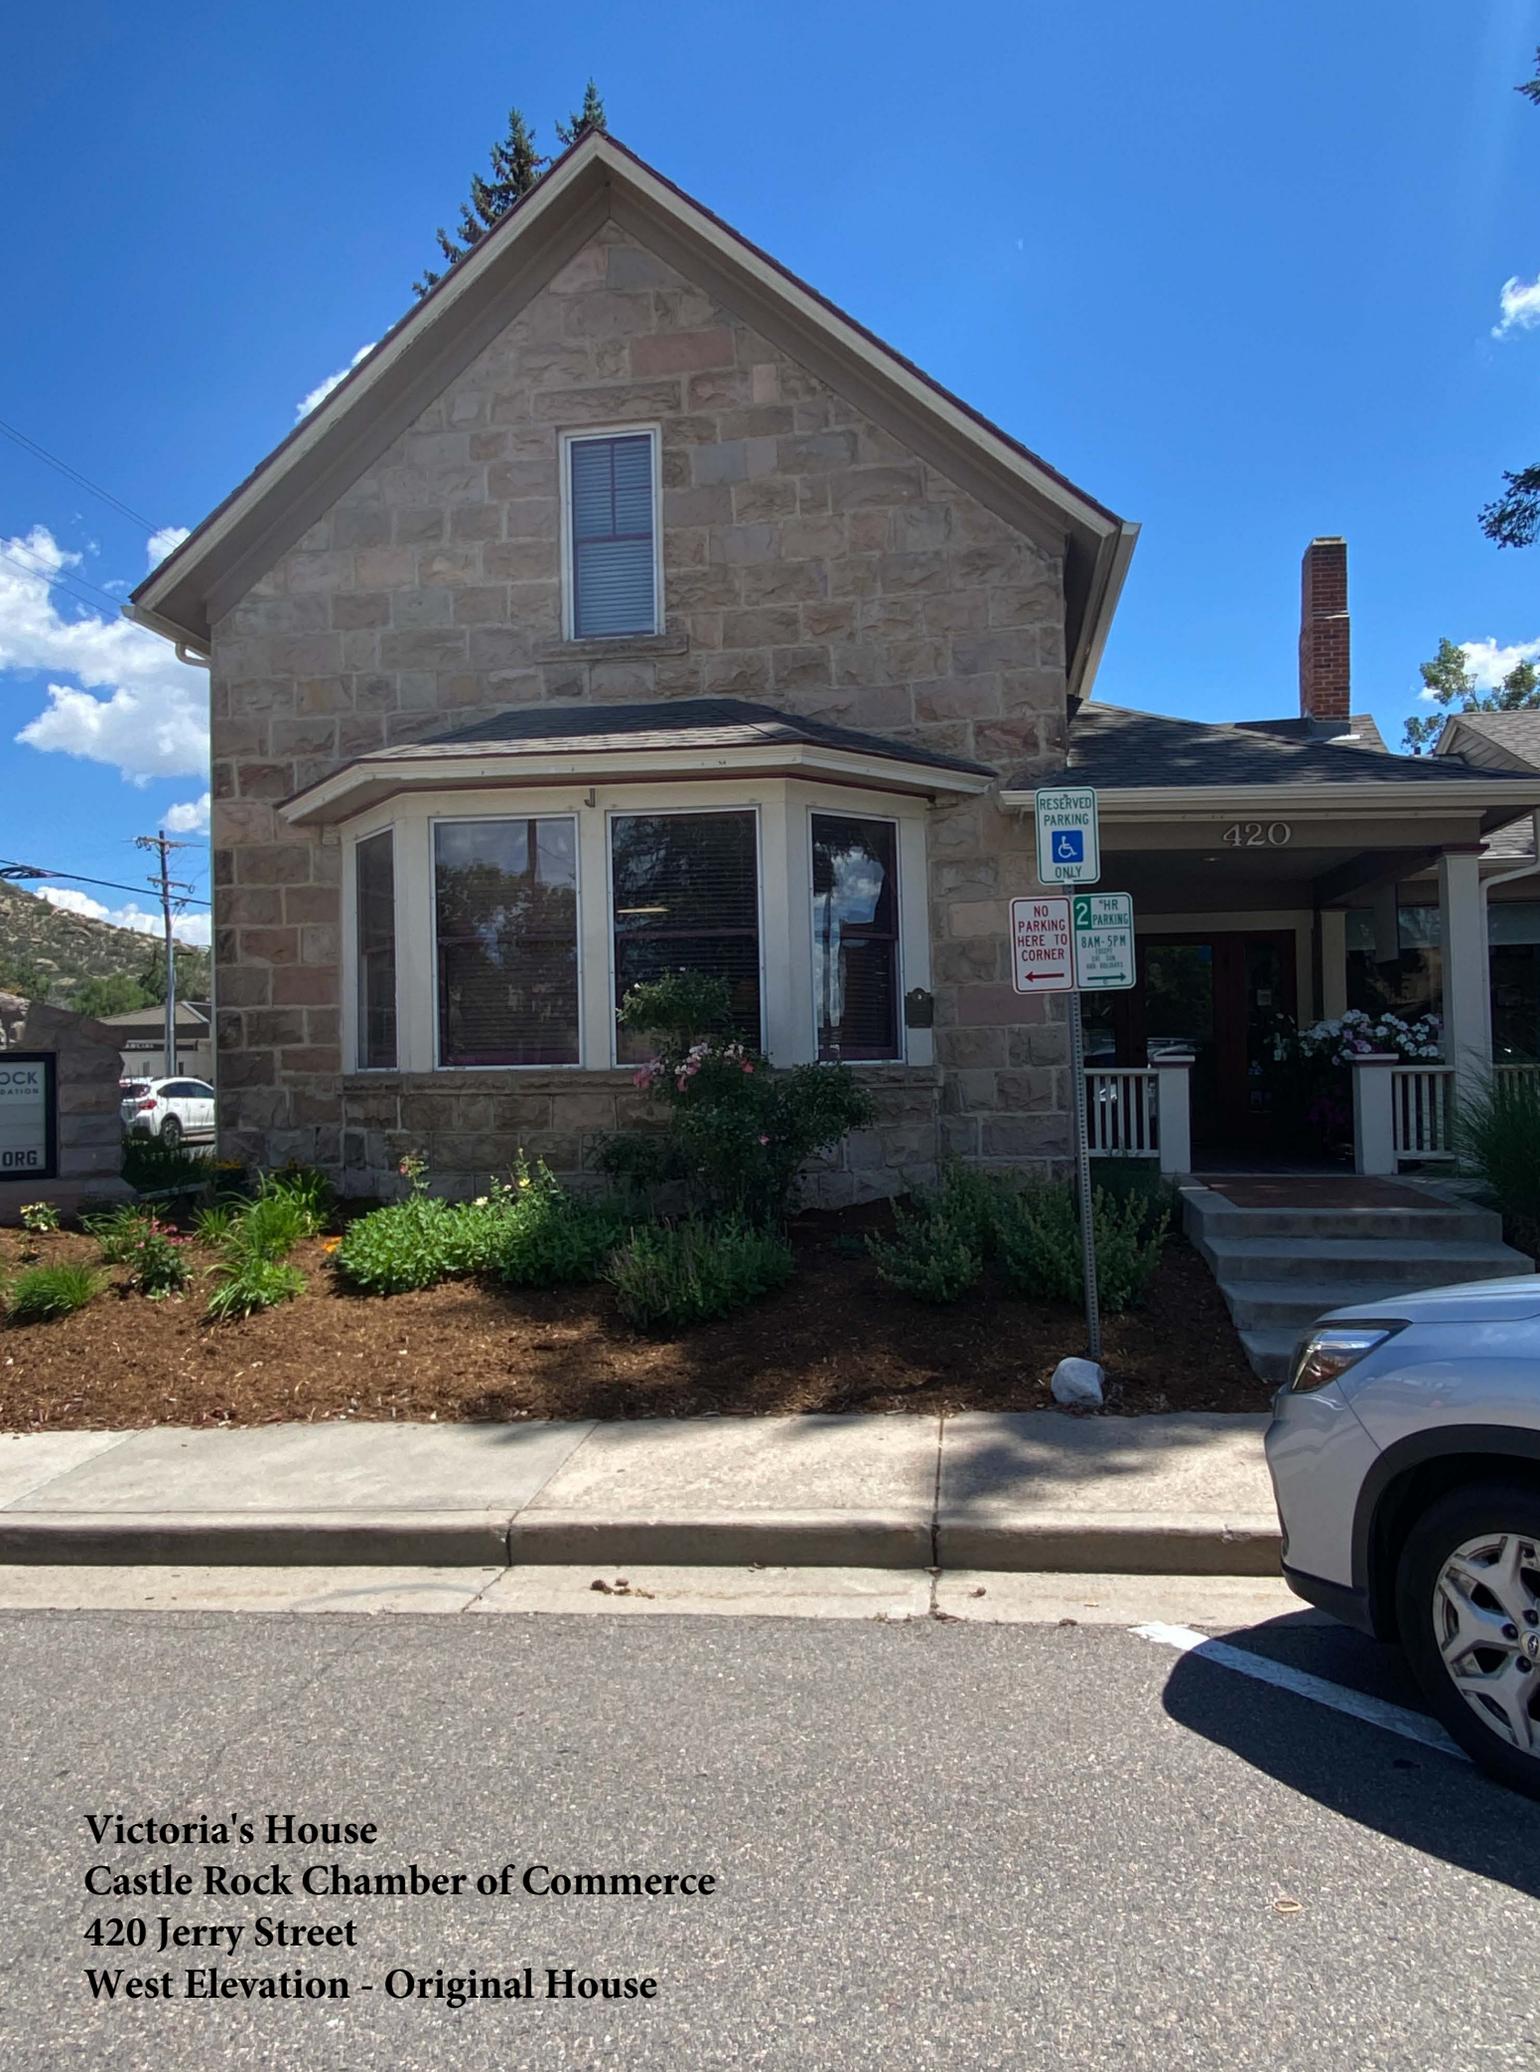
Victoria's House
Castle Rock Chamber of Commerce
420 Jerry Street
West Elevation - Original House

The original building (circa 1889) is a front gable vernacular building constructed of Castle Rock rhyolite that was quarried locally and can be seen in numerous buildings in town. The stone is rusticated with a historic beaded mortar joint that has not been replicated consistently with the more contemporary repointing. The sills of the windows, unless noted otherwise are a rusticated rhyolite with a tooled edge banding. The heads of the windows have a similar detail. The original plan was square with a front gable roof. A framed historic addition was added on the east and south elevation (circa 1917). The addition is two story with the second floor having a shed roofed dormer on the south elevation and a large, hipped dormer on the east elevation. In 1995, a contemporary addition was added to the south elevation. There are three masonry chimneys. One is at the south elevation of the historic addition. This chimney straddles the ridge of the roof. Another chimney is centered on the main roof of the original rhyolite building. The final chimney is located at the southeast corner of the rhyolite building and extends up the face of the east elevation.

Front Façade: The front façade has an original four window hipped-roofed bay on the first floor. The original 1/1, wood double hung windows remain behind aluminum storm windows. Above, centered on the gable, is a 4/1 double hung window behind an aluminum storm window. The main entrance to the historic building is on the south elevation and was accessed by a historic porch. The porch that now exists, does not appear to be original and is a hipped porch that dies into a hipped roof addition, covering the L-shaped original floor plan on the west elevation.

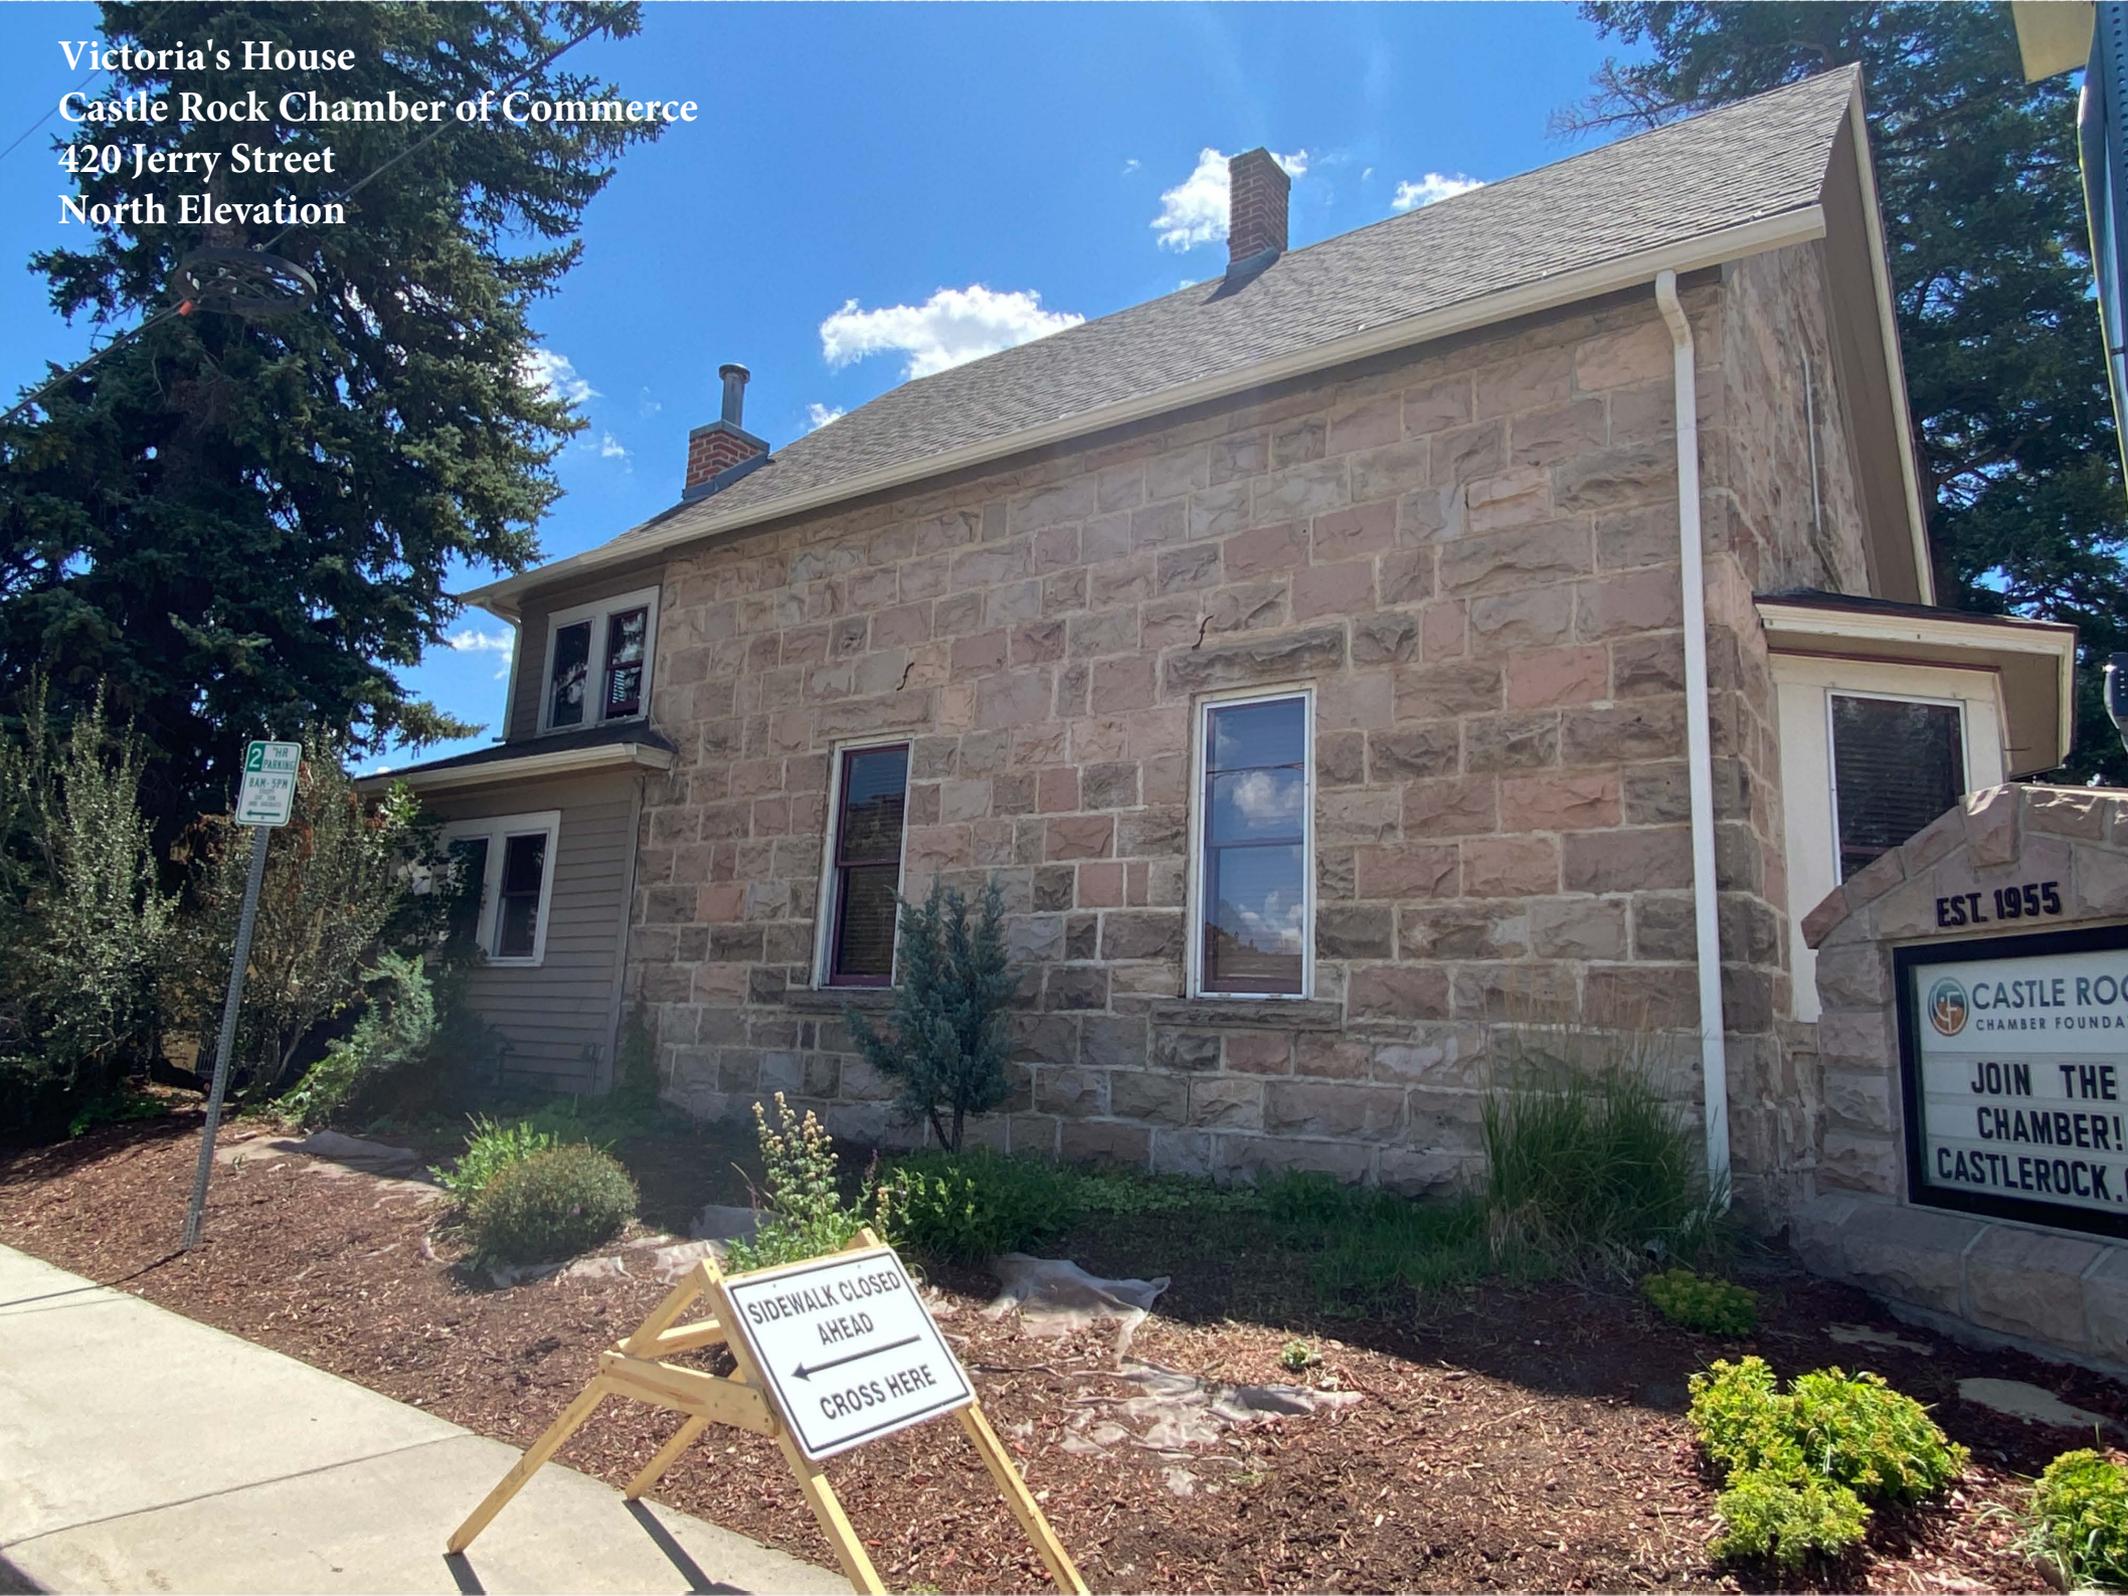
Victoria's House
Castle Rock Chamber of Commerce
420 Jerry Street
North Elevation

North Elevation: The north elevation of the original rhyolite building has two double hung, original 1/1, wood sash windows with aluminum storms centered on the elevation. To the east is the framed addition which abuts and aligns with the north side of the stone building. The addition has 1" x 4" corner boards with approximately 8" barge boards at the top. There are 3, 1/1 double hung wood windows with ¼ wood trim and head and wood sills centered on the elevation. Above the large shingle sided dormer has two 1/1, double hung, wood windows with storms. There is 1" x 4" trim surrounding the windows with a rain cap at the head.

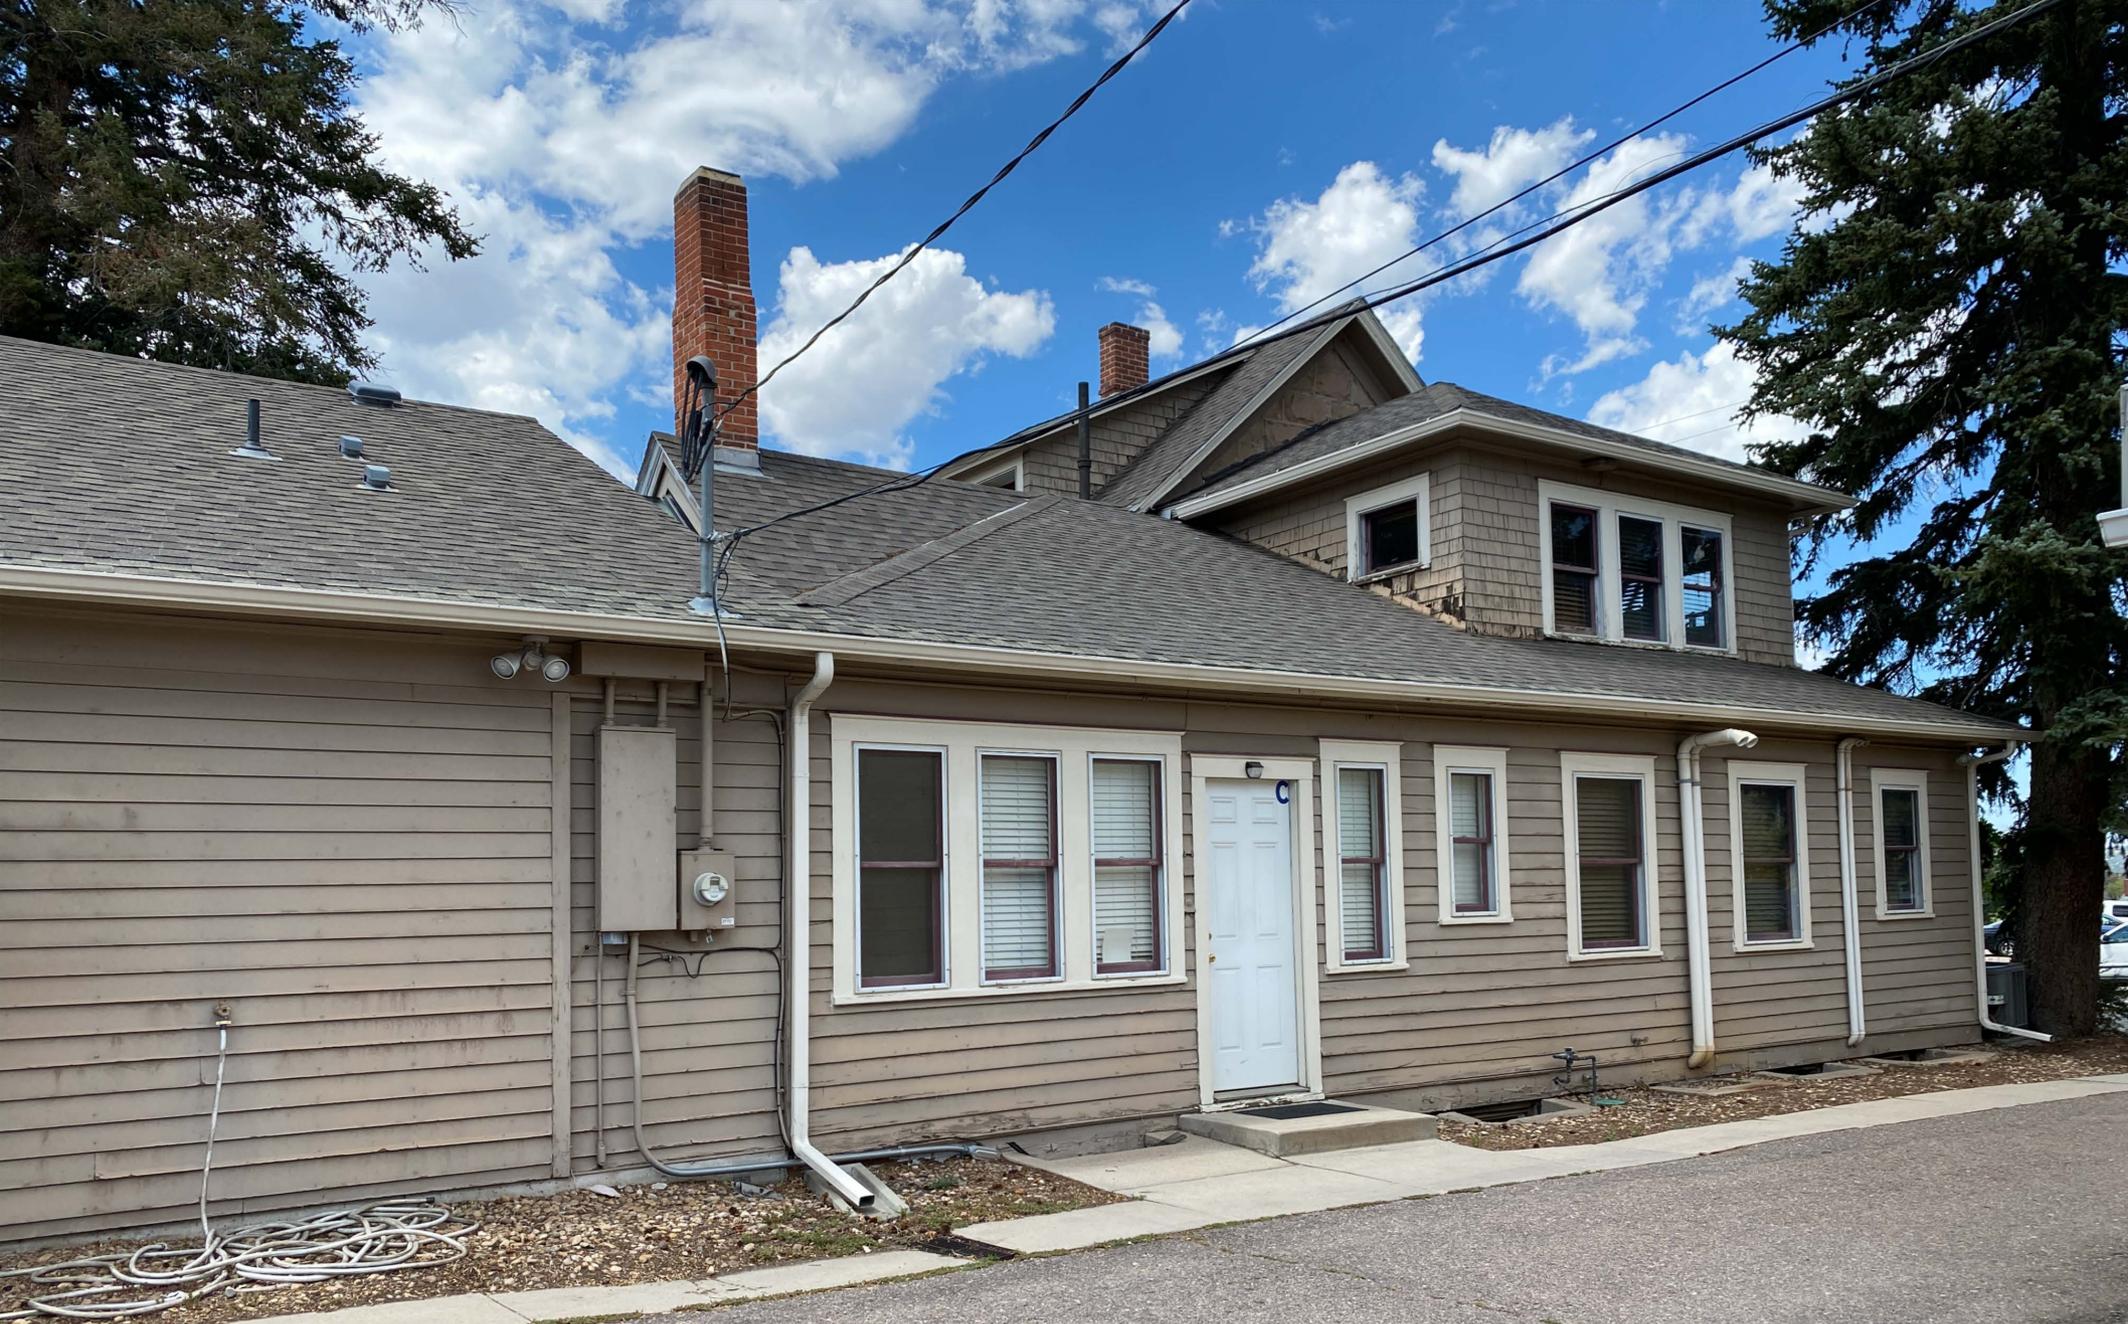
Victoria's House
Castle Rock Chamber of Commerce
420 Jerry Street
East Elevation - North End

East Elevation: The addition has a set of French doors near the south end of the elevation, flanked by two 1/1, wood sash windows. There is also another wood 1/1, single hung window near the north end of the addition. The historic addition has three 1/1, wood sash, double hung windows to the south of the back door. The historic door has been replaced with a contemporary 6-panel, metal door. To the north of the door are two windows. They differ in size and most likely the northern one was a historic bathroom window, as it is smaller and has obscure glazing. All the windows have aluminum storms. Centered on the dormer and to the north of the two windows is two historic double hung windows.

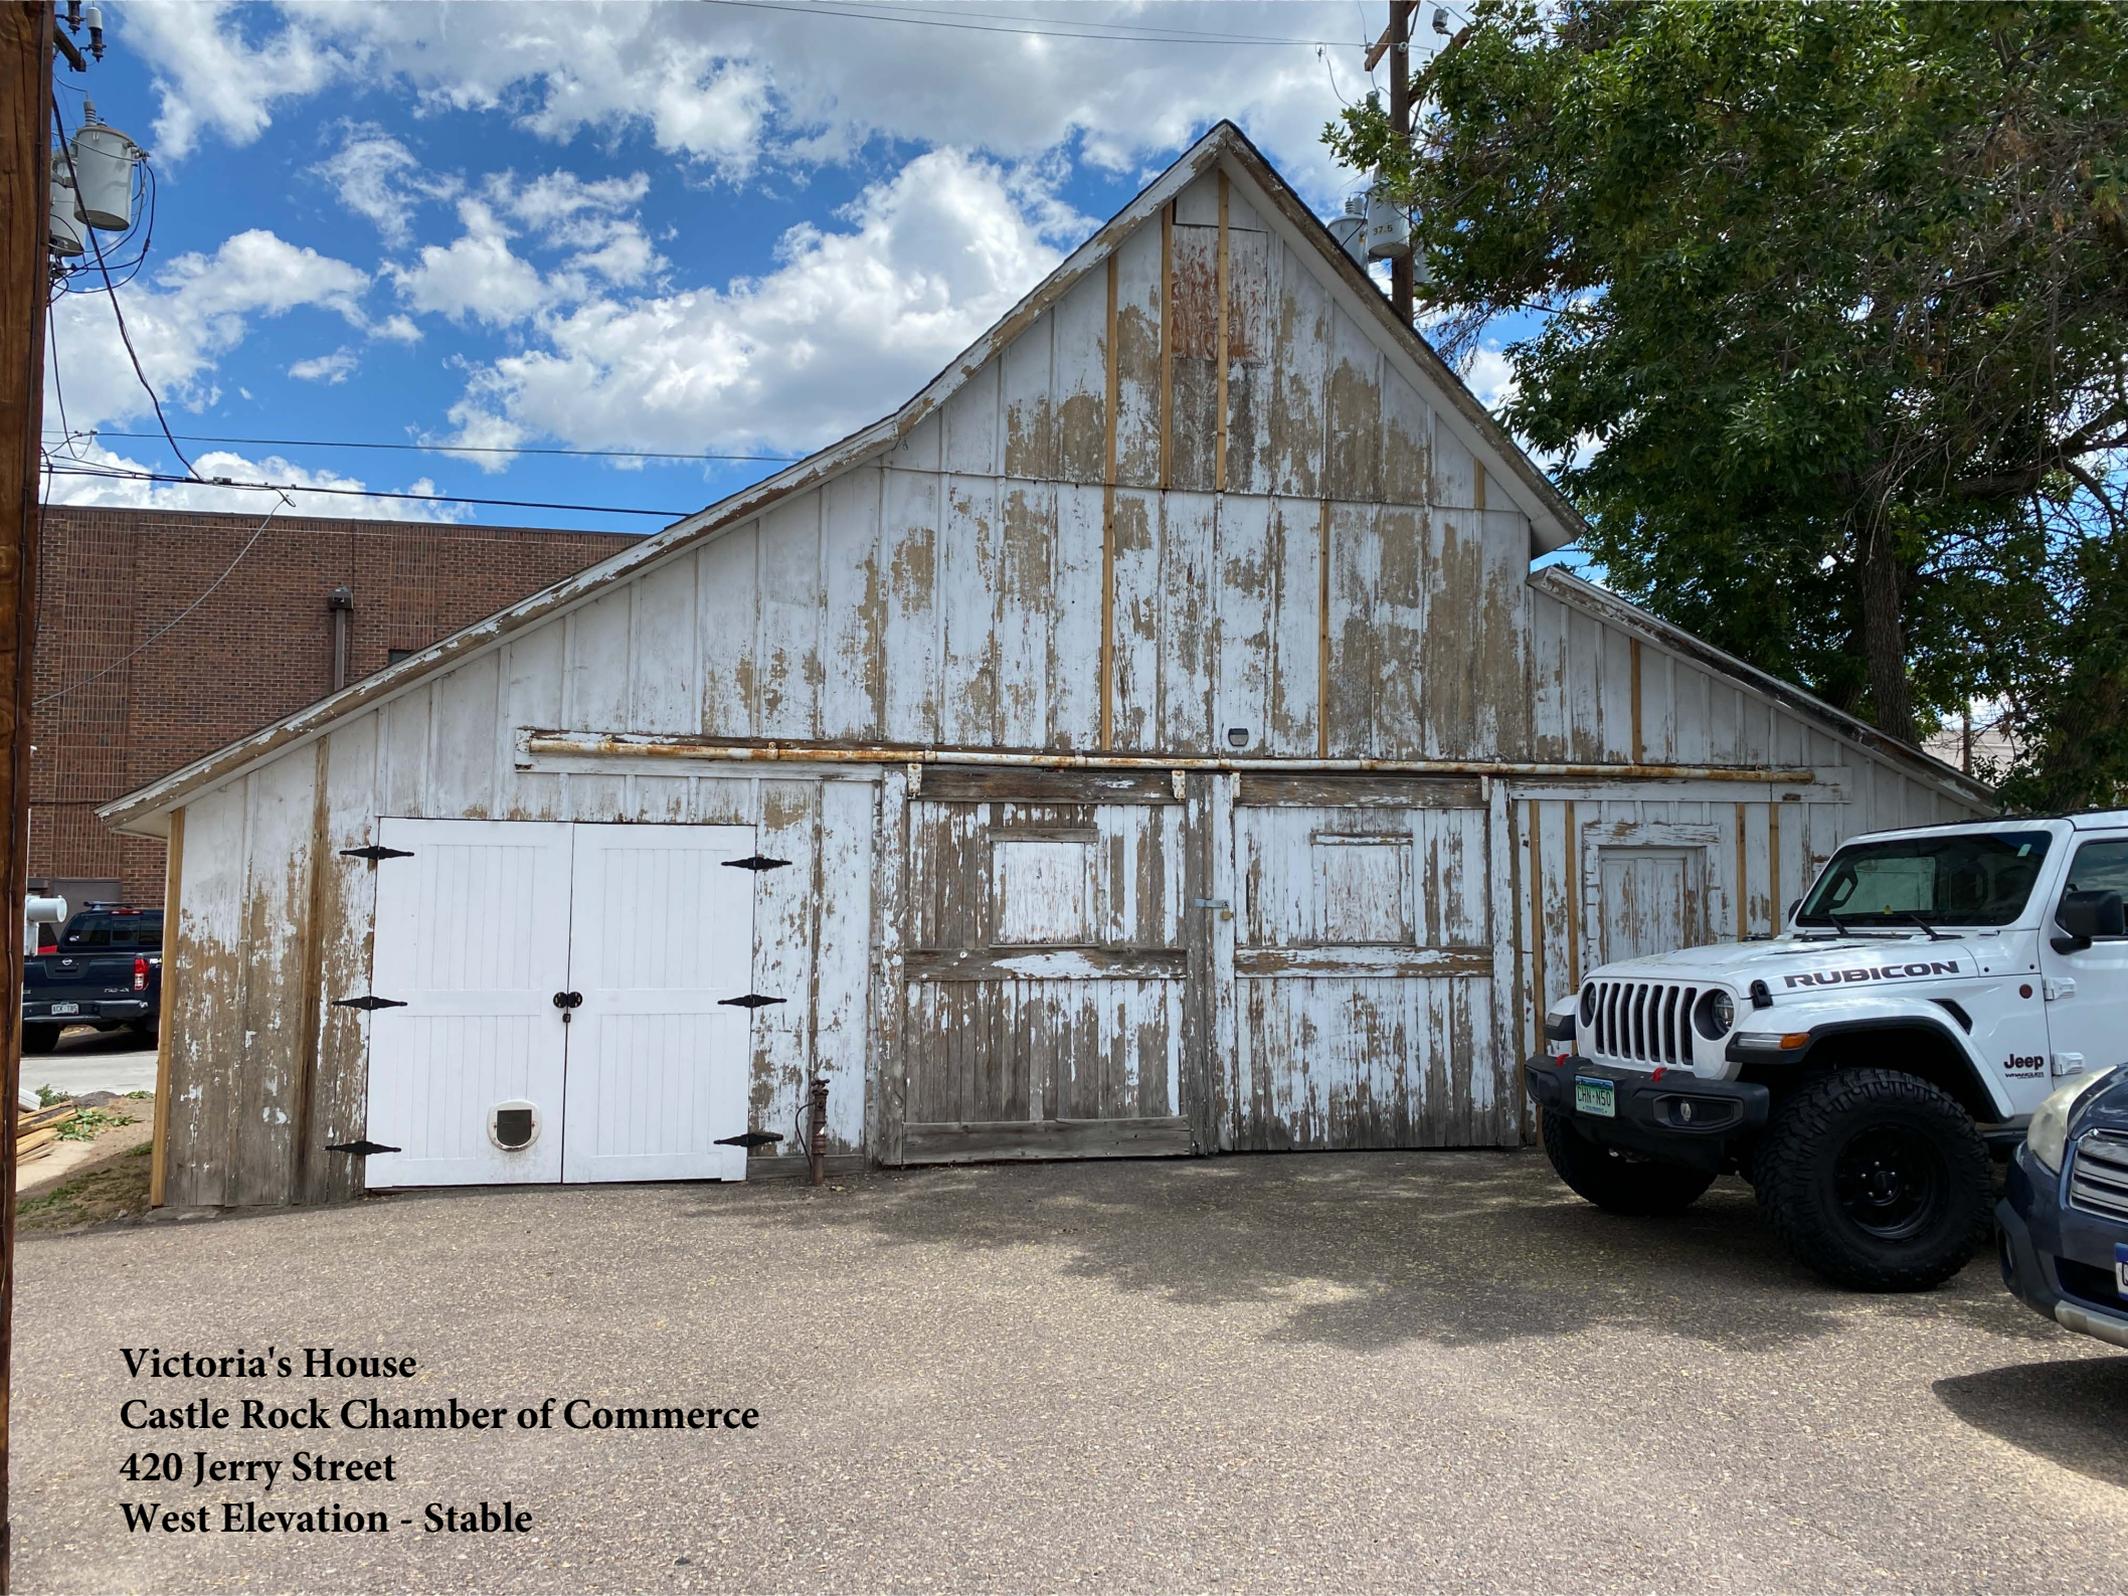
**Victoria's House
Castle Rock Chamber of Commerce
420 Jerry Street
West Elevation - Stable**

Barn: The barn is a front gable framed building with two side sheds. It is a rectangular plan with a smaller shed on the south elevation and a larger shed on the north elevation. The roof is clad with asphalt shingle siding. The walls are clad with board and batten siding.

West Elevation: There is a pair of newer doors on the north shed addition, while the historic sliding barn doors

remain on the center gabled portion and the single man door remains on the south shed, along with a boarded-up window.

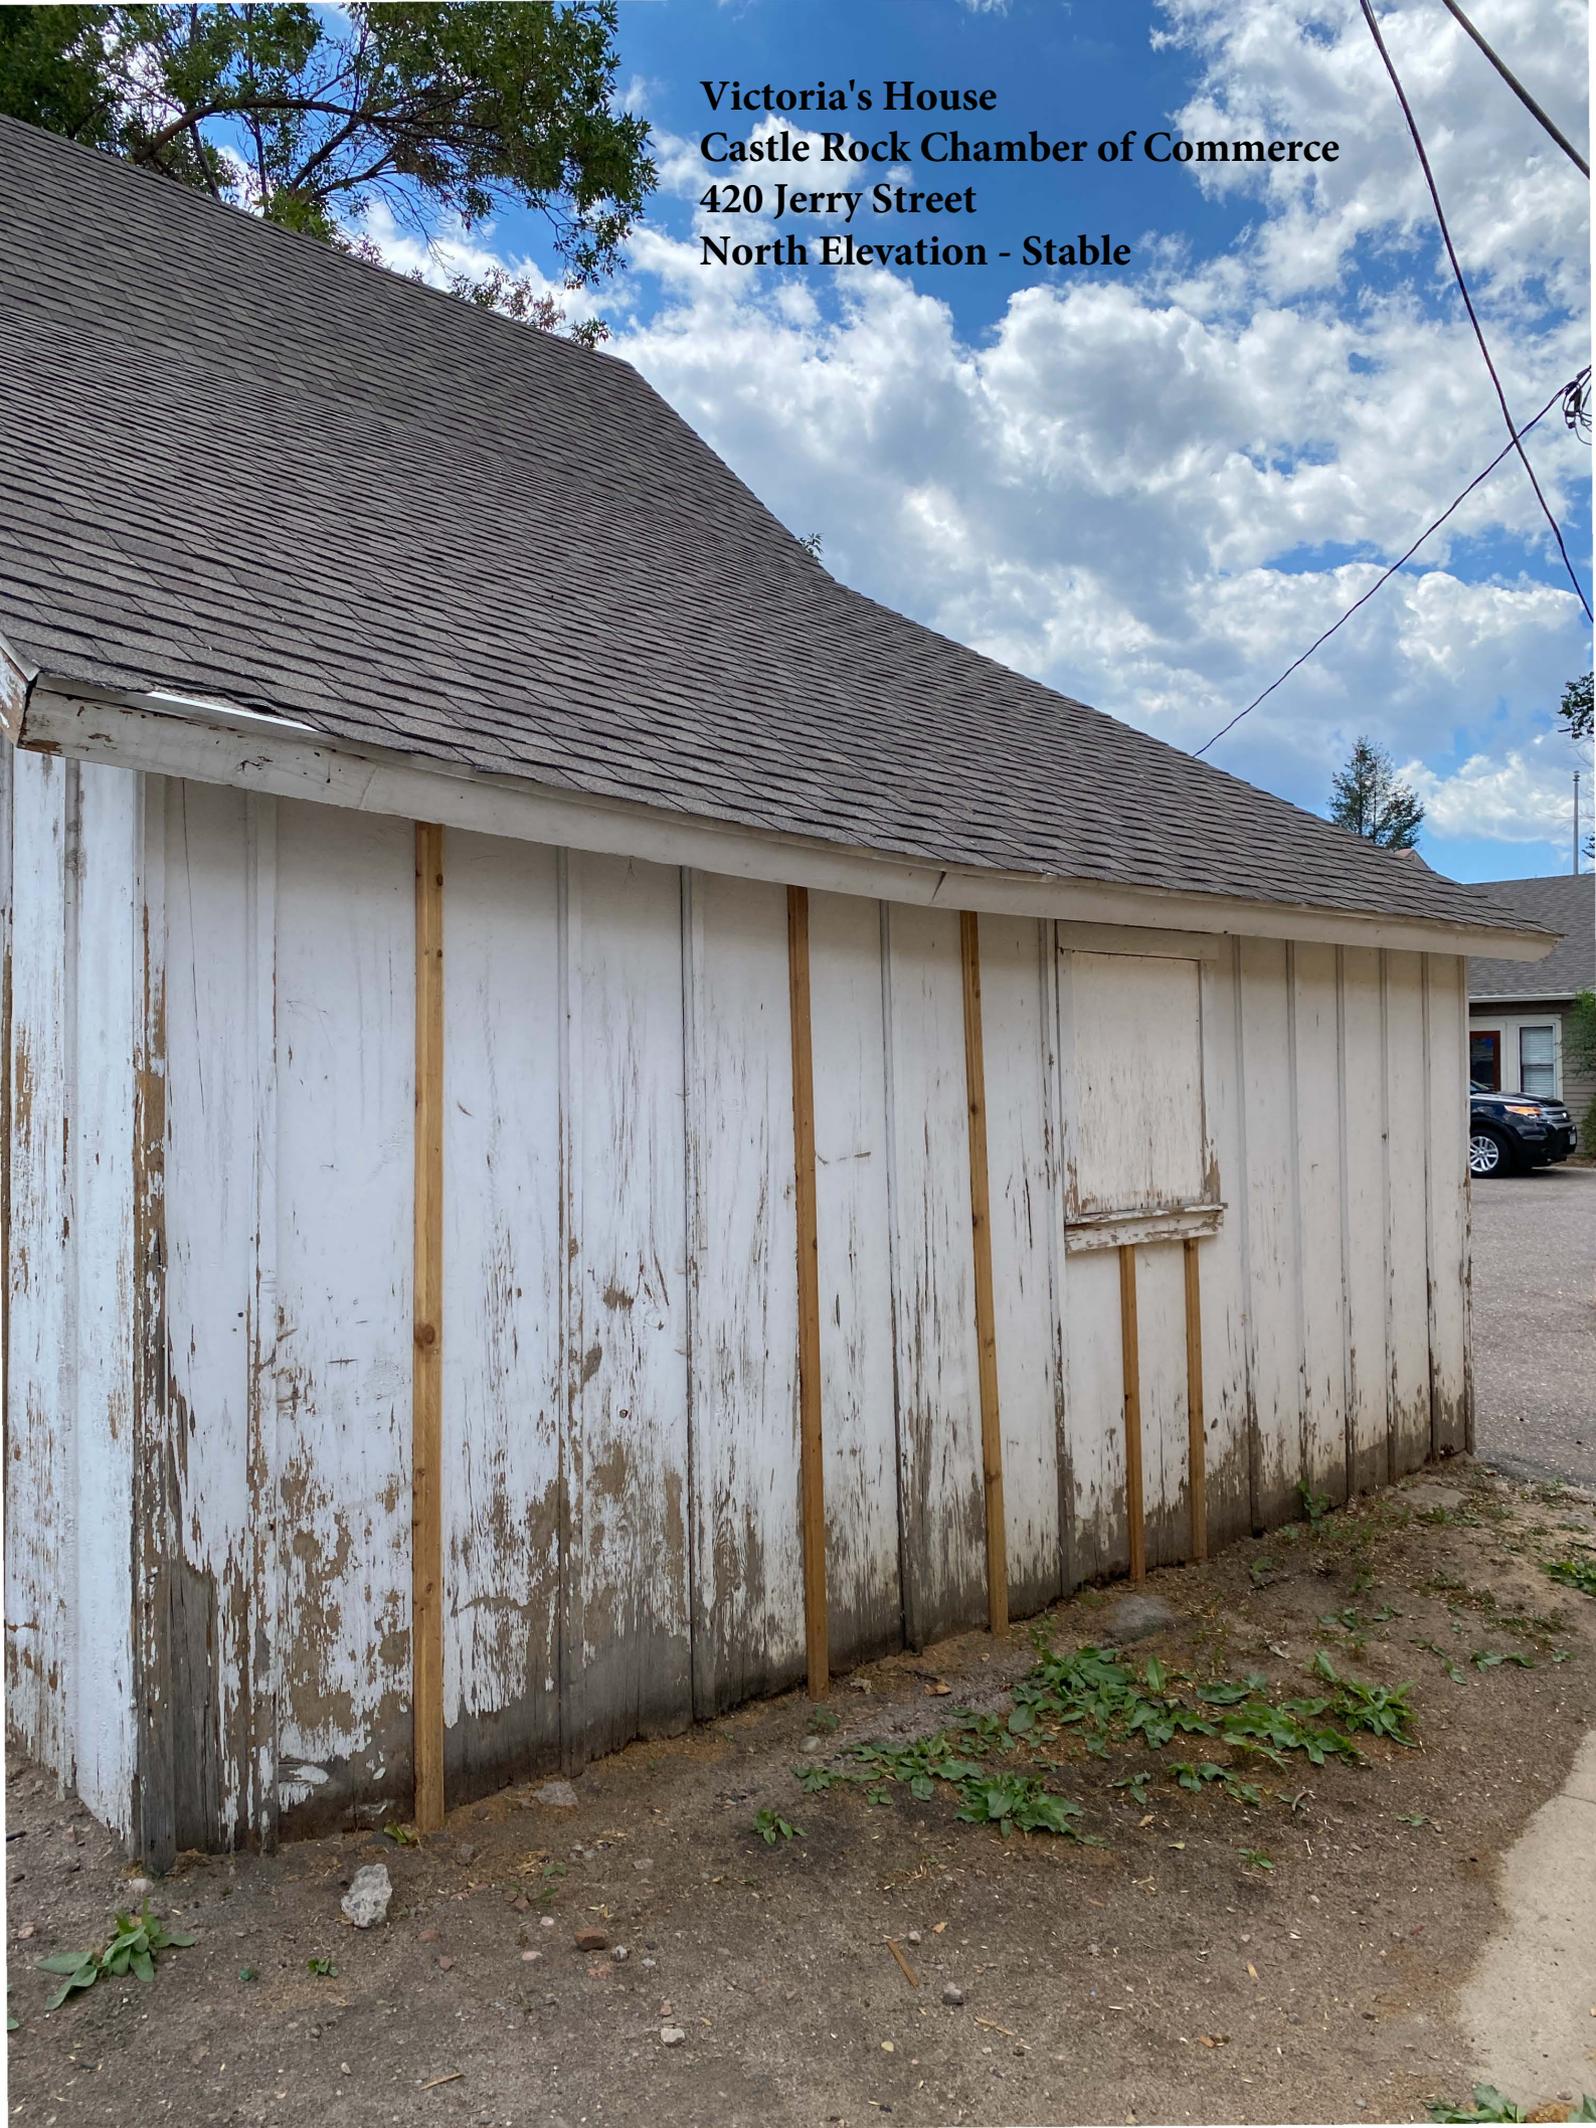
**Victoria's House
Castle Rock Chamber of Commerce
420 Jerry Street
North Elevation - Stable**

North & South Elevations: There is an offset, boarded-up window.
