COLORADO CULTURAL RESOURCE SURVEY

Architectural Inventory Form

1. Resource Number: 5DA.217
2. Temporary Resource Number: 838
3. County: Douglas
4. City: Castle Rock
5. Historic Name: Christensen House (Victoria's House)
6. Current Building Name: Castle Rock Chamber of Commerce
7. Building Address: 420 Jerry Street
8. Owner Name and Address: Castle Rock Chamber of Commerce; 420 Jerry Street, Castle Rock 80104

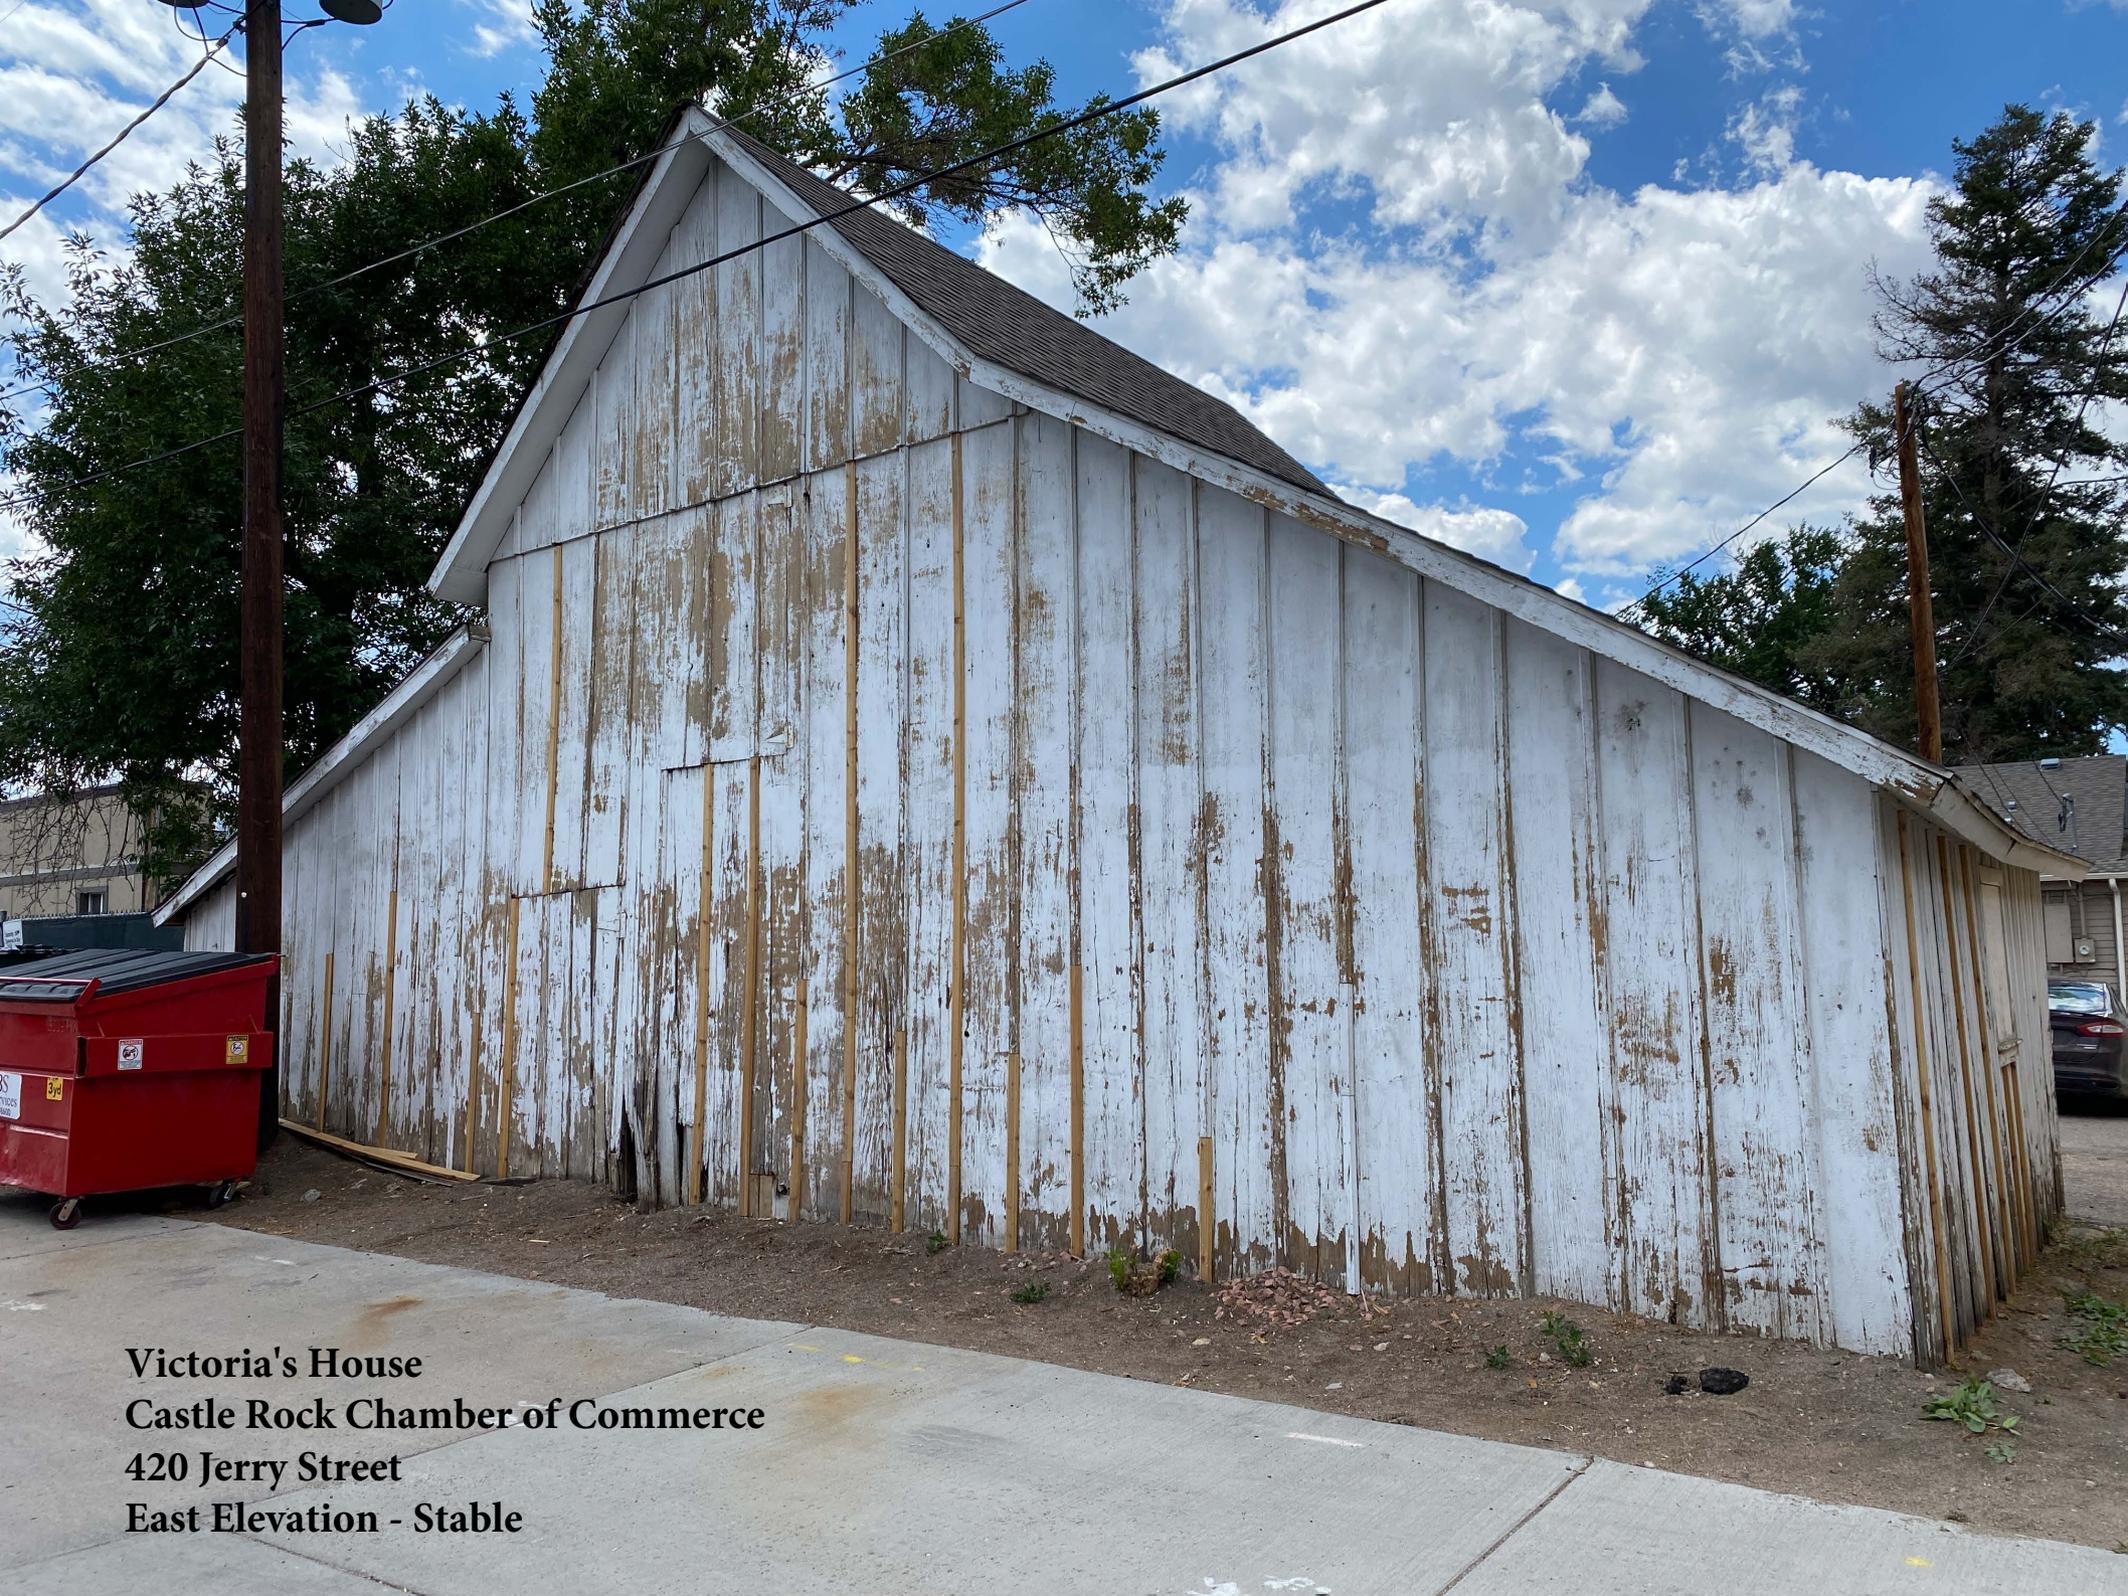
**Victoria's House
Castle Rock Chamber of Commerce
420 Jerry Street
East Elevation - Stable**

East Elevation: This elevation may have had several doors, which have been removed and replaced with board and batten siding. Above, in the central gable section, there appears to be another door into the hay loft.
