COLORADO CULTURAL RESOURCE SURVEY Architectural Inventory Form

1. Resource number: **5DA.2041**
2. Temporary resource number: **[NONE]**
3. County: **Douglas**
4. City: **Castle Rock**
5. Historic building name: **[NONE]**
6. Current building name: **[NONE]**
7. Building address: **104 Lewis**
8. Owner name and address:

47. Photograph numbers: 1 Roll# 6810, Frame 21A
2 Roll# 6810, Frame 22A
3 Roll# N/A, Frame
- Negatives filed at: **Preservation Partnership**
48. Report title: **Castle Rock Survey of Historic Resources**
49. Date (s) **August 29, 2005**
50. Recorder (s): **Nancy Lyons and John Hoffecker**
51. Organization: **Preservation Partnership Colorado**
52. Address: **1540 Cook Street Denver, Co. 80206**
53. Phone number (s): **303-780-0056 nrlyons@qwest.net**

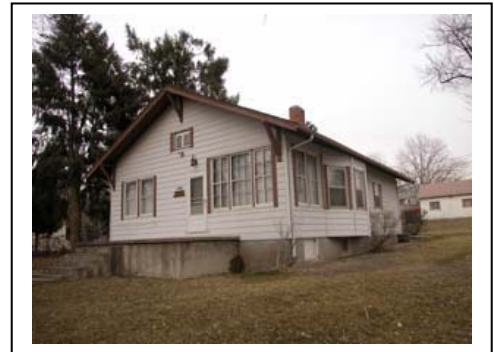
This is a rectangular plan frame house with moderately-pitched gable roof that incorporates a small bay on the south. The building is set on a concrete foundation with basement. The floor level is approximately three feet above grade, and the front entry has a concrete porch and stair with seven risers. The house is finished with aluminum siding and contemporary wood trim. All windows and doors are newer aluminum units.

A small two-car garage at the rear of the lot has a front gable roof with exposed rafter ends, divided-light wood windows, and is finished with wood shingles. This building also is set on a concrete foundation.
