COLORADO CULTURAL RESOURCE SURVEY

Architectural Inventory Form

1. Resource number:
2. Temporary resource number: CR-EW-01
3. County: Douglas
4. City: Castle Rock
5. Historic building name: N/A
6. Current building name: Peach Residence
7. Building address: 607 6th Street, Castle Rock, CO 80104
8. Owner name and address: Luke Steven Peach and Elissa Ann Peach, 607 Sixth Street, Castle Rock, CO 80104

49. Date(s): May 20, 2026

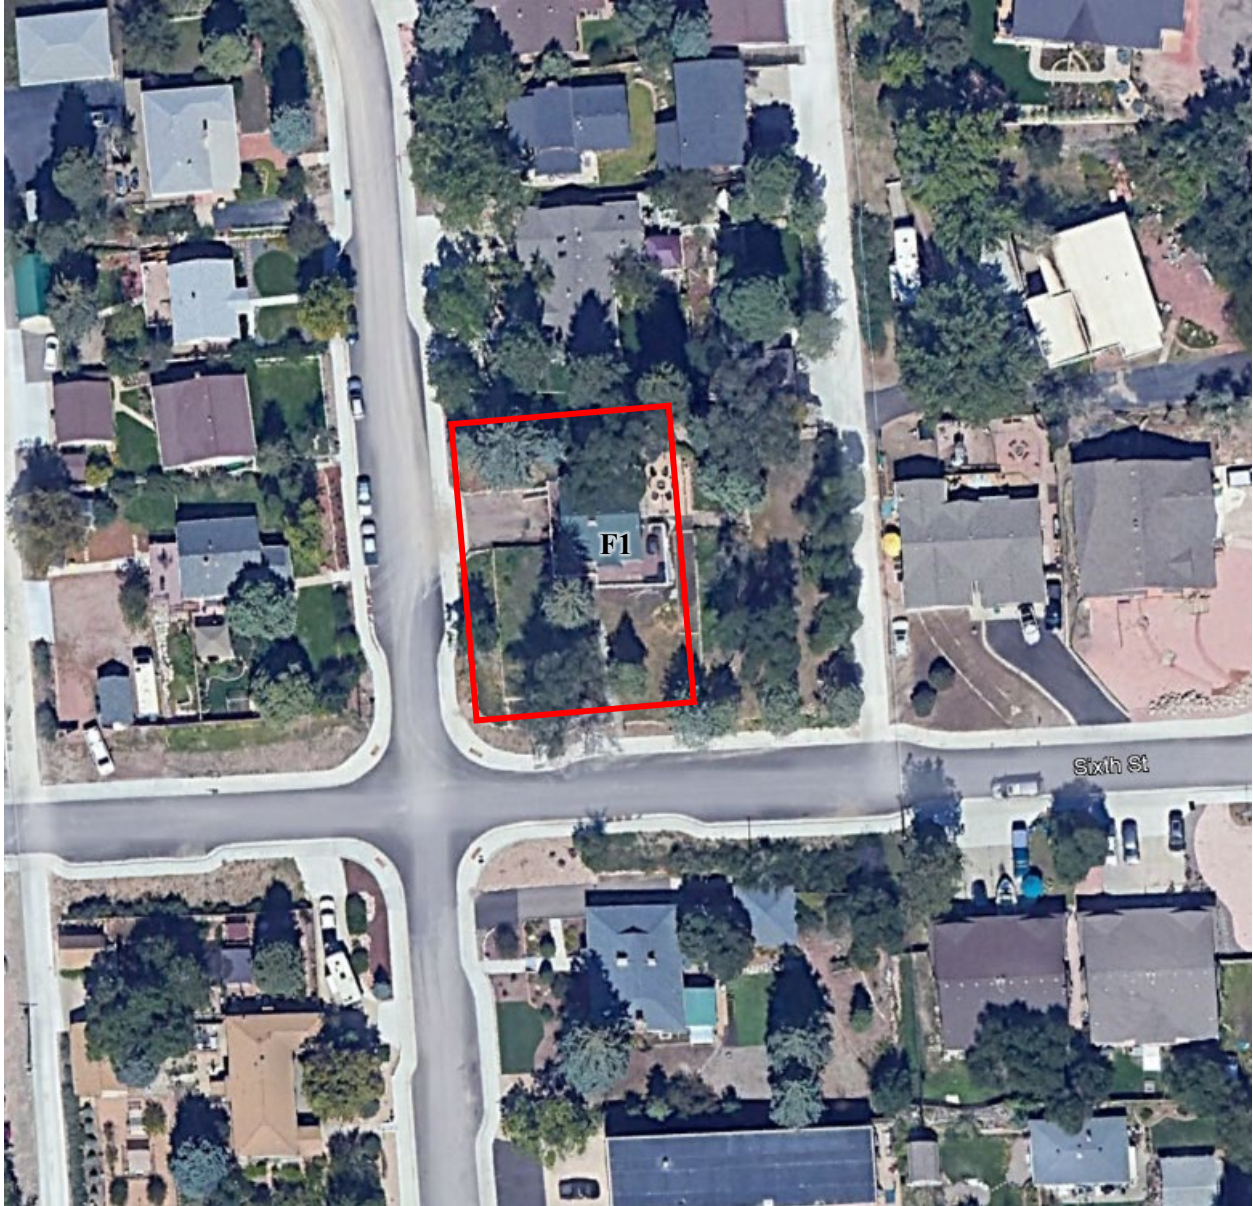
Map 3. Sketch Map of 607 Sixth Street, Castle Rock, Colorado, including rough parcel boundary; see Map 2 for official parcel boundary. September 2023 aerial imagery.

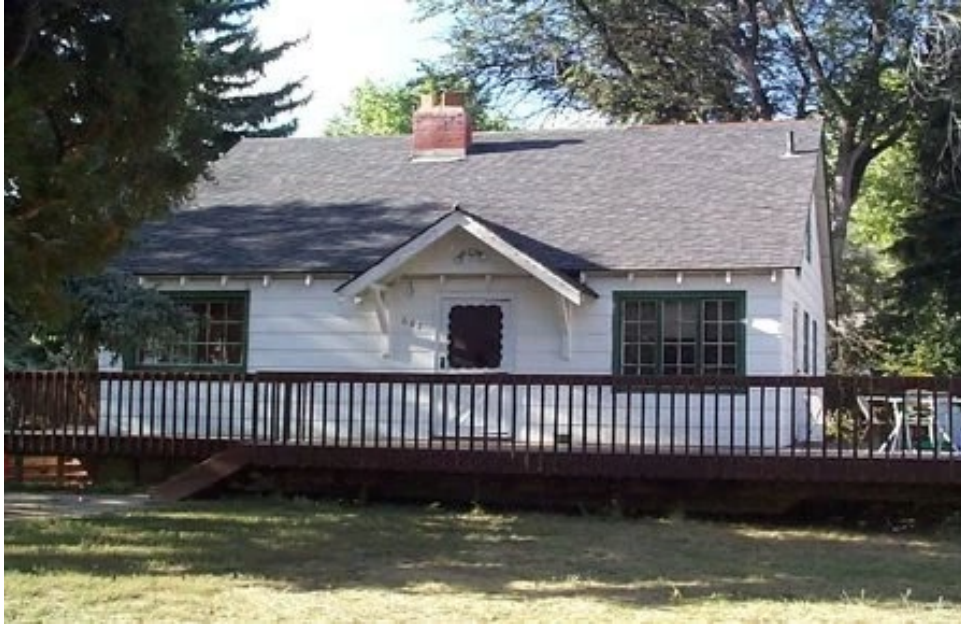
Photo of residence in ca. 2002. Courtesy of the Douglas County Assessor's Office database.

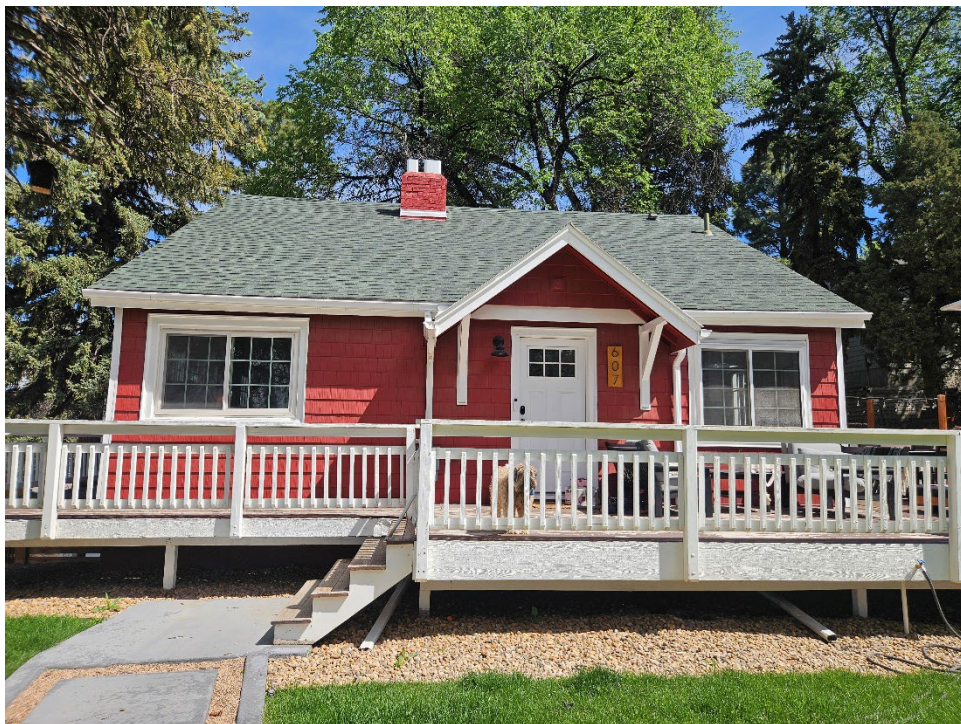
The primary elevation faces south and is accessible via a set of steps that extend off the front porch. The primary elevation is asymmetrical, with the primary entrance located on the east side of the elevation. The entrance is a two-panel, six-light, aluminum door. The entrance is topped by a gable wall dormer with wooden brackets. The primary elevation features a nine-by-nine, horizontal sliding window unit and an eight-by-eight, horizontal sliding window unit.

Primary (south) elevation of the residence, view north
(Roll 26-450, image 103208; Emily Wren; 5/22/2026)

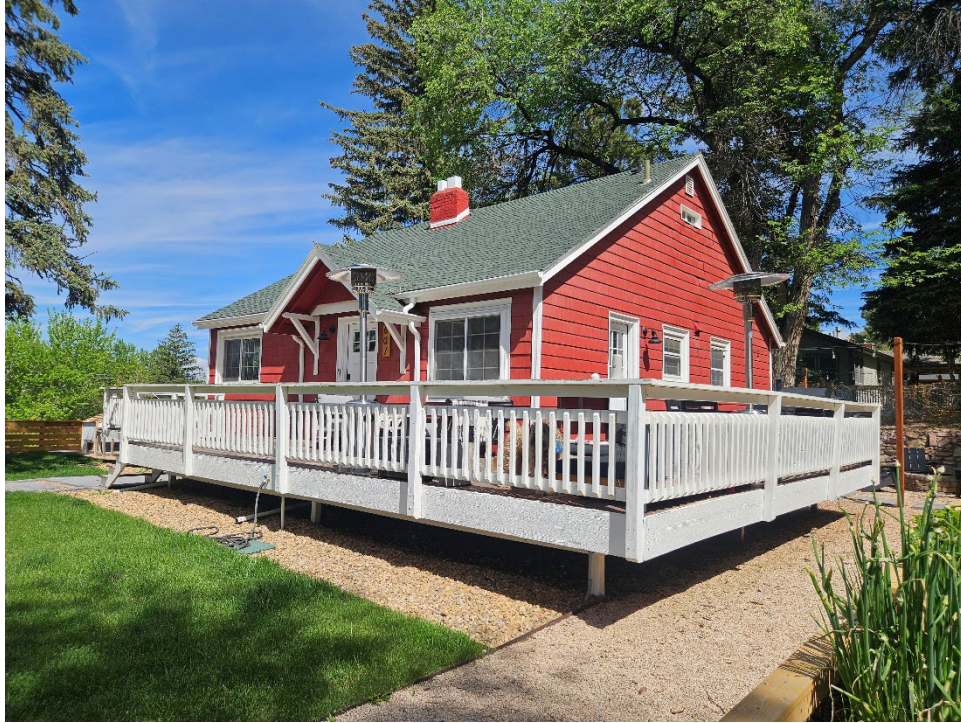
Primary (south) and east elevations of the residence, view northwest
(Roll 26-450, image 103222; Emily Wren; 5/22/2026)

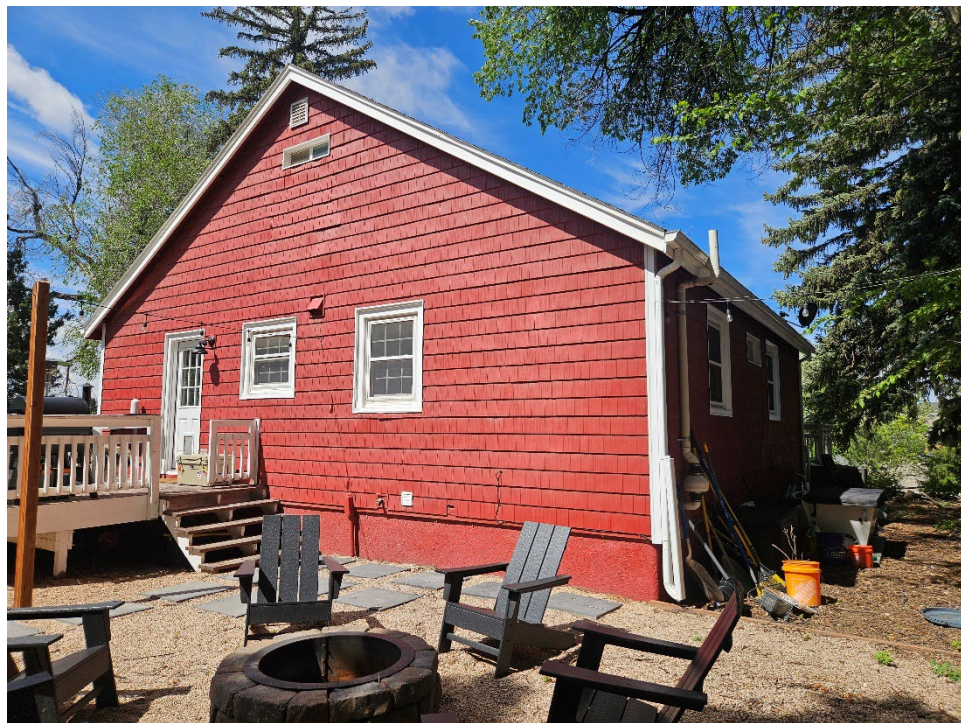
The north elevation features two six-over-six, double-hung sash window units and a one-by-one, horizontal slider unit in between.

The east elevation features an additional entrance through a two-panel, nine-lite aluminum door; the door features a pet entrance cut out of the bottom. The east elevation features two six-over-six, double-hung sash windows that are two different sizes. A small, one-by-one window is just below the gable end peak.

East and north elevations of the residence, view west
(Roll 26-450, image 103249; Emily Wren; 5/22/2026)

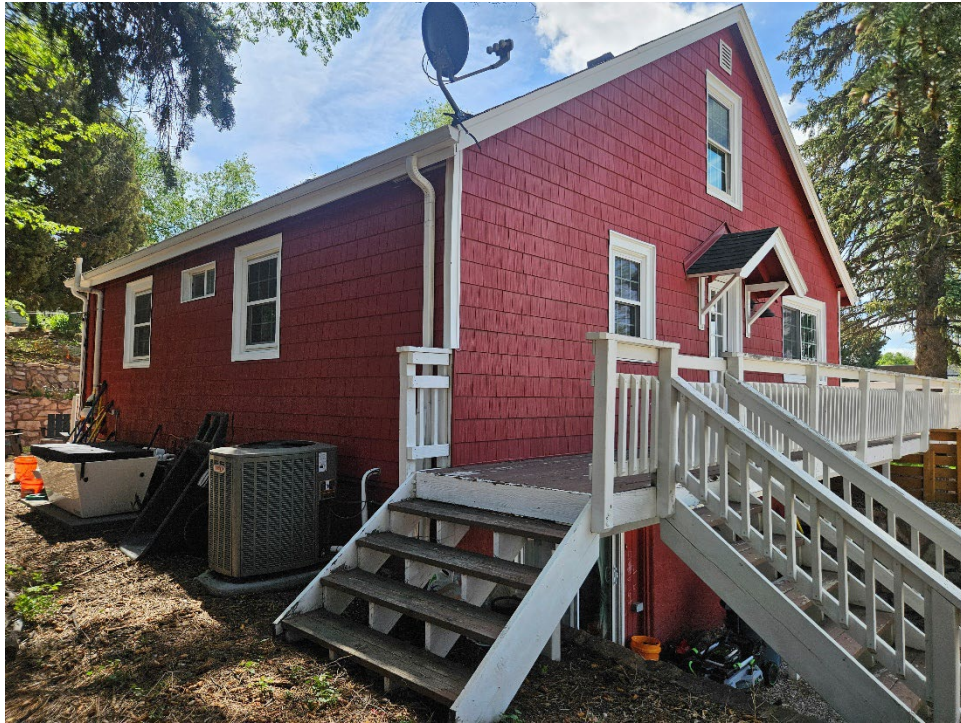
North and west elevations of the residence, view southeast
(Roll 26-450, image 103316; Emily Wren; 5/22/2026)

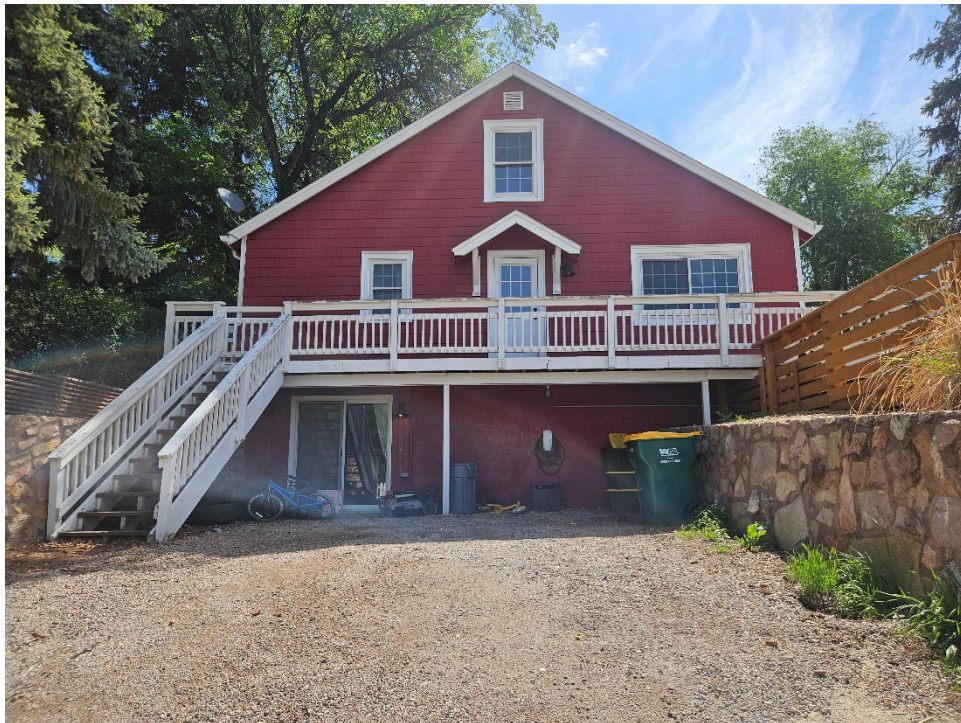
The west elevation features the exposed basement level, which consists of a vinyl sliding glass door. The basement level appears to be of concrete construction. The sliding glass door is surrounded by vertically oriented wood siding. The main floor of the west elevation is spanned by the wraparound porch. The porch features a long stairway that extends west into the gravel driveway in front of the basement level. The main floor has a centrally located secondary entrance that is topped by a front gable portico with wood brackets. The entrance is a two-panel, nine-lite, aluminum door. There are three windows along the west elevation: a six-over-six, double-hung sash unit; a twelve-by-twelve, horizontal slider unit; and a six-over-six, double-hung sash unit just beneath the gable end.

West elevation of the residence, view east
(Roll 26-450, image 103504; Emily Wren; 5/22/2026)

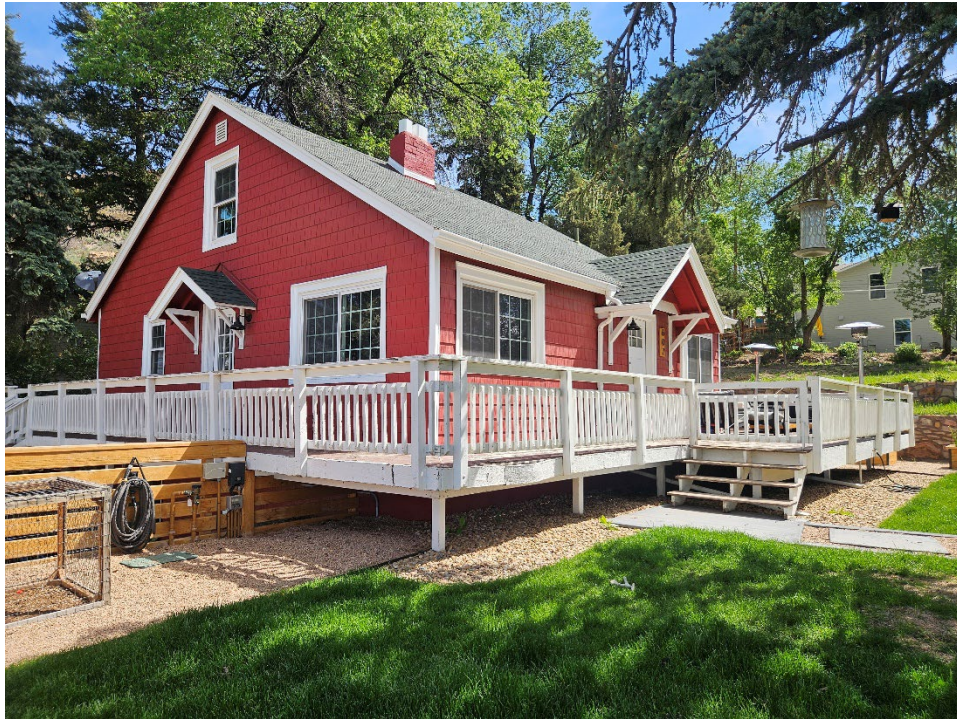
Primary (south) and west elevations of the residence, view northeast
(Roll 26-450, image 103604; Emily Wren; 5/22/2026)

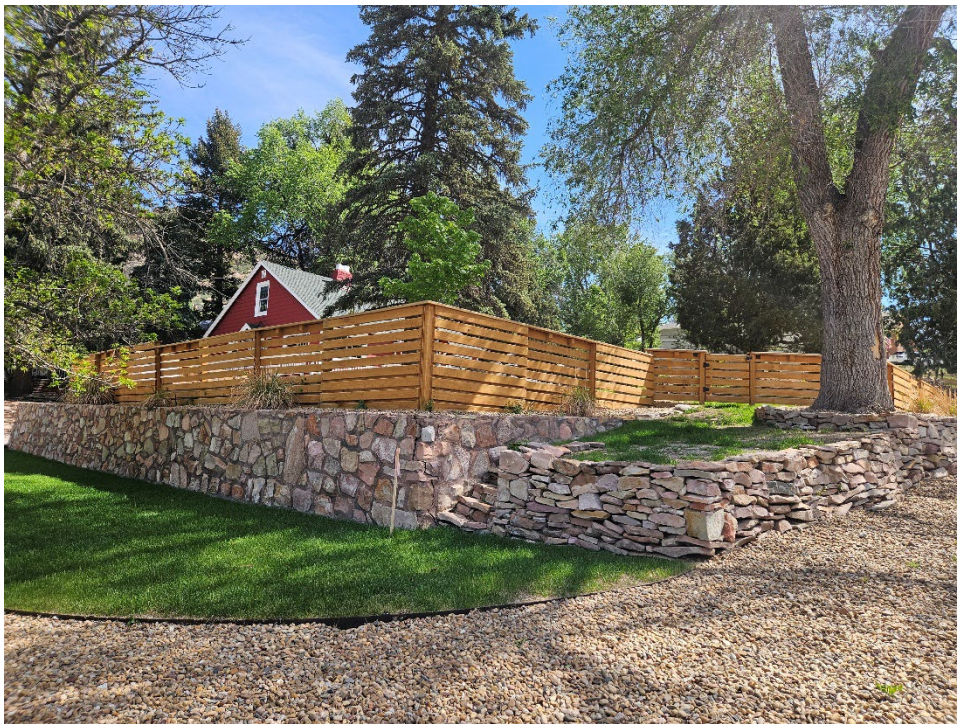
View of the property from the intersection of Sixth Street and Cantril Street, view northeast
(Roll 26-450, image 103028; Emily Wren; 5/22/2026)

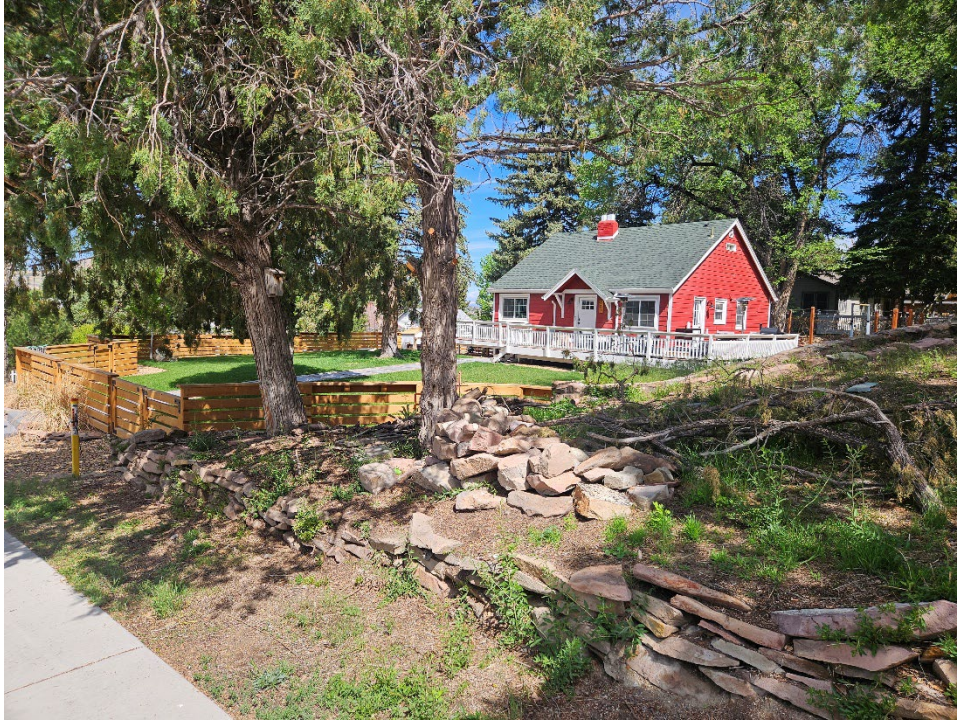
View of the property from the east adjacent parcel, view northwest
(Roll 26-450, image 102945; Emily Wren; 5/22/2026)

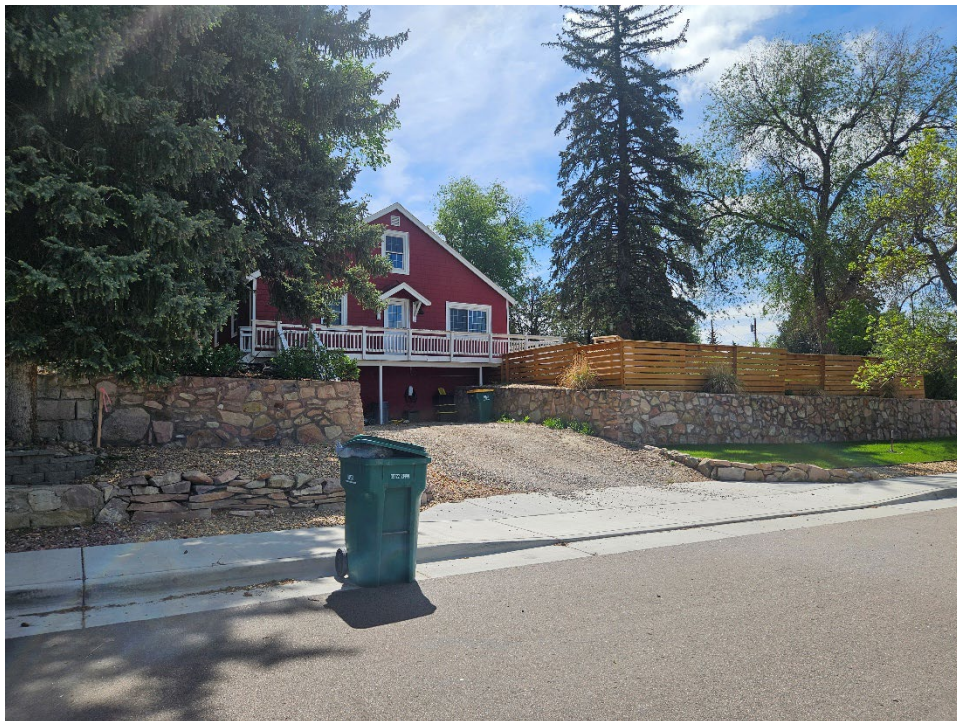
View of the property from Cantril Street at the northwest corner, view southeast
(Roll 26-450, image 103100; Emily Wren; 5/22/2026)

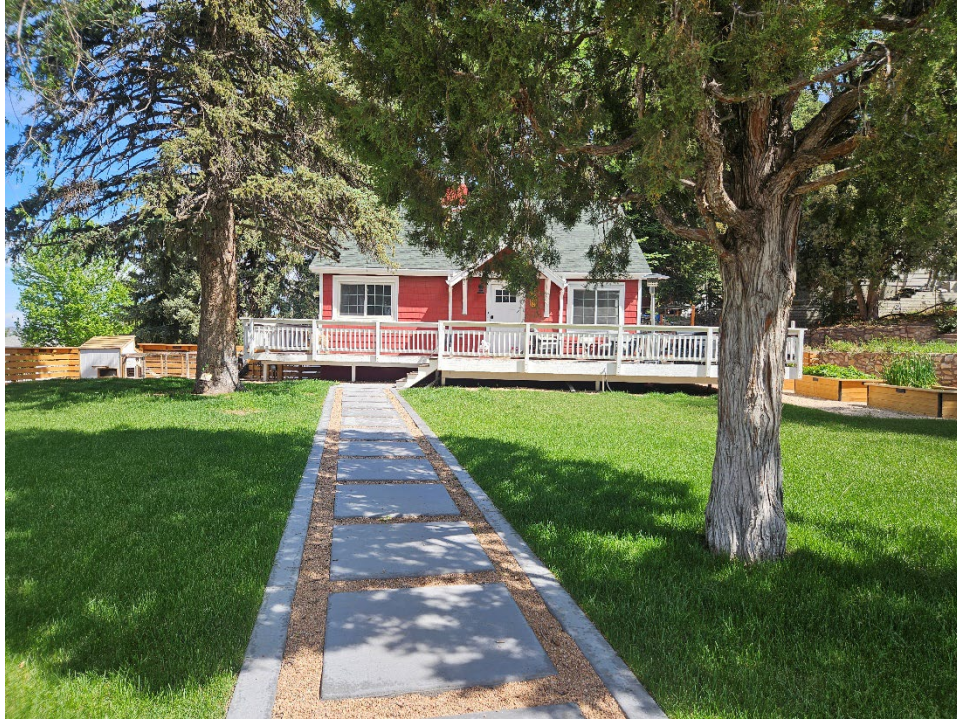
View of front yard and concrete pathway to south elevation of residence, view north
(Roll 26-450, image 103150; Emily Wren; 5/22/2026)

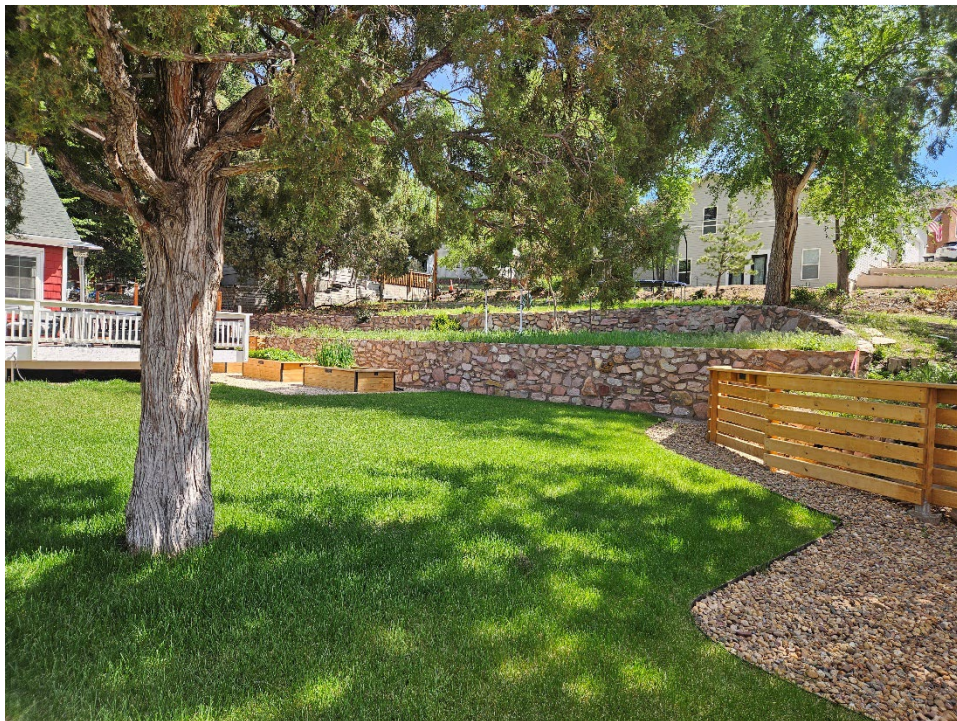
23. Landscaping or special setting features: The residence is located within a residential neighborhood. The building is built on a sloped surface. The west and east sides of the front yard are bordered by wet laid retaining walls, while the south end of the property features dry laid stone. A similar, wet-laid retaining wall is located on the northwest corner of the property. The west side of the property features a gravel driveway, with the aforementioned retaining walls on the north and south sides. The yard on the south side of the residence is bordered by a modern wood fence. A modern, concrete and pea gravel path leads through the yard to the porch. The east side of the residence features a large section of pea gravel and features a built-in fire pit.
24. Associated buildings, features, or objects: N/A

View of the front yard and terracing retaining walls on adjacent parcel, view northeast
(Roll 26-450, image 103153; Emily Wren; 5/22/2026)

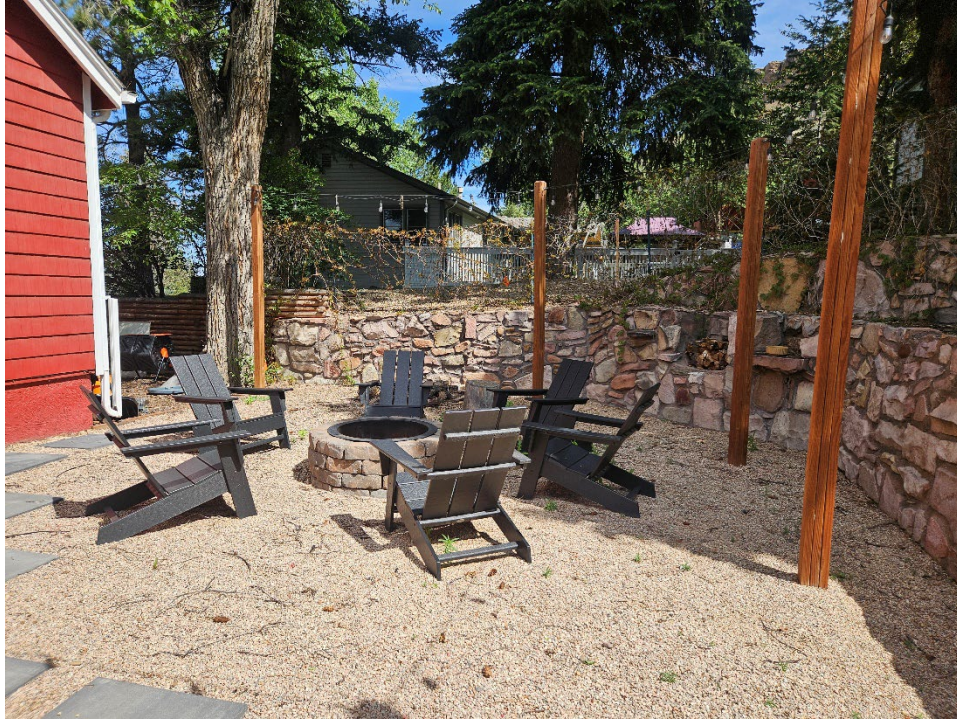
View of outdoor seating area, fire pit, and retaining wall on northeast corner of residence, view north

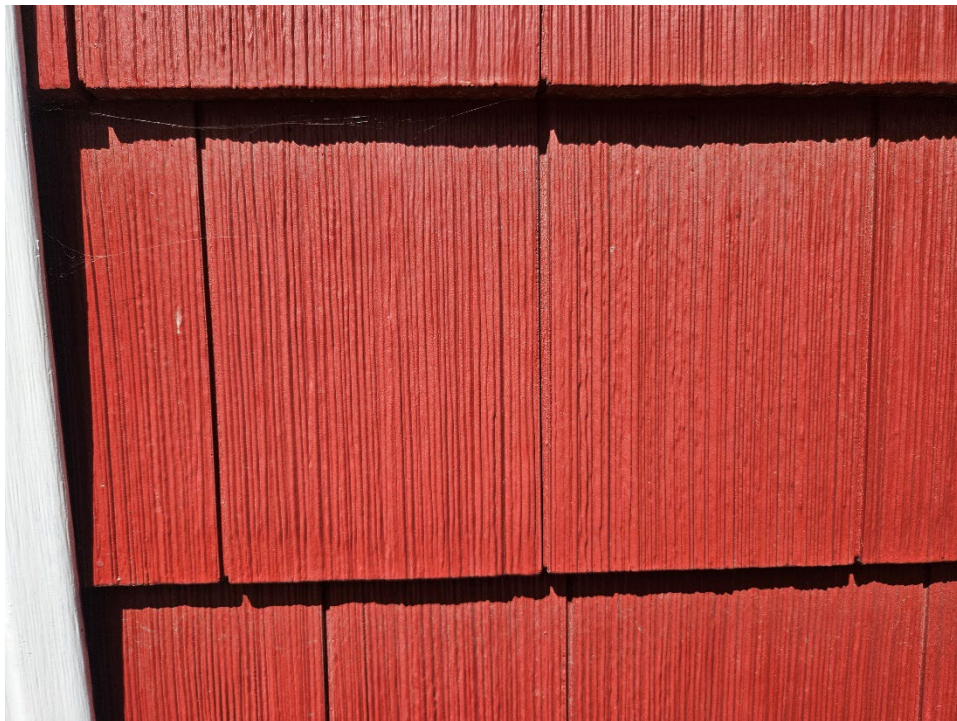
- 2012 – 2015: The residence is re-sided with faux cedar shingles.
30. Original location X Moved Date of move(s):

The residence has undergone significant modern alterations. It features replacement siding and windows, an unoriginal wraparound porch, and its original exposed rafter ends have been removed. Thus, the residence lacks integrity of design, materials, and workmanship.

Close-up of the replacement shingle siding
