**Town of Castle Rock, CO
Castle Rock Recreation Center
2301 Woodlands Boulevard
Castle Rock, CO 80104**

Roof and Exterior Building Envelope Inspection

Re: Roof and Exterior Building Envelope Investigation

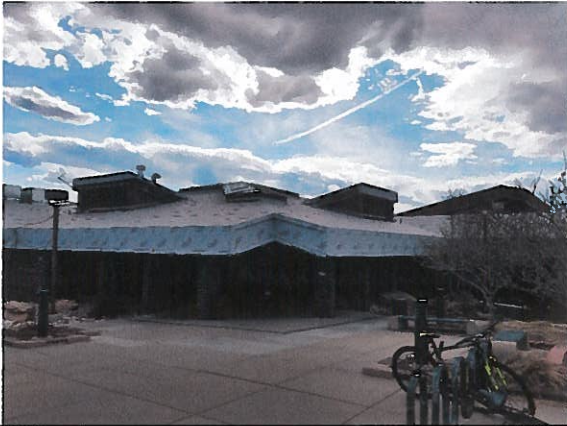
Photo #1:	Visual inspection starts here at front entrance and moves to the right around the entire building.
-----------	--

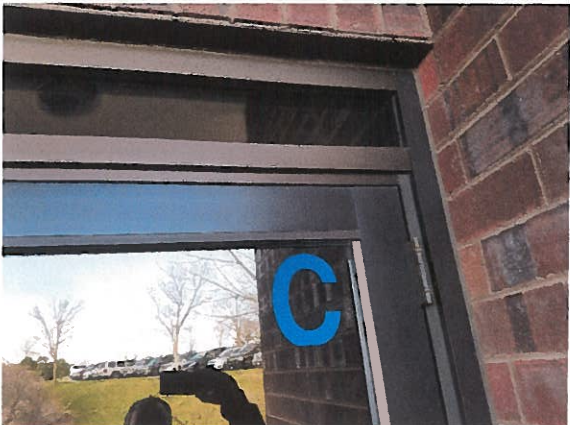
Photo #35: Photo to show where we are as we encircle building.

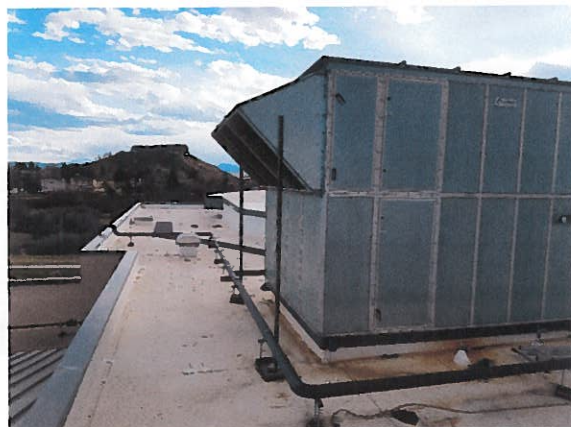
Photo #39: Roof with large roof top air handler for pool.

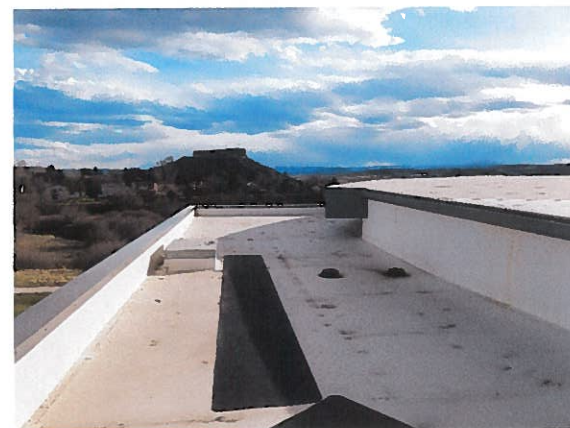
Photo #42: Roof overview.

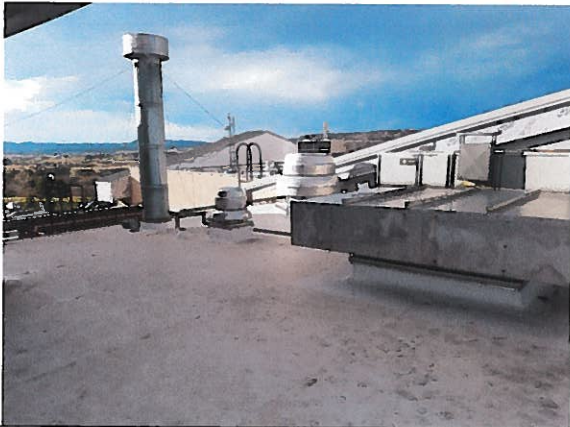
Photo #49: Roof area recently re-roofed.

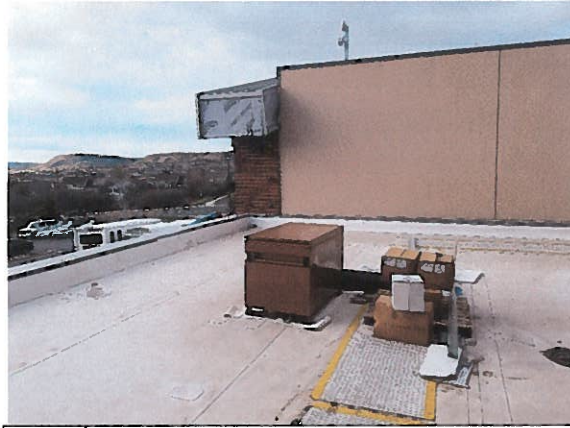
Photo #56:	Roof area at roof access from boiler room.
---------------	--
